**Australian Transport Safety Bureau**

# Low-speed collision between trains M05519A and M05519B

Finucane Island Balloon Loop, Port Hedland, Western Australia on 2 March 2024

RO-2024-002

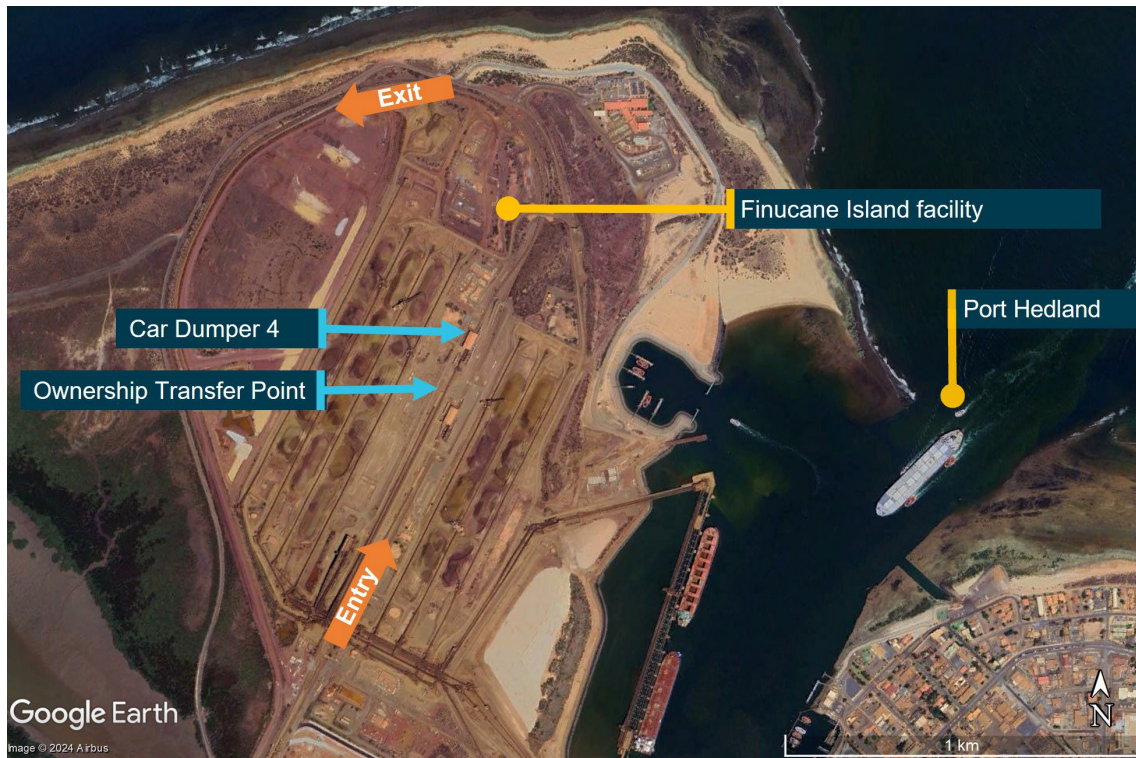
Figure 1: Finucane Island facility showing car dumper 4 and its owner transfer point

At about 2320 local time, train A entered Finucane Island yard limits.<sup>1</sup> Within the yard limits, drivers had authority to move their train up to the owner transfer point (OTP) board for the relevant CD (Figure 1). There were no signals and limited controller oversight of the section between the yard limits board and the OTP board, and train drivers were responsible for visually maintaining separation with other rail traffic. Train A slowly progressed, before coming to a stand between 28 points and the OTP board for CD4, where it remained between 0156 and 0425 on 2 March 2024.

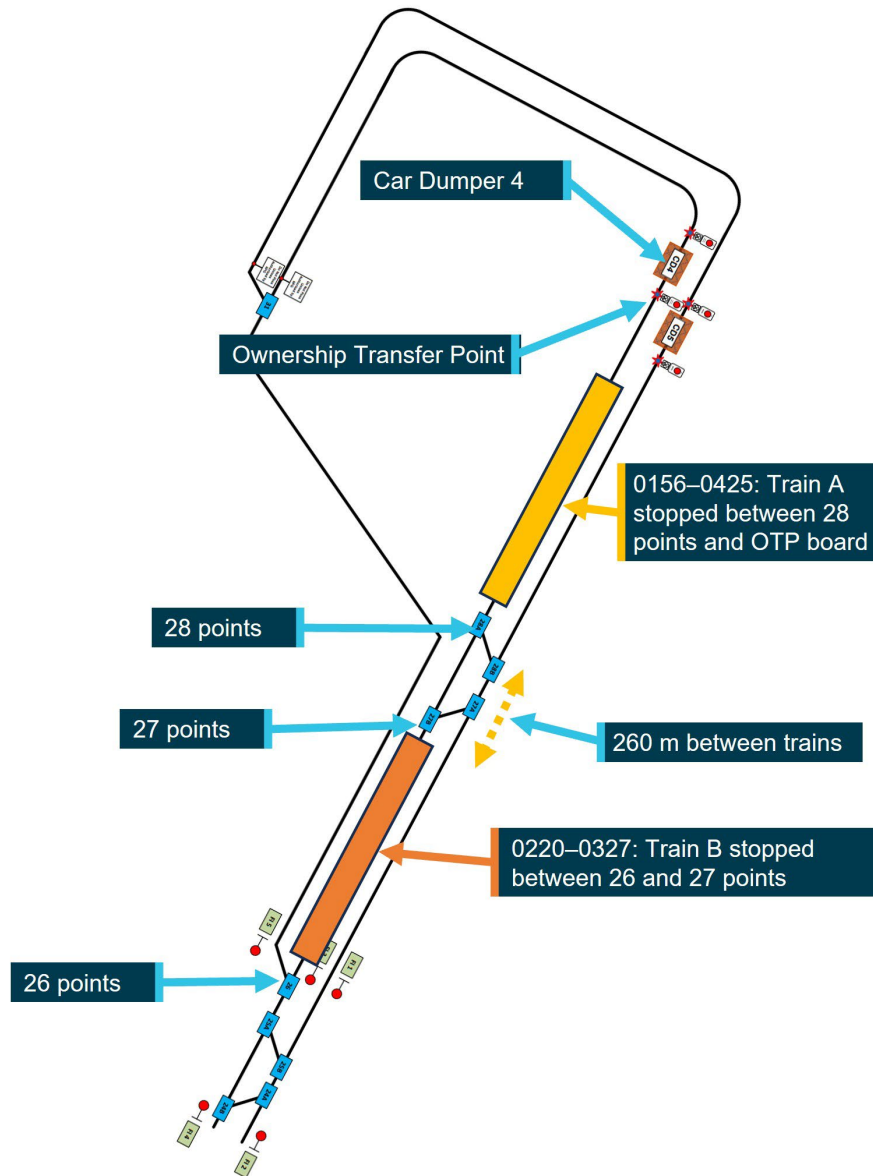
Figure 2: Diagrammatic representation of train positions from 0220 to 0327

At about 0200, having been stopped by train control for one hour at an en route yard, train B was authorised to enter Finucane Island yard limits and, at 0220, came to a stand 260 m behind train A. The entirety of train B was stopped between 26 and 27 points, the section of track with the steepest uphill grade before the car dumpers. Train B remained stopped in that location from 0220 until 0327 (Figure 2).

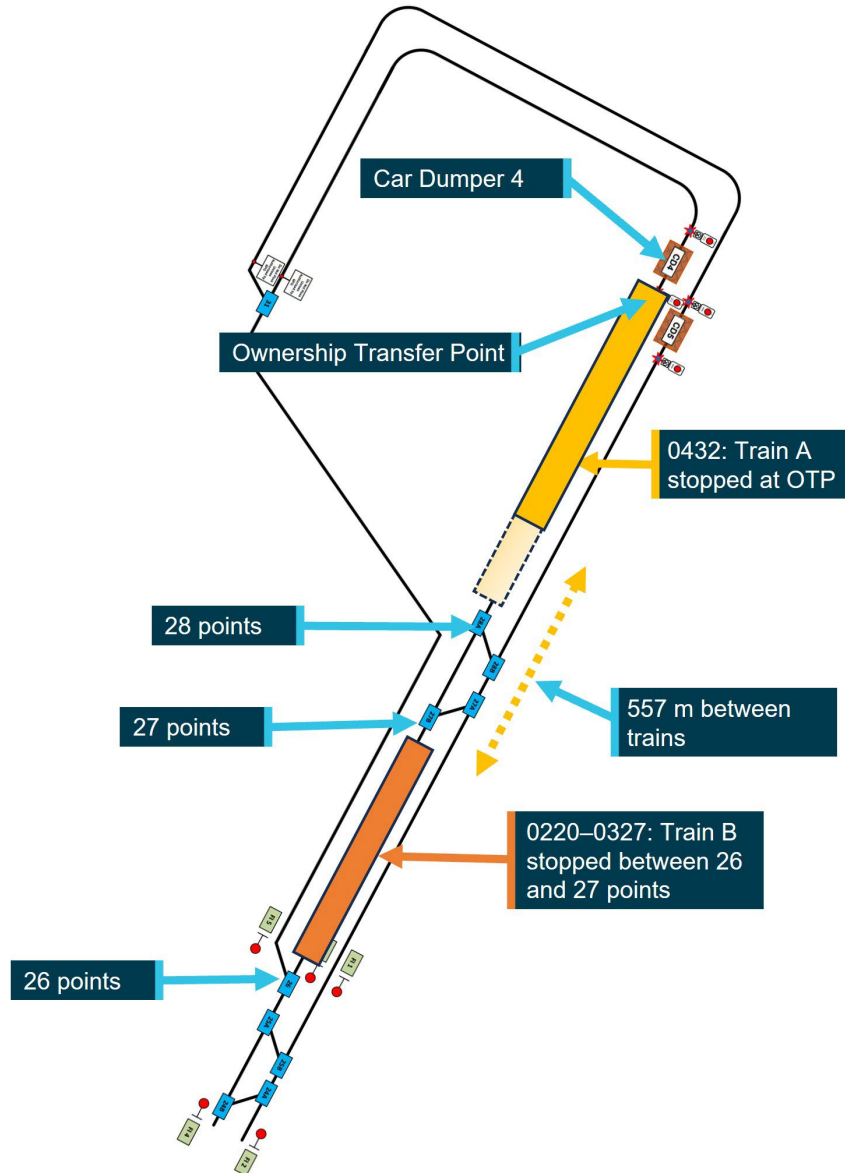
**Figure 3: Diagrammatic representation of train positions at 0432**

At 0425, after the preceding train departed CD4, the driver of train A placed the throttle into 2 notch, applying sufficient tractive effort to slowly move the train 325 m to the OTP board, before coming to a stand at 0432 (Figure 3). Train A's driver then awaited authority from the dumper operator to start the process for the train to proceed into CD4 and commence unloading.
