# Level crossing collision between freight train 6839 and truck

Gooray Road, Gooray, Queensland on 23 May 2024

## **ATSB Transport Safety Report**

RO-2024-004

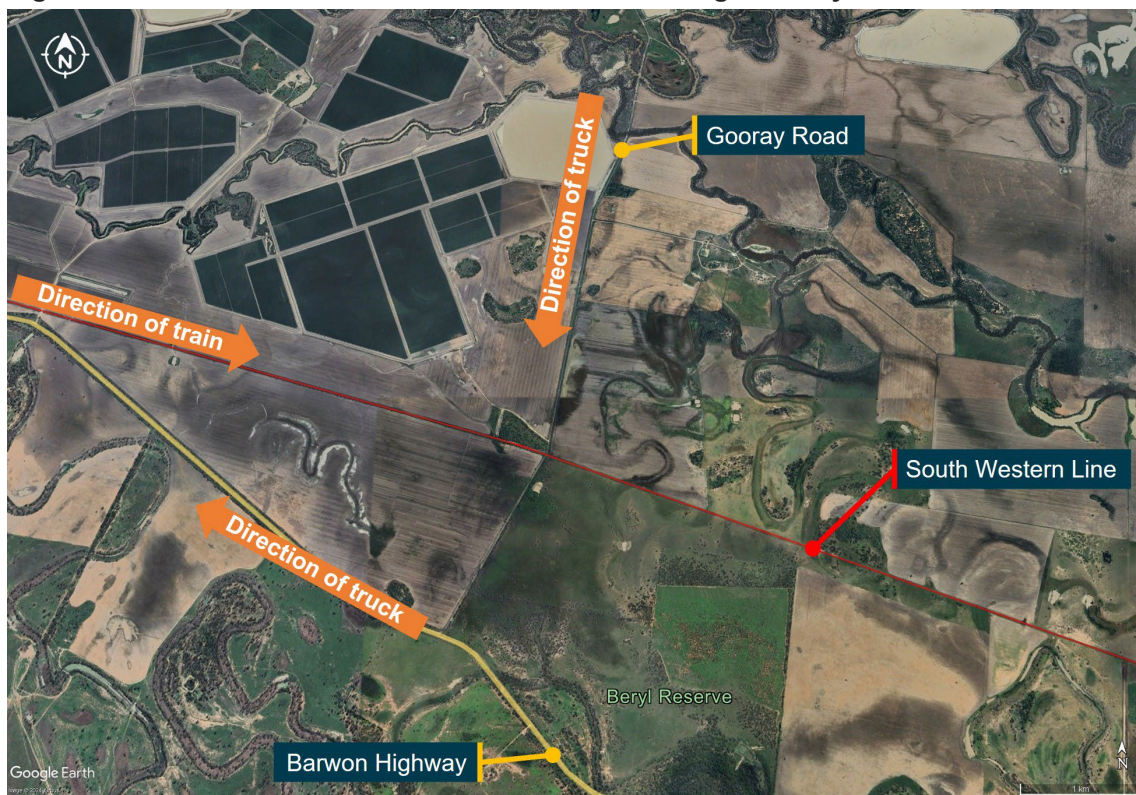
**Figure 2: Direction of travel for the truck and train through Gooray**

By the time train 6839 arrived at Toobeah, the truck driver had exchanged the flat-top trailer for a low-loader trailer at the farm on Gooray Road. The farm workers placed a bobcat or skid steer onto the low-loader, and the truck driver secured this equipment to the trailer. The truck driver intended to take this equipment back to the St George area via the Barwon Highway (Figure 2).

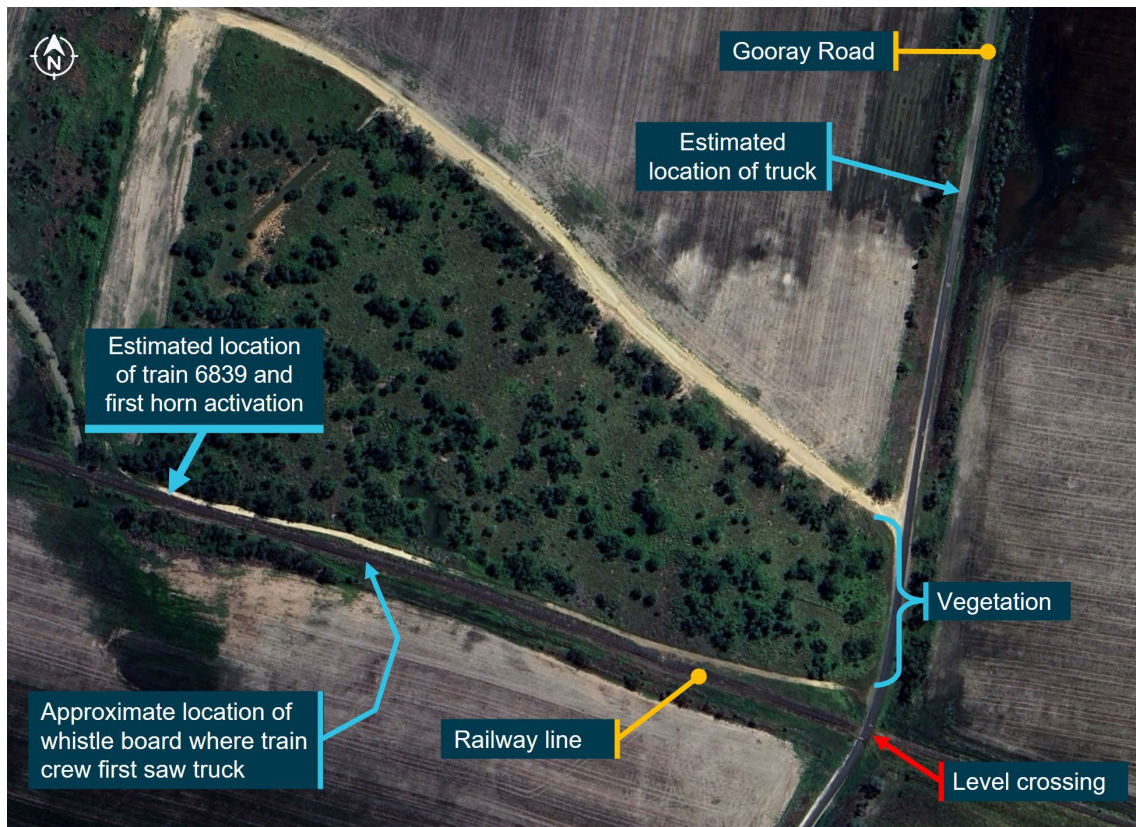
**Figure 3: Location of train and truck 30 seconds prior to the collision**

At about the same moment the crossing and warning signs would have come into the truck driver's view, the train DIC first sounded the train horn. Train drivers were required to sound the horn at a whistle board located about 316 m from the crossing. However, the train DIC sounded the horn earlier, 442 m prior to the crossing, aware that trees immediately prior to the crossing prevented extended line of sight for drivers of vehicles and trains (Figure 3).

As train 6839 passed the whistle board, the DIC first became aware of the truck and estimated the truck was doing at least 40 km/h and did not look like stopping. The train was 19 seconds from the crossing at that time, and the train crew sounded the horn almost continuously from this point.
