Breakaway occurrences involving *OOCL Brisbane* and *CMA CGM Bellini*

Port of Brisbane, Queensland, on 16 May and 20 May 2022, respectively

ATSB Transport Safety Report

MO-2022-004

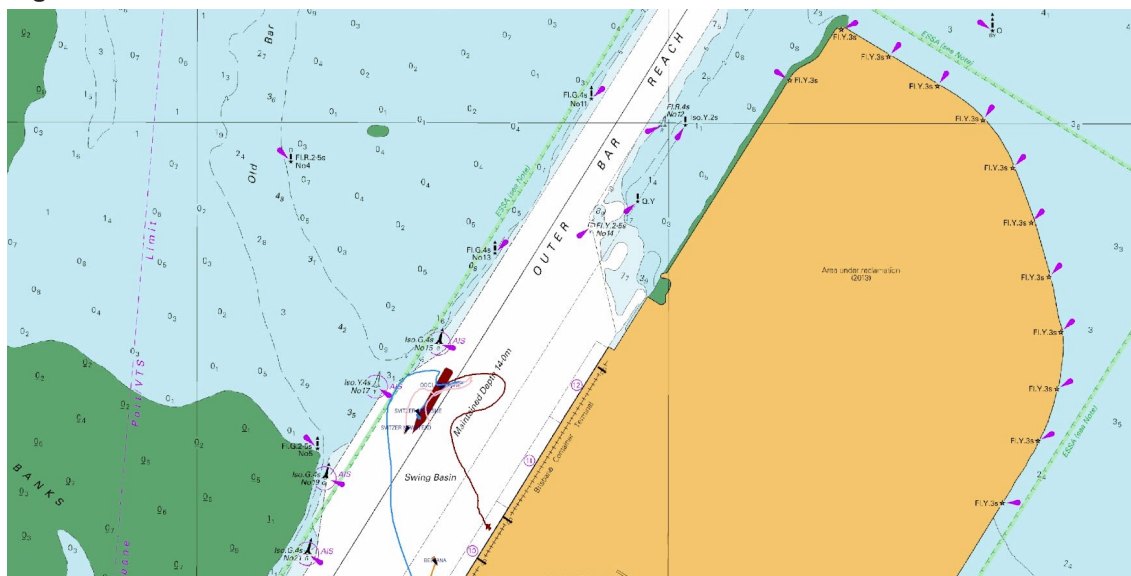
Figure 6: OOCL Brisbane at 1323

By 1323, *OOCL Brisbane* was near the opposite side of the channel with the 2 tugs assisting with controlling its movement (Figure 6). Shortly afterwards, the other tug attending *Delos Wave* was

also released to assist *OOCL Brisbane*. The 3 tugs then aided *OOCL Brisbane* to remain within the channel while VTS arranged a pilot.
