Steering failure and contact with navigational beacon involving *CMA CGM Puccini*

Port of Melbourne, Victoria on 25 May 2023

Marine Occurrence Investigation

MO-2023-002

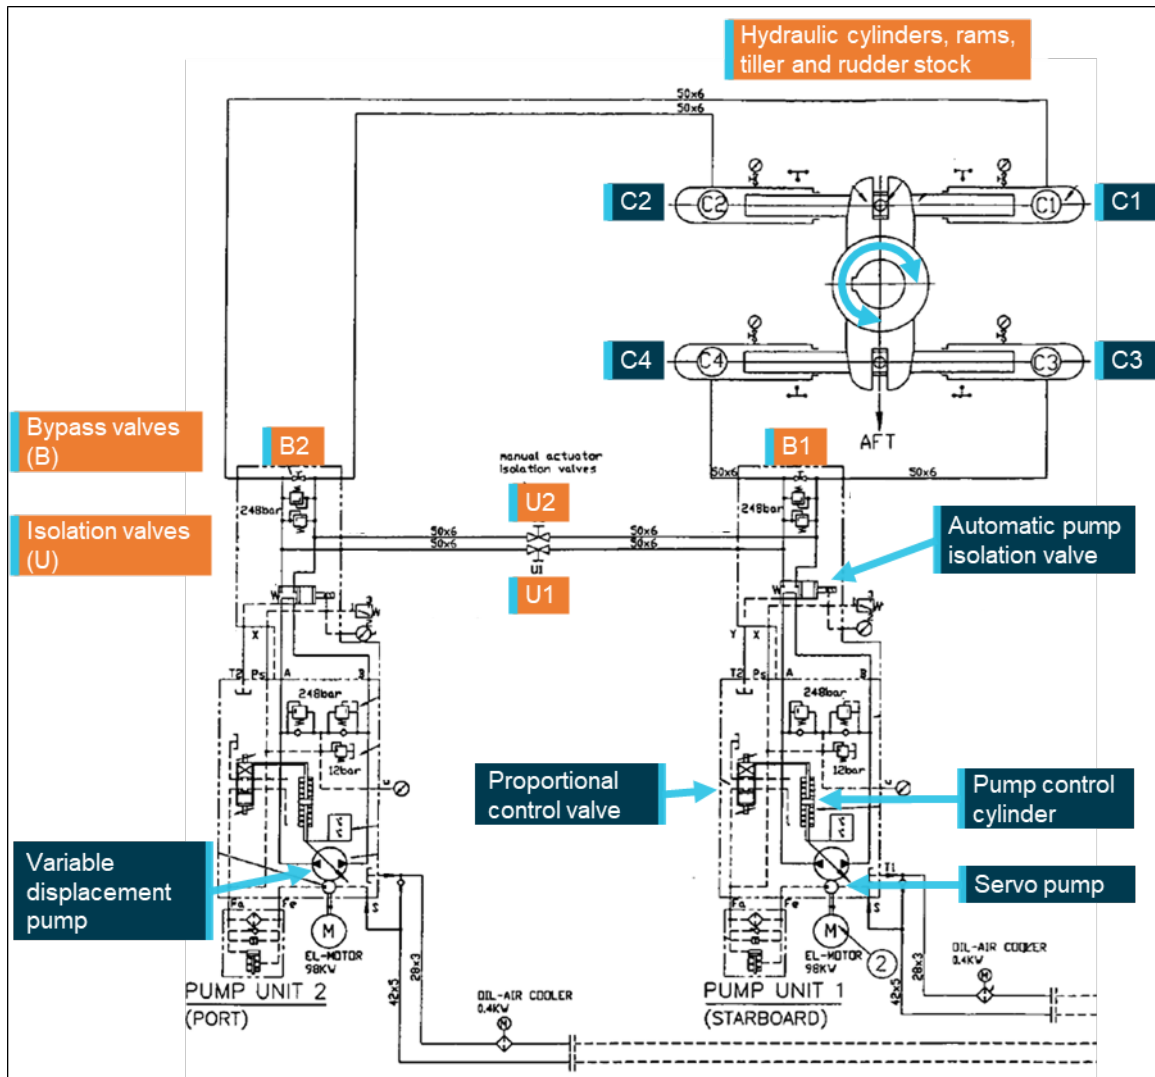
Figure 4: Steering gear hydraulic diagram

Each electric motor also drove a smaller, hydraulic auxiliary servo pump which provided 25 kg/cm² control oil to the machinery. An electric solenoid-operated hydraulic proportional control valve altered control oil flow to/from either side of the pump control cylinder to adjust the swashplate angle and oil flow rate and direction at the pump, as required. The rudder position was thereby changed by altering the rate and direction of oil flow to or from the cylinders connected to the tiller (Figure 4).

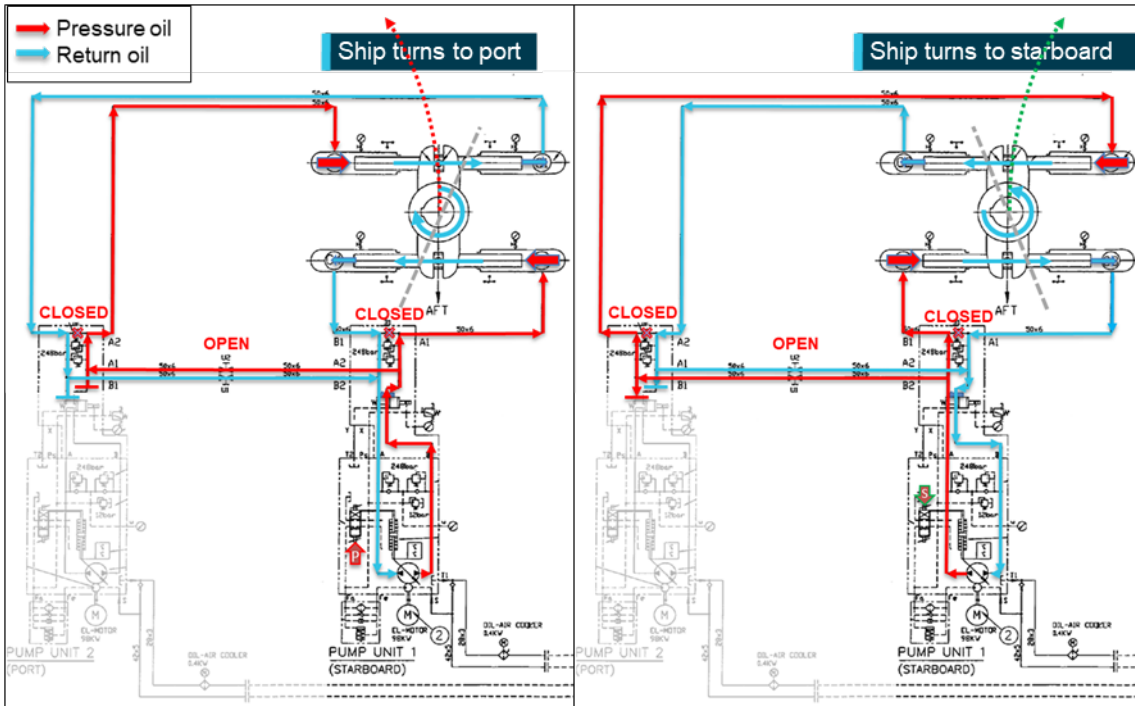
Figure 5: Single pump, 4-cylinder, normal operation of steering, to port and starboard

Single pump (#1) operation shown; diagram is similar for pump 2. Isolation valves (U1, U2) open, pump bypass valves (B1, B2) closed. Signal is received into the proportional valve altering the flow rate and direction of oil at the pump. System response will be improved (faster) with second pump operating in parallel.

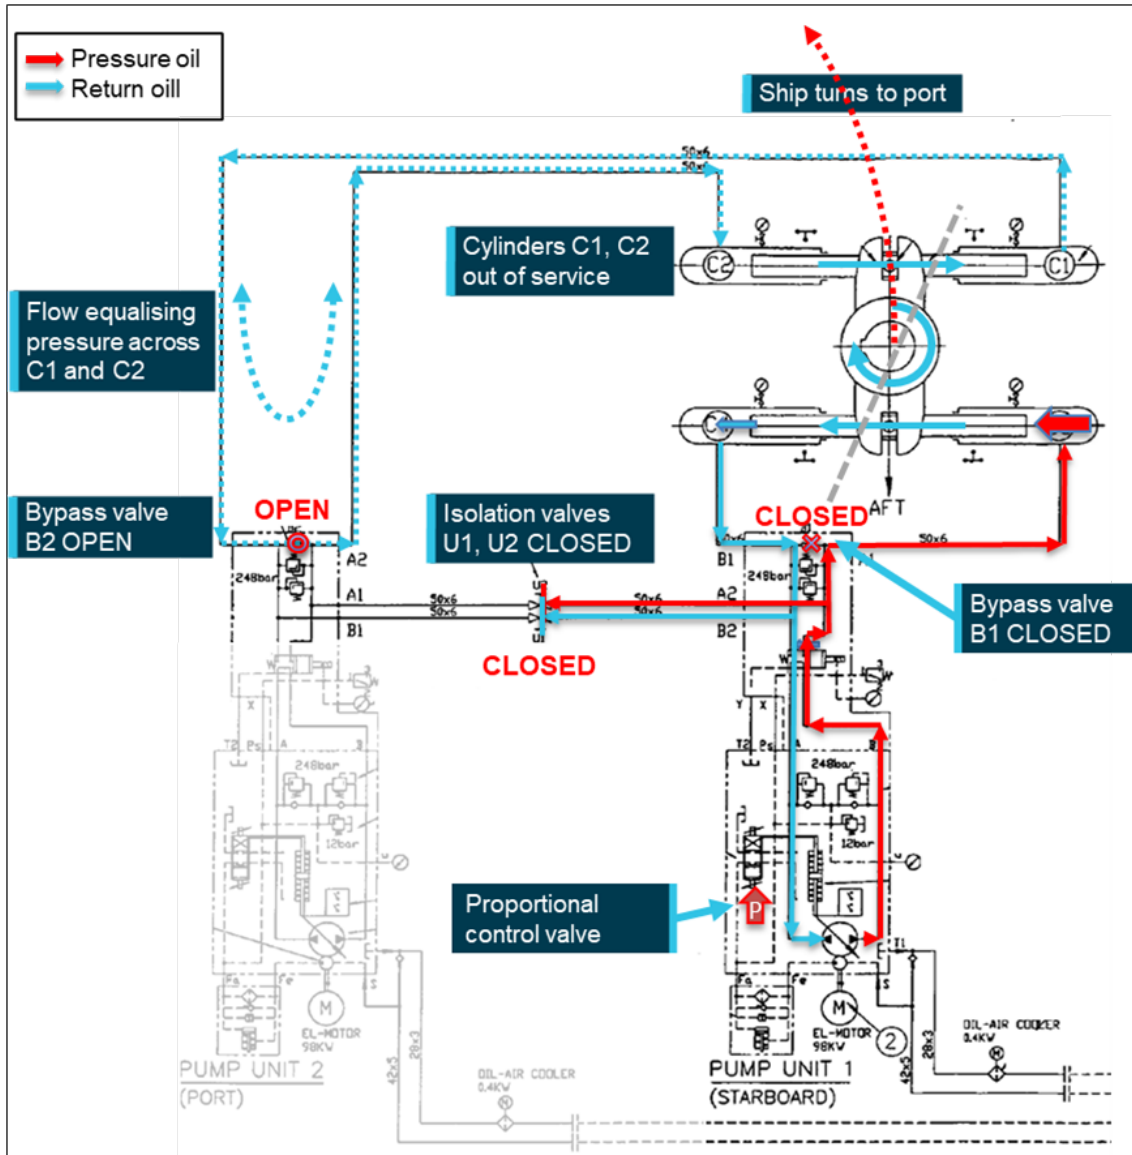
Figure 6: Port rudder using pump 1 with hydraulic system 2 (pump 2, cylinders C1 and C2) isolated

It was possible to separate the 2 hydraulic circuits and operate on one circuit (and pump) alone. In this case, the isolation valves were to be closed and the bypass valve on the non-running pump was to be opened (Figure 6). This mode of operation was referred to in the shipboard procedures in relation to steering gear failure with oil leakage in one of the circuits.

Hydraulic system 2 out of service, isolation valves (U1, U2) closed, pump 2 isolated, pump 2 bypass valve (B2) open to allow oil flow between cylinders C1 and C2 and prevent hydraulic locking.
Source: CMA CGM, annotated by the ATSB
