# Collision with terrain involving Bell 206B-1, VH-ZDI

9.3 km south-south-east of Tumbarumba, New South Wales, on 16 July 2023

## **ATSB Transport Safety Report**

AO-2023-034

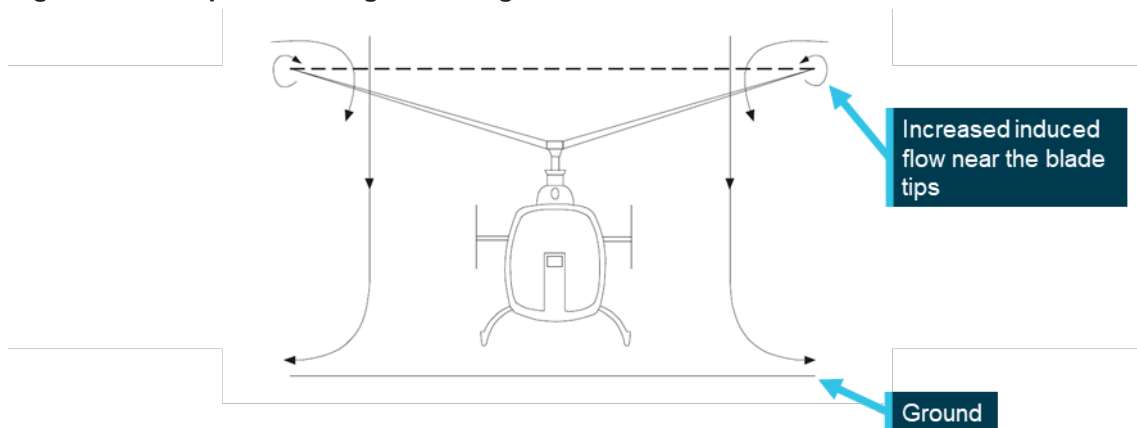
**Figure 5: Helicopter hovering near the ground with recirculated air**

Whenever a helicopter is hovering near the ground, some of the air passing through the disc is recirculated and it would appear that the recirculated air increases speed as it passes through the disc a second time (Figure 5). This local increase in induced flow near the tips gives rise to a loss of rotor thrust.

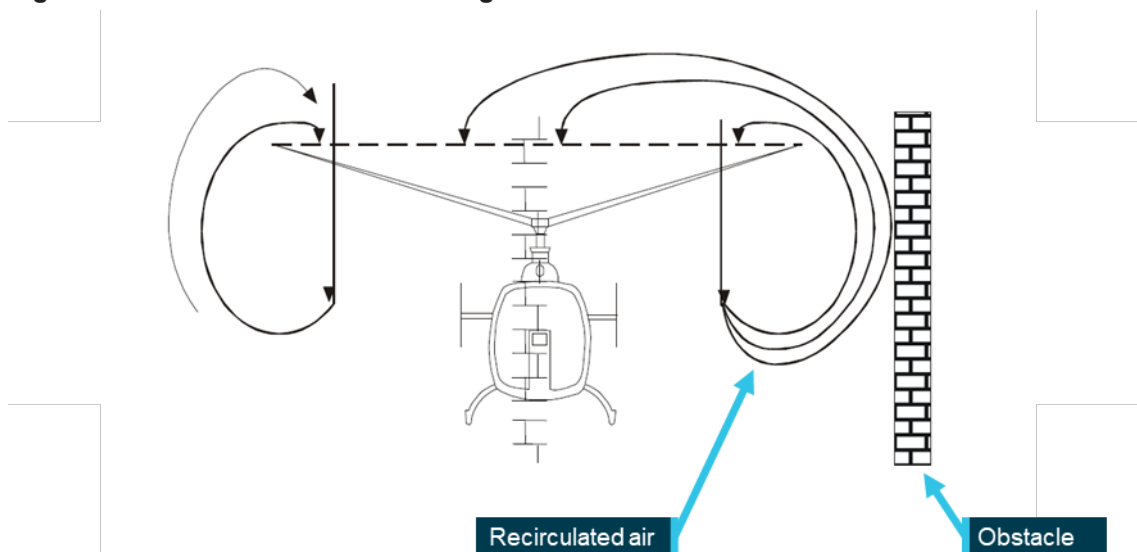
**Figure 6: Recirculation near a building**

Recirculation will increase when any obstruction on the surface or near where the helicopter is hovering prevents the air from flowing evenly away. Hovering close to a building, wire link fencing or cliff face may cause severe recirculation (Figure 6).

The section of the rotor disc largely affected by recirculation was the side closer to the obstruction (right side of disc in Figure 6). A tail rotor positioned on the far side of the helicopter relative to the obstacle would experience less recirculated air than a tail rotor positioned on the near side.
