# Partial power loss and collision with terrain involving Cessna 208, VH-UMV

near Barwon Heads Airport, Victoria on 20 October 2023

Aviation Occurrence Investigation (Systemic)

AO-2023-049

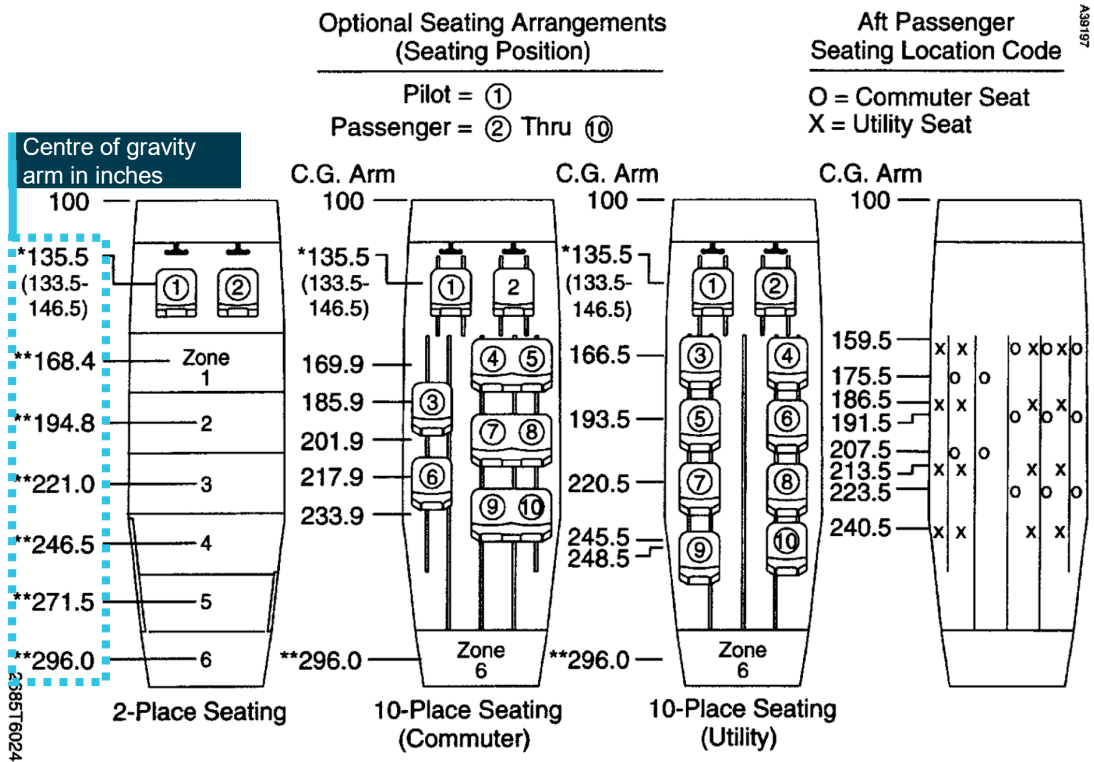
Figure 4: Cessna 208 Pilot’s Operating Handbook seating configuration

To enable calculation of the aircraft’s weight and balance, the C208 POH included a 2-place seating option, which divided the cabin into 7 zones (zones 0–6) (Figure 4). The flight manual supplement for the Texas Turbine Conversions STC did not include changes to the zones or seating configuration, therefore the POH applied.

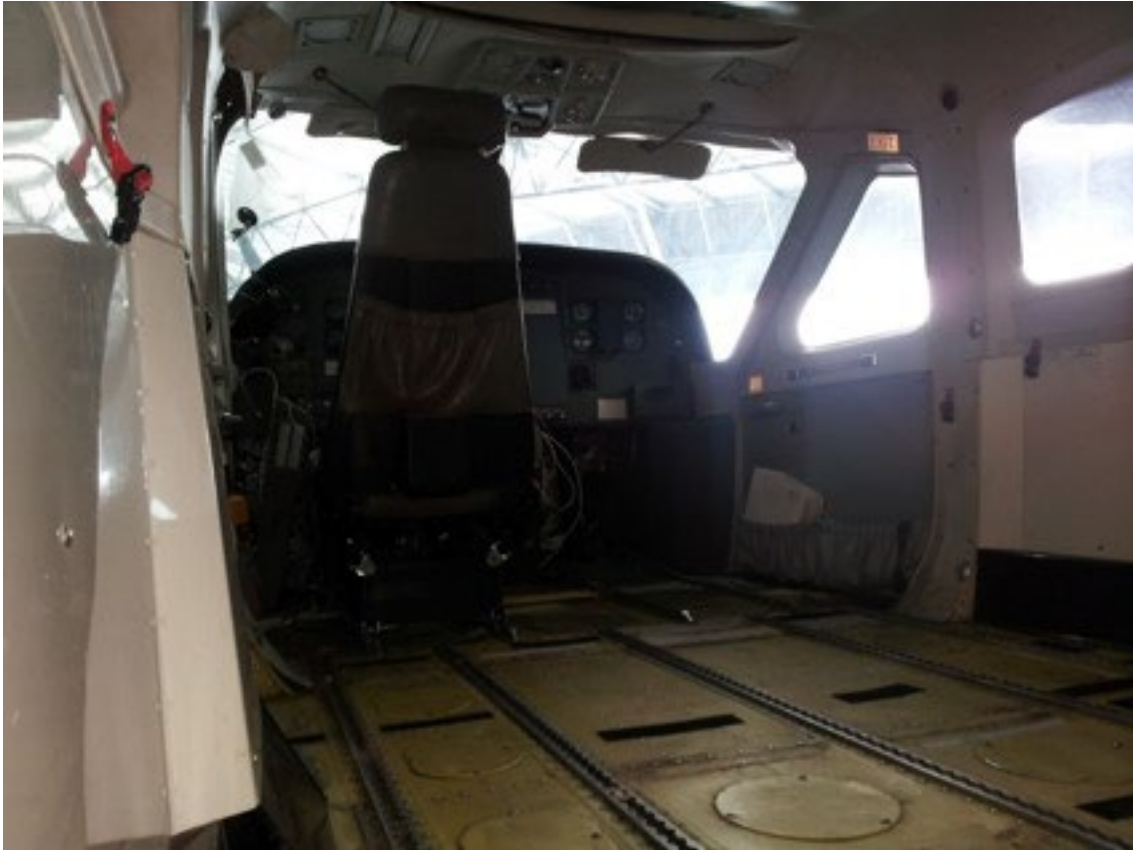
**Figure 5: VH-UMV configuration on date of reweigh**

A weigh of VH-UMV on 17 October 2017 identified that the aircraft's basic empty weight was 1,889 kg in the single pilot seat configuration (Figure 5).

The image meta-data showed the image was taken on 17 October 2017 – the reweigh date.  
Source: AeroWeigh.

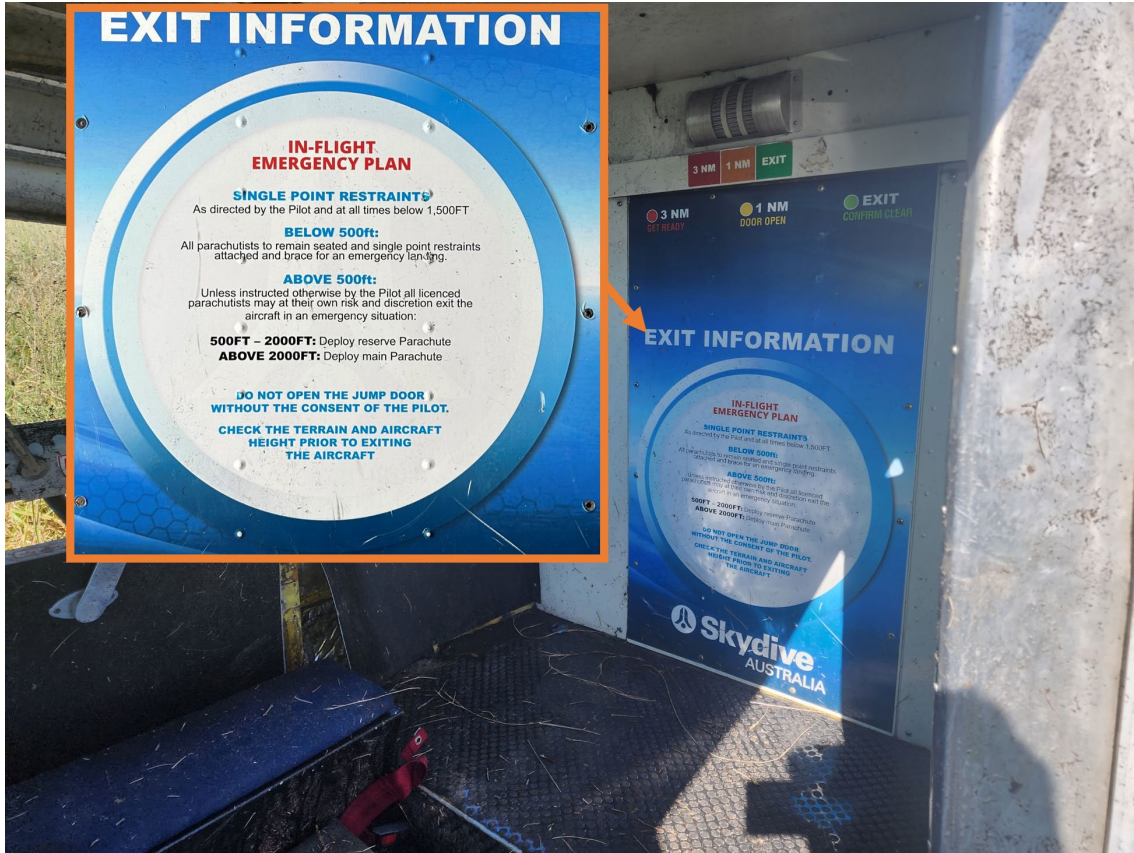
Figure 8: In-flight emergency plan

The aircraft also had a sign on the rear wall of the internal cabin, detailing the in-flight emergency plan (Figure 8). The sign stated that single point restraints were required as directed by the pilot and at all times below 1,500 ft, differing from the 2,000 ft stipulated in the sport jump video.

The APF Jump Pilot Manual required that restraints were utilised by all occupants below 1,000 ft, or as directed by the pilot.
