Collision with terrain involving Oficinas Gerais de Material Aeronautico DHC-1 MK 22 Chipmunk, VH-POR

Jandakot Airport, Western Australia on 26 April 2024

ATSB Transport Safety Report

AO-2024-013

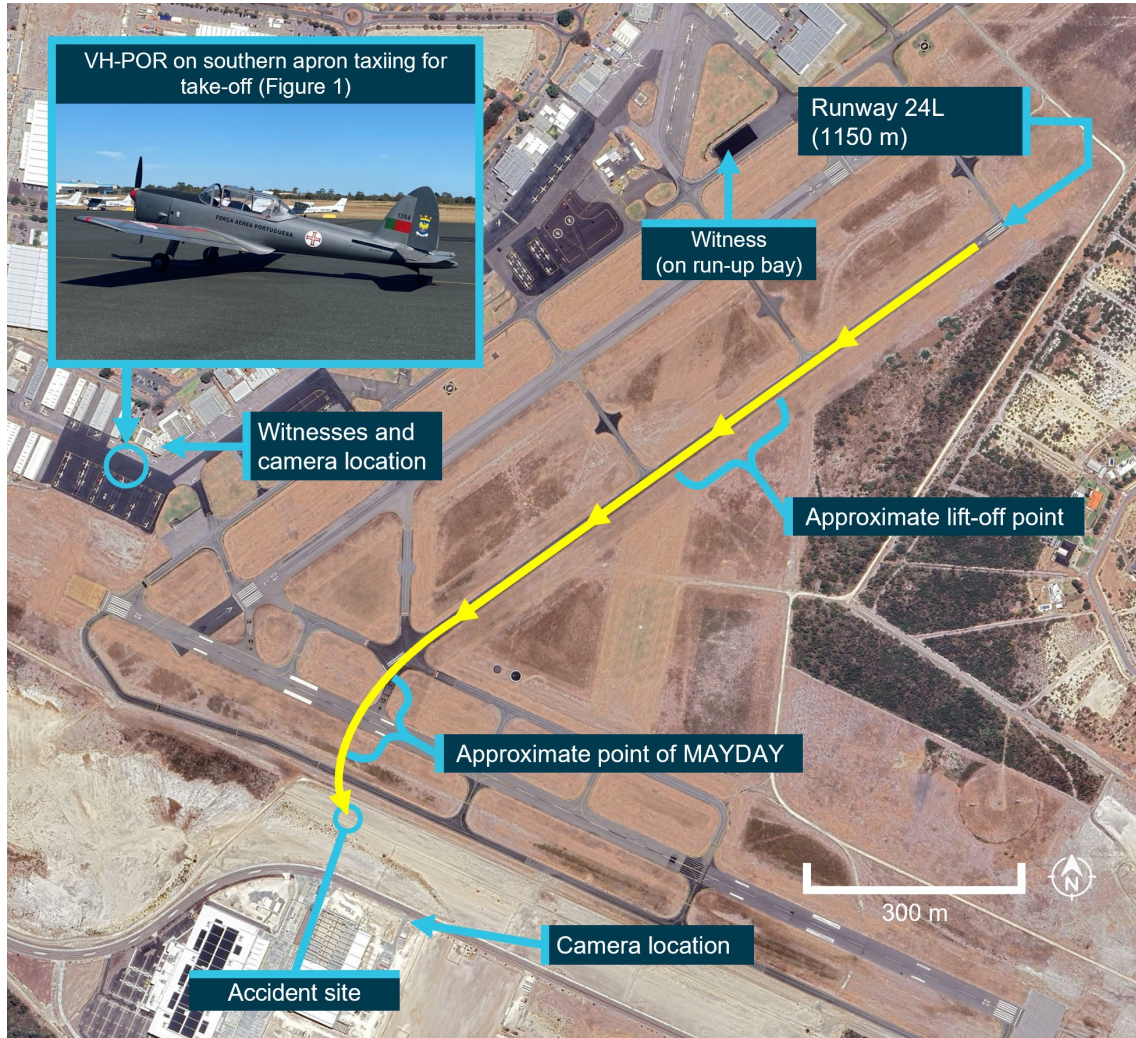
Figure 2: Approximate flight path

One witness, located at the run-up bay, recalled seeing something 'flapping' on the aircraft during the take-off. This witness, and witnesses in a nearby building looking through a window, observed the aircraft turn to the left at low height near the end of runway 24L. There were no reports of an abnormal engine sound. At 1314:24, the pilot made a radio call stating 'papa oscar romeo papa oscar romeo MAYDAY MAYDAY MAYDAY'.²

The camera footage showed the aircraft's angle of bank increasing and the aircraft descending before colliding with terrain.

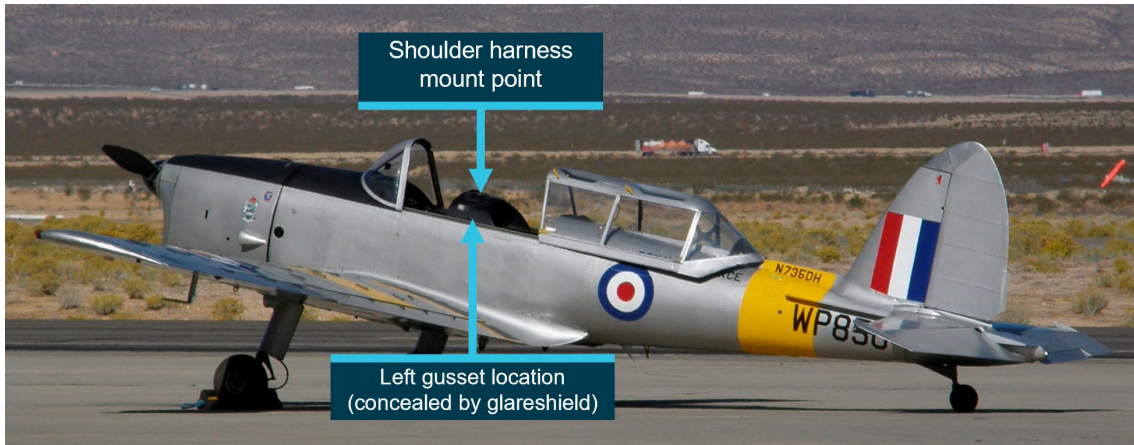
Figure 5: DHC-1 Chipmunk cockpit showing gusset and shoulder harness locations (exemplar aircraft)

The upper structure between the front and rear cockpits of the DHC-1 Chipmunk, corresponding to the attach point for the front cockpit shoulder harness, had 2 mountings, called gussets (Figure 5 and Figure 6).

The structural shell which carries the front shoulder harness attachment is in itself quite rigid, but fails by tearing at its attachment to the aircraft upper longerons when subjected to a high load applied through the shoulder harness. A sheet aluminium alloy doubler running from the shoulder harness attach point down to the longeron bolts and using existing rivets and bolts will provide the reinforcement desired.

The ATSB found that on impact the upper structure between the front and rear cockpits, corresponding to the attach point for the front cockpit shoulder harness, was torn away from its mountings (Figure 7). All 12 rivets (6 per side) that attached the structure to the mountings had sheared.

In October 1966, modification H.268 was issued⁶ to strengthen this structure. The modification was classified as ‘desirable’, and was applicable to DHC-1 Chipmunk marks 20 (which included Portuguese-manufactured aircraft), 21, 22, 22A and 23. The modification replaced the original aluminium alloy gussets with high-tensile steel. The modification required the forward row of rivets attaching the structure to the gussets to be part number SP85 mushroom head rivets, and the rear row to be part number AS2230 countersunk rivets. Later testing by the manufacturer subjected the front cockpit shoulder harness of a modified aircraft to a 22 G load, with no failures.
