Level crossing irregularity involving freight train 1MP9 at Torrens Road

Ovingham, South Australia, on 7 December 2020

ATSB Transport Safety Report

RO-2020-021

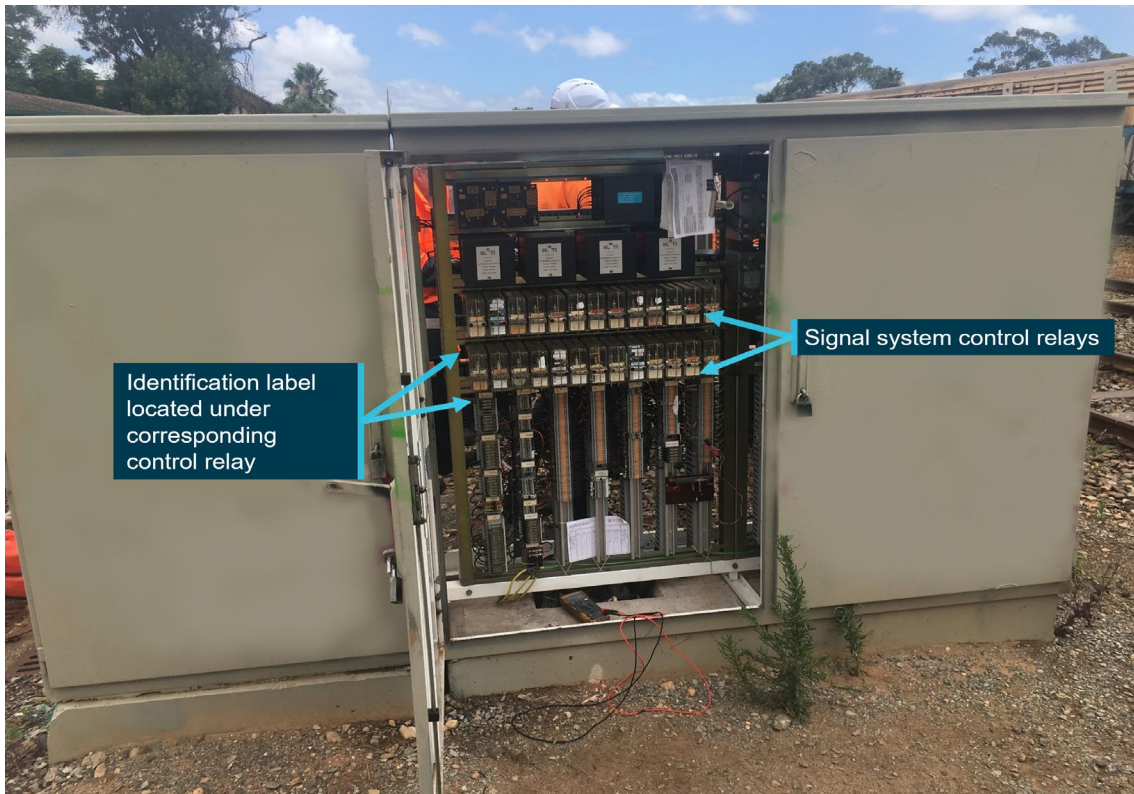
Figure 2: Torrens Road location case (Loc 472) front view

The TIC and signal electrician positioned themselves at the front (Figure 2) and rear (Figure 3) of the location case (Loc 472) respectively to begin installation of the jumpers. The TIC kept the ITP, as was their usual practice, and called instructions to the signal electrician on where to connect the ends of each jumper wire. The ITP circuit diagram required 3 jumper wires to be installed. The TIC marked off the installation of each corresponding connection on the ITP as the work progressed.

Note: Location case 472 showing signalling control equipment, image modified by ATSB to annotate and remove graffiti tags from exterior of location case.

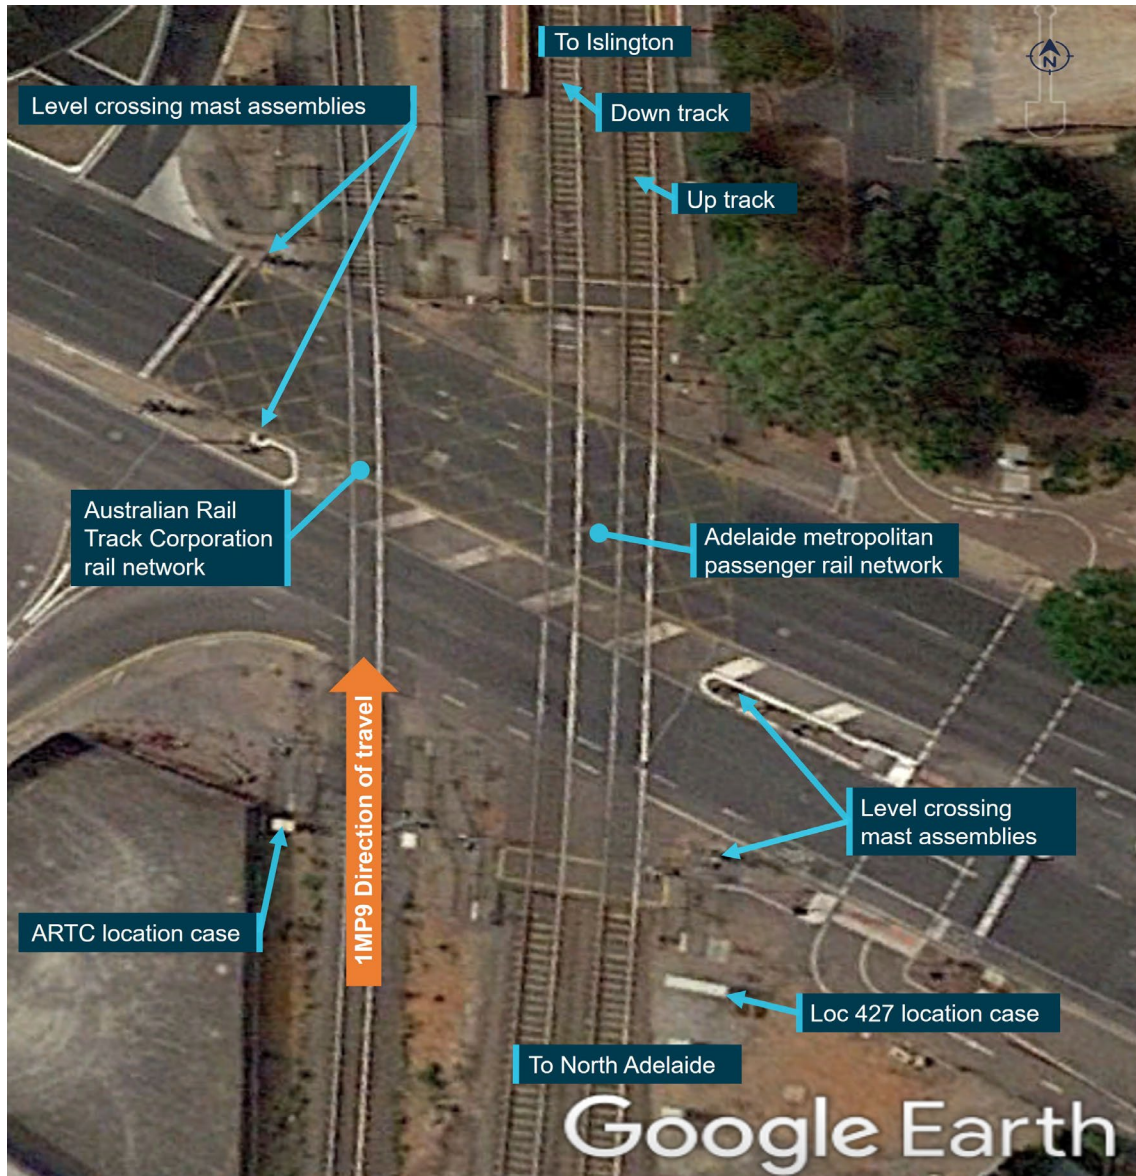
Figure 5: Road and rail track layout at Torrens Road level crossing

The Torrens Road level crossing was located on an arterial road near the north-western fringe of the Adelaide central business district. The rail track infrastructure of the AMPRN and ARTC network ran in parallel at that location (Figure 5).
