**ATSB TRANSPORT SAFETY REPORT**

Aviation Occurrence Investigation – AO-2007-030

**In-flight engine failure  
23 km N of Ardrossan, SA  
25 July 2007  
VH-OAA**

**Cessna Aircraft Company ‘Conquest II’ 441**

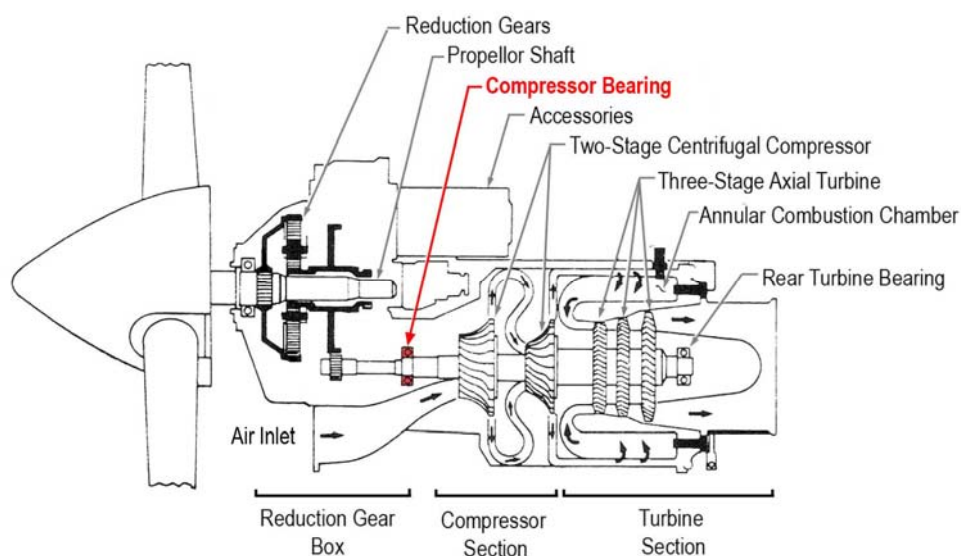
**Figure 3: Cutaway illustration of the TPE331-8 engine**

The TPE331-8-402S turboprop engine fitted to the Cessna 441 aircraft comprised a single fixed-shaft that used a two-stage centrifugal compressor, an annular combustion chamber and a three-stage axial turbine (Figure 3).

The main rotating group, known as the 'gas generator', was comprised of the compressor, combustor, and turbine sections. Supporting the gas generator was the compressor bearing at the front of the compressor and a roller bearing at the rear of the axial turbine. At 100 per cent thrust, the gas generator rotated at 41,730 RPM.
