ATSB TRANSPORT SAFETY INVESTIGATION REPORT
Marine Occurrence Investigation No. 215
Final

Independent investigation into the engine room fire
on board the Singapore registered general cargo ship

Java Sea

24 May 2005

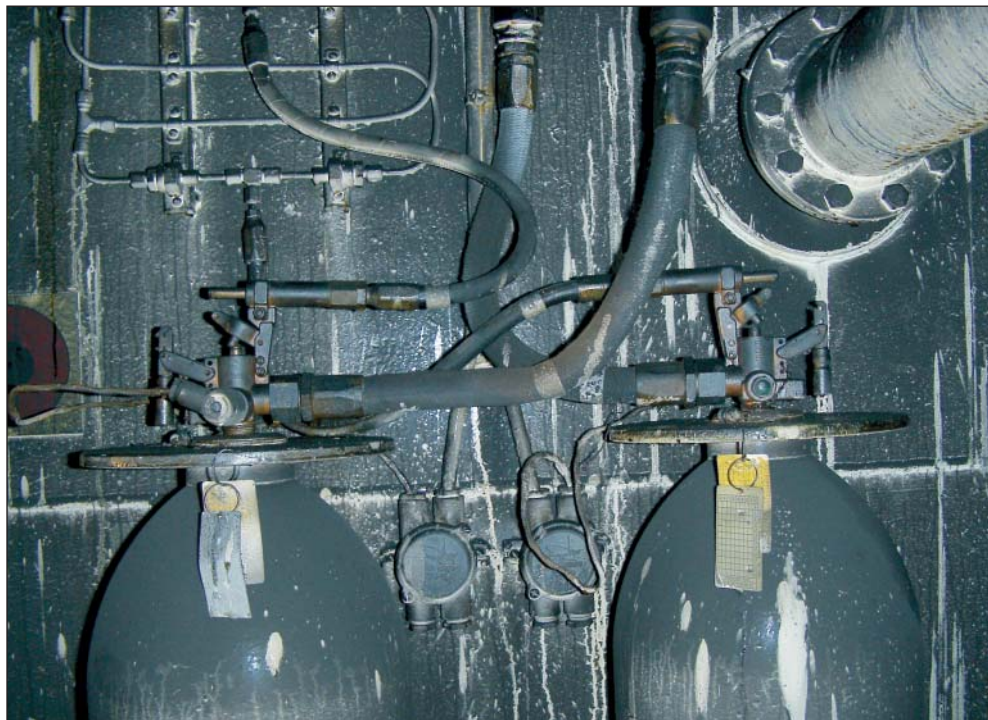
Figure 2: Halon 1301 storage cylinders

The Halon 1301 fixed fire extinguishing system fitted in *Java Sea's* engine room comprised discharge nozzles and distribution piping supplied by four, separately located, and pneumatically operated gas cylinders. Each cylinder contained 67 litres of Halon 1301 at a storage pressure of 42 bar⁴ (Figure 2).

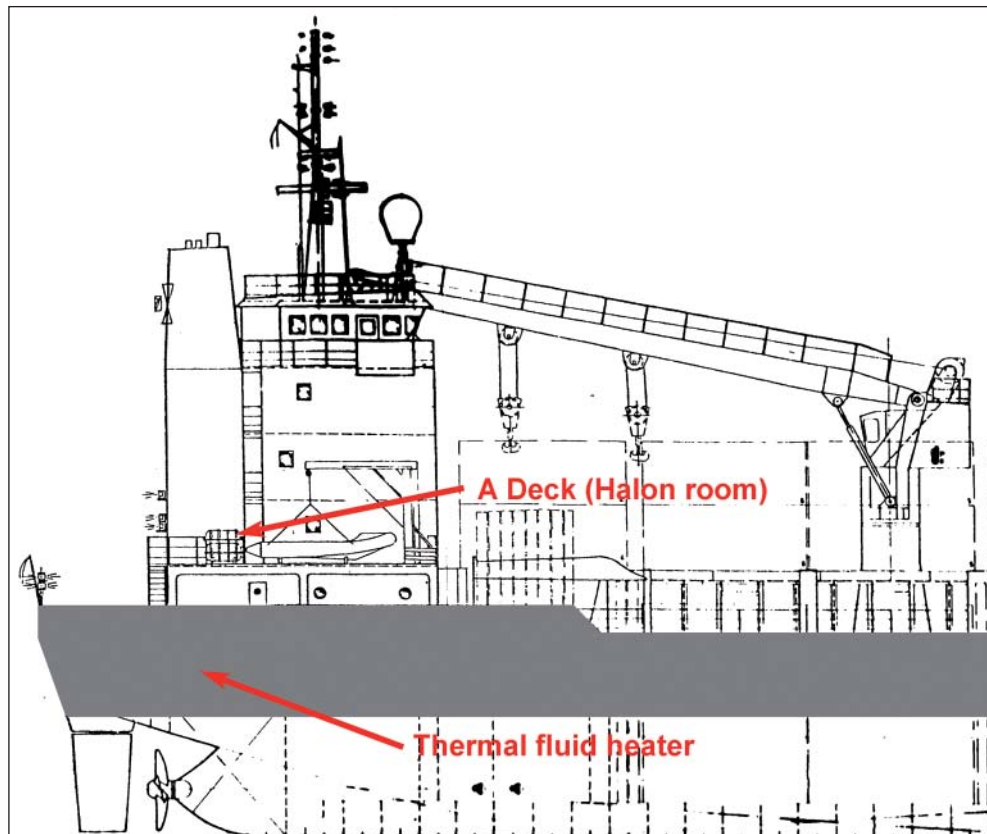
Figure 3: Plan of the ship

The four cylinders are linked to ensure the simultaneous release of the total charge of the extinguishing agent and the whole system can be operated remotely from the halon room, located on the port side of A deck (Figure 3).

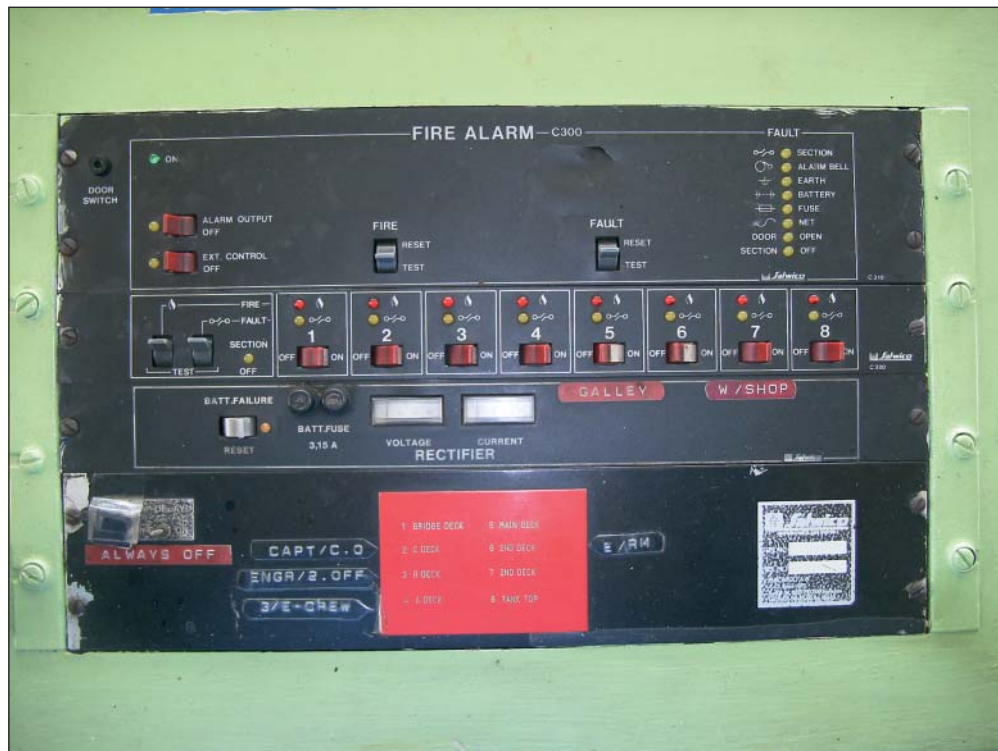
Figure 4: Bridge fire alarm control panel

The main control panel of *Java Sea*’s fire detection and alarm system is located on the bridge (Figure 4). The system is divided into eight independent detection ‘loops’ covering the various decks or areas of the ship. Each loop comprises a number of heat and smoke activated sensors, together with a push button to manually initiate a fire alarm.
