ATSB TRANSPORT SAFETY INVESTIGATION REPORT
Marine Occurrence Investigation No. 217 & 219
Final

Independent investigation into the grounding of the
sail training ship

Leeuwin II

in Prince Frederick Harbour, Western Australia

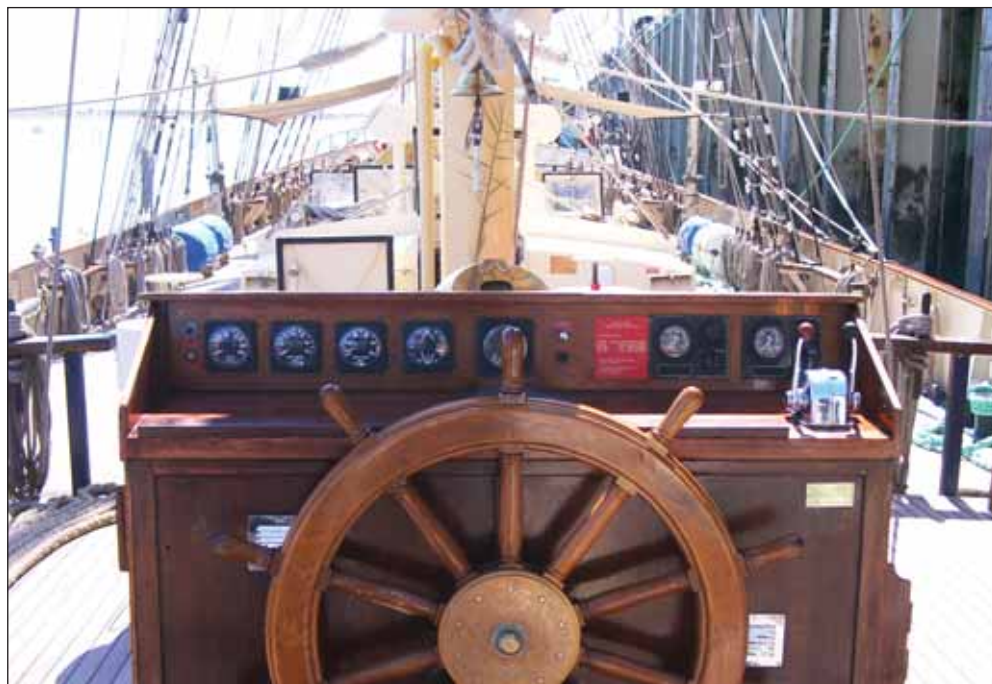
Figure 2: Helm position looking forward

At sea the helmsman steers the ship, while the messenger communicates between the helmsman and the officer of the watch. Two lookouts are posted port and starboard on the bow due to the lack of forward vision from the helm position (Figure 2). The remainder of each watch act as deck hands.

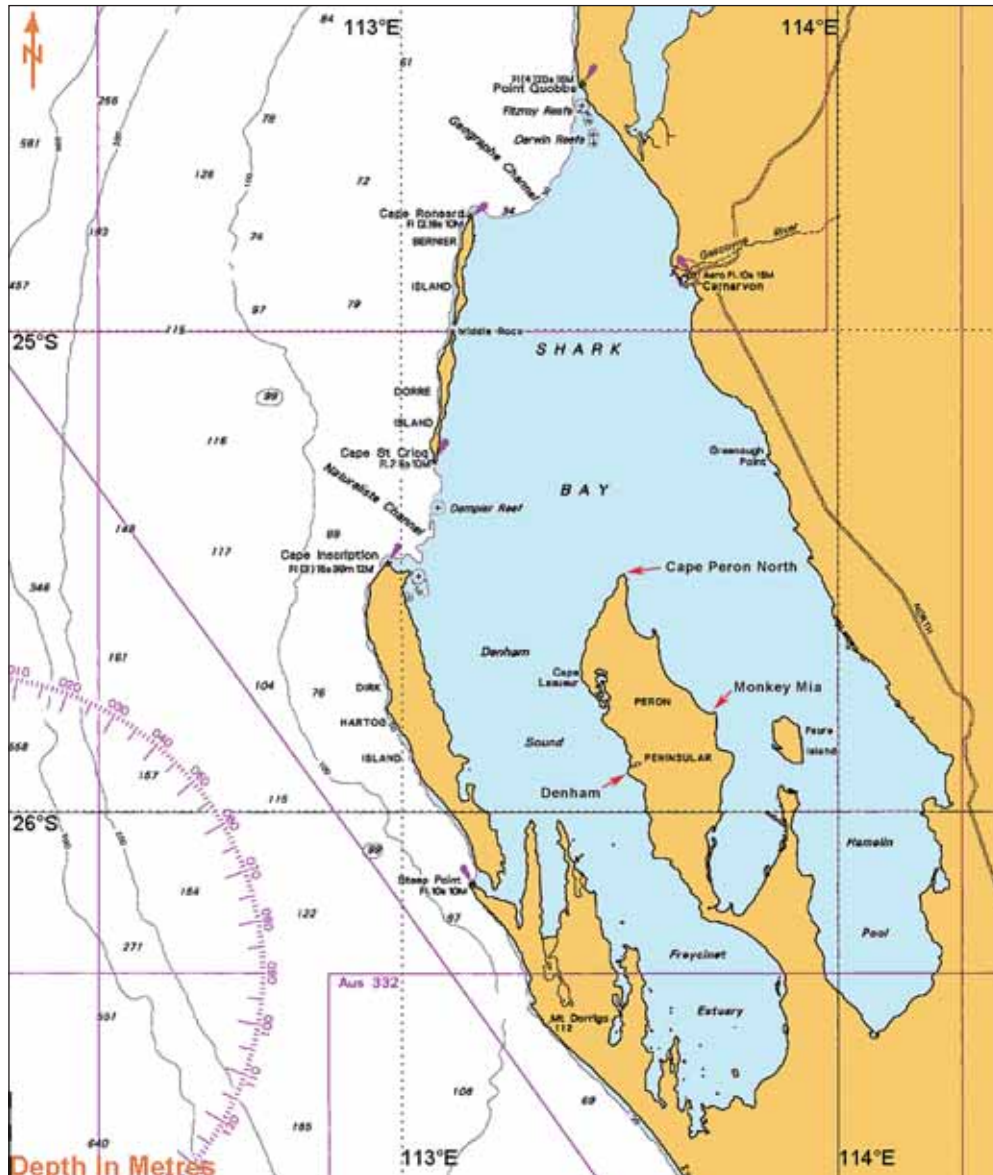
Figure 10: Portion of chart AUS416 showing Shark Bay

Because of the absence of reliable hydrographic survey data, local knowledge, while not essential, is preferred when navigating within Shark Bay.

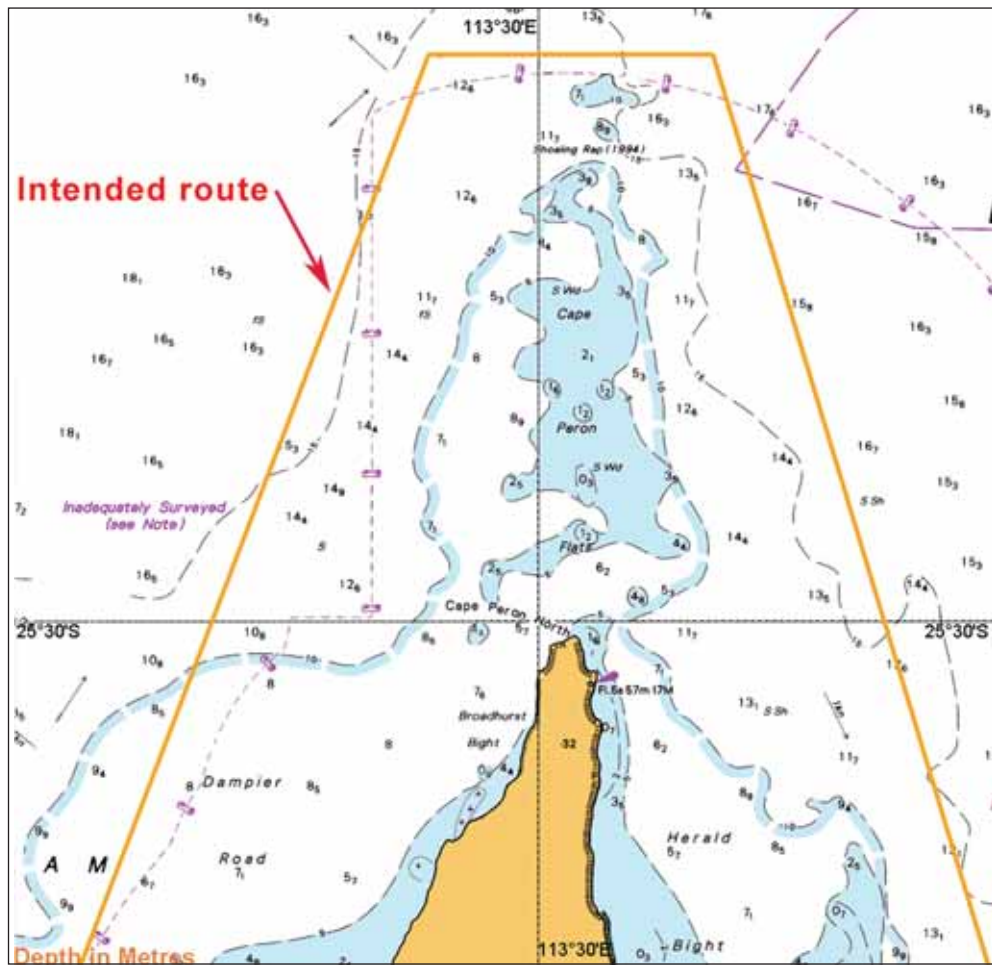
Figure 11: Portion of chart AUS749 showing Cape Peron North, Cape Peron Flats and the inshore route

At 1600, the master discussed the possibility of changing the voyage plan to bring the vessel through an inshore route immediately to the north of Cape Peron North with the chief mate and the second mate (Figure 11).

At about 1745, with Cape Peron North about one nautical mile off *Leeuwin II*'s starboard beam, the course was altered to 090°(T). However, as the engineer had reported discolouration on the vessel's starboard side, the master adjusted this course to 080°(T), to keep clear of any possible shallow patch. The master altered another ten degrees to port as the vessel approached a charted 4.8 m shallow patch which was to the north-east of the cape. This shallow patch was passed at about 1755.

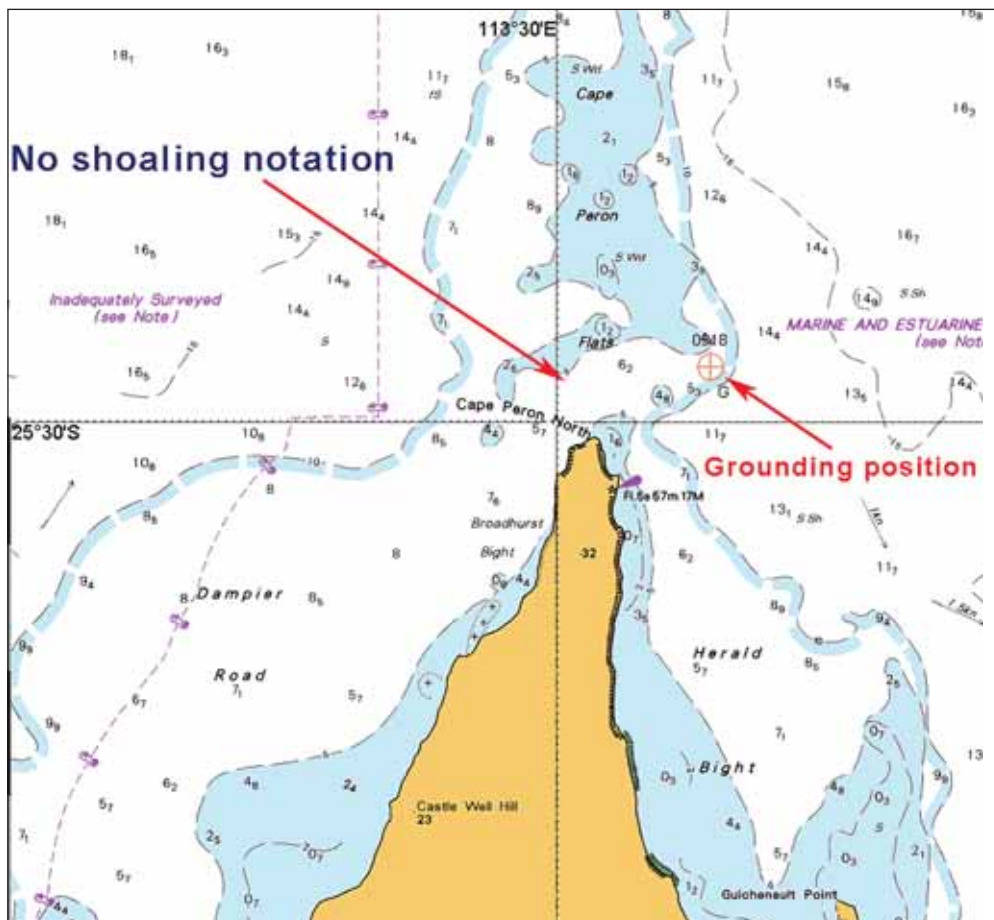
Figure 17: Eastern portion of navigation chart AUS749

Additionally, there is a printed warning on AUS747 and AUS748 (Figure 16) in the inshore route used by the master on 16 September which states that shoaling was reported in this area in 1994. This warning was not present on either AUS749 (Figure 17) or the ECS chart (Figure 12), both of which were in use at the time of the grounding. The master stated, however, that he was aware of the warning of the reported shoaling as printed on AUS747 and AUS748 prior to his deciding to transit the inshore route.
