ATSB TRANSPORT SAFETY INVESTIGATION REPORT
Rail Occurrence Investigation No. 2005/002
Final

Derailment of
Pacific National Train 6MP4
Koolyanobbing, Western Australia
and
Pacific National Train 6SP5
Booraan, Western Australia

30 January 2005

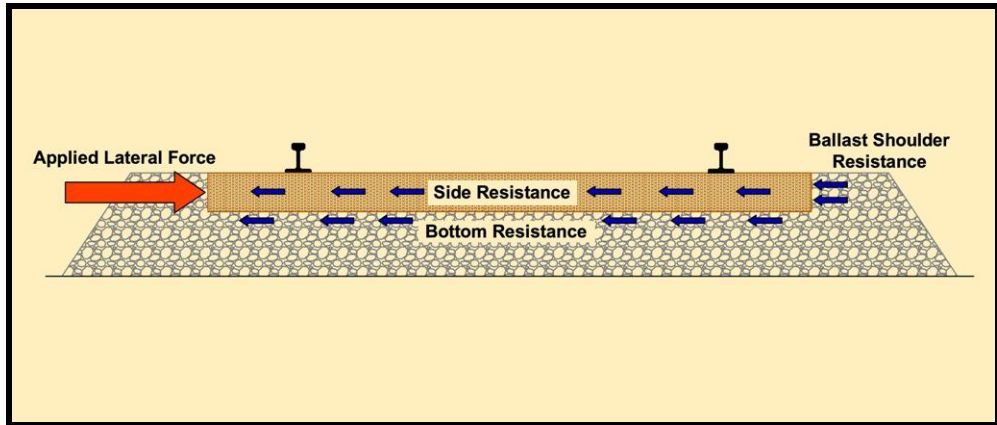
Figure 10: Lateral resistance factors

Bottom friction is primarily influenced by the ballast angularity and the sleeper type and weight, which in turn affects the friction developed at the sleeper's bottom-ballast interface. Side friction is primarily influenced by the ballast angularity and the compaction of ballast between each sleeper, which in turn affects the friction developed at the sleeper's side-ballast interface. End restraint is primarily dependent upon the ballast shoulder geometry and its ability to resist sleeper movement through ballast shearing resistance (i.e. an increase in shoulder width will generally increase sleeper end restraint).

If ballast is missing from the shoulders or cribs, the ability for track to resist lateral movement will be reduced. Reducing the friction bond between the ballast and sleeper through track maintenance can reduce the track's ability to resist lateral movement by more than 50 per cent.

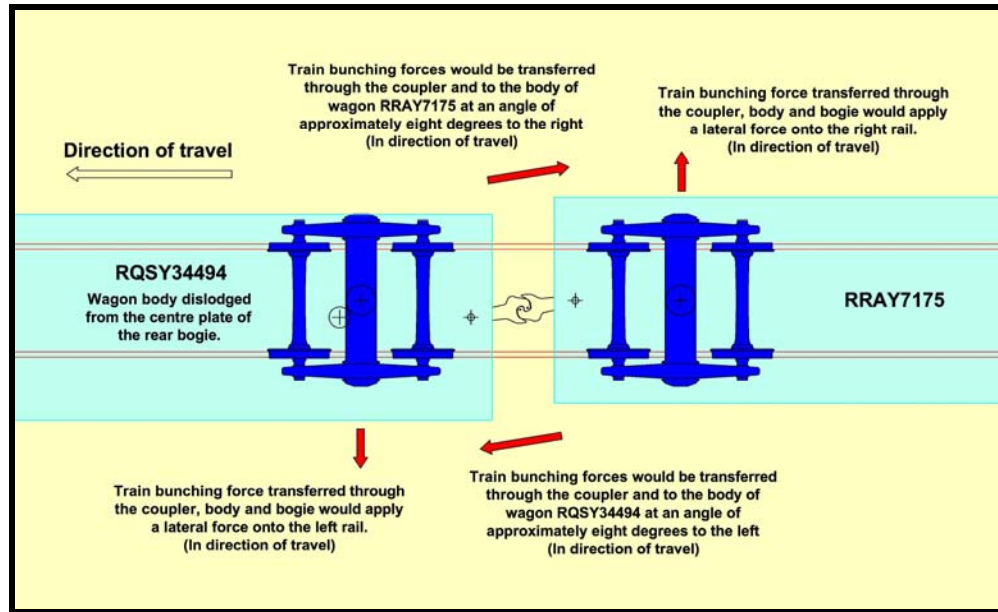
Figure 19: Lateral forces due to train bunching and coupler angle

Figure 19 illustrates the direction of lateral forces, had bunching forces been applied to the dislodged body on wagon RQSY34494. If the lateral forces were sufficient to cause wheel flanges to climb, the most likely direction of derailment would be for the rear bogie of wagon RQSY34494 to derail to the left and the lead bogie of RRAY7175 to derail to the right. However, the evidence indicates that the opposite occurred.

Similarly, if the lateral forces were sufficient to cause the track to fail (for example spread gauge), the rear bogie of RQSY34494 would exert force on the left rail and the lead bogie of RRAY7175 would exert force on the right rail. A spread gauge derailment usually results in wheels falling between the left and right rails. However, as previously mentioned, the first two derailed bogies have derailed towards opposite sides of the track.

Alternatively, the spreading forces may cause the failure of rail fastenings thereby allowing the rail to roll outwards. While the rear bogie of RQSY34994 did exhibit significant wear to wheel flanges on the left side, examination of the wheel flanges and the relevant wagon body found that the worn flanges were consistent with rubbing on the wagon body. However, if some of the wear was a result of wheels running over rail that had rolled outwards, it is reasonable to assume that the rail to have rolled was the left rail.
