ATSB TRANSPORT SAFETY REPORT
Marine Occurrence Investigation No. 262
MO-2009-001
Final

Independent investigation into the grounding of the
Hong Kong registered products tanker

Atlantic Blue

at Kirkcaldie Reef, Torres Strait

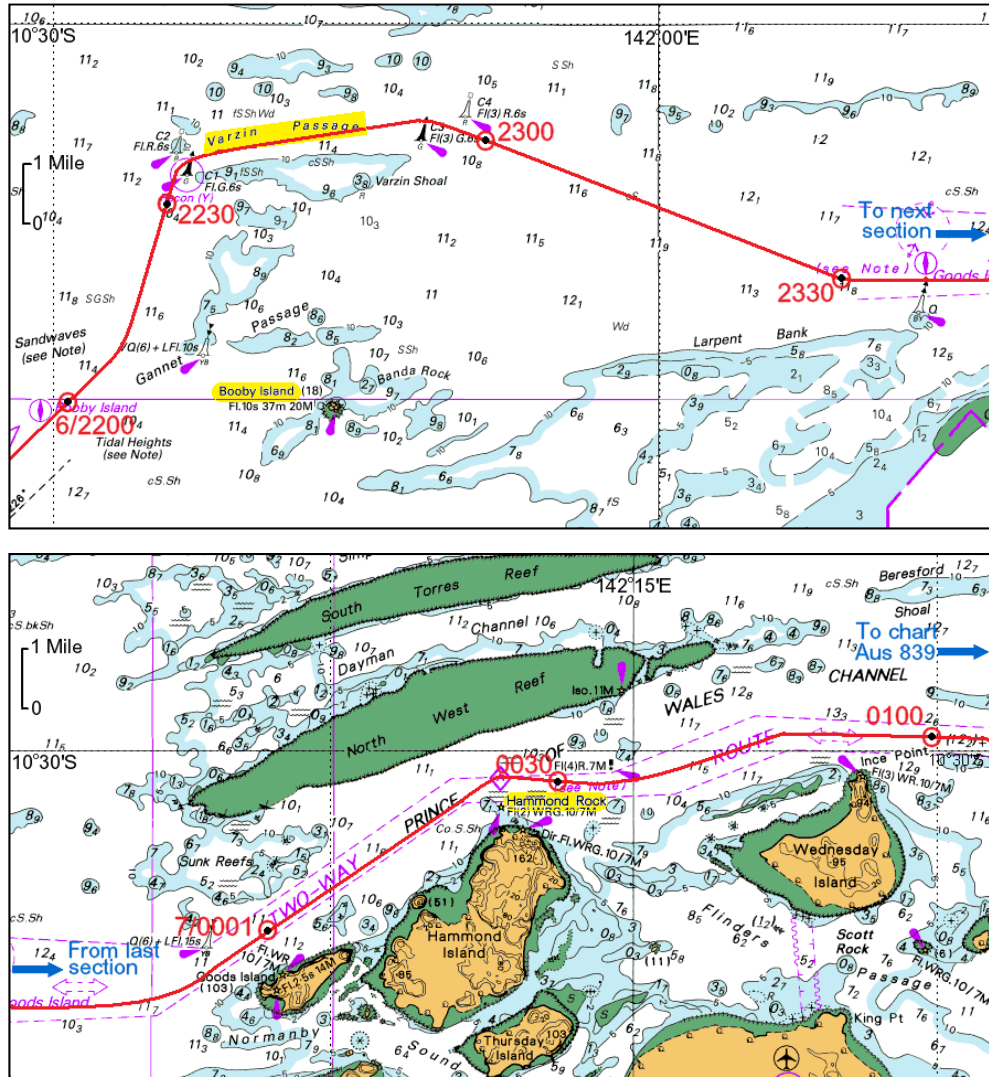
Figure 4: Sections of navigational chart Aus 700 showing *Atlantic Blue's* track (AIS/GPS data recorded by REEFVTS) between about 2200 on 6 February and about 0100 on 7 February

At 2200, the pilot boarded *Atlantic Blue* off Booby Island (Figure 4). On the bridge, he met the master and checked necessary information, including the ship's draught, expected speed, cargo and readiness of its navigational equipment and machinery. The third mate was on watch and two seamen were on duty, one manually steering the ship and the other posted as a lookout. The second mate, responsible for passage plan preparation, was also on the bridge and began marking the planned courses on the large scale chart that the pilot had brought so that it could be used immediately.

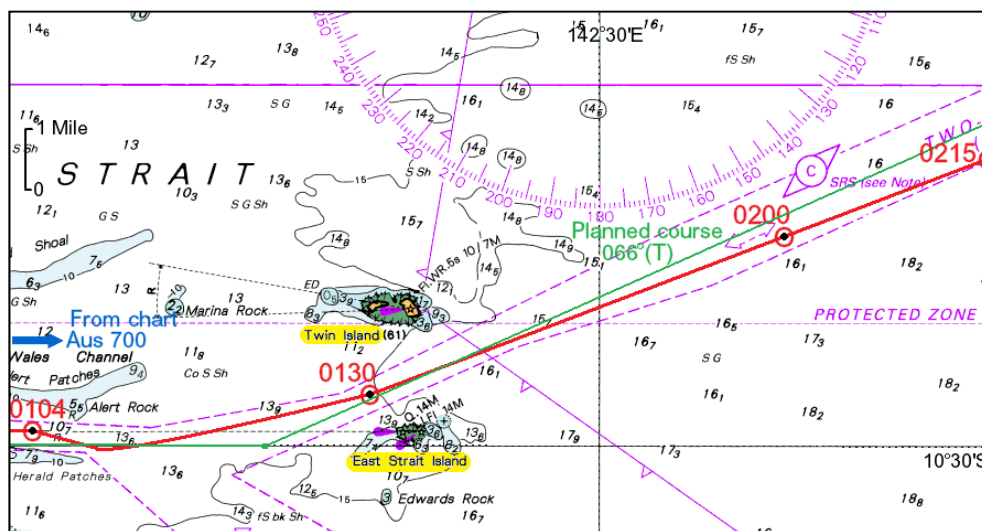
Figure 5: Section of navigational chart Aus 839 with *Atlantic Blue's* track between about 0100 and 0215 on 7 February

Atlantic Blue continued to make good 070° (T) at about 14.5 knots. The ship's recorded GPS data indicates that at 0215, it was at the southern boundary of the two-way route, about 6 cables south of the planned track (Figure 5). The position plotted on the chart using Kirkcaldie Reef light and racon²⁴, however, indicated that the ship was about 2 cables south of the planned track.

Although *Atlantic Blue* grounded before it reached the area where the courses described above were changed, what is important is that not all of the charted course-lines were the same as the ones that the pilot intended to follow. The tracks followed between 0104 and 0130 (Figure 5) represent a readily apparent difference. This should also have indicated to the pilot that the charted courses were not the same as the ones he was following as per his plan.
