Australian Transport Safety Bureau

**RAIL SAFETY INVESTIGATION
2004/003**

**Signal MR5 Passed at
Danger, Freight Train Y245
Murarrie, Queensland
28 June 2004**

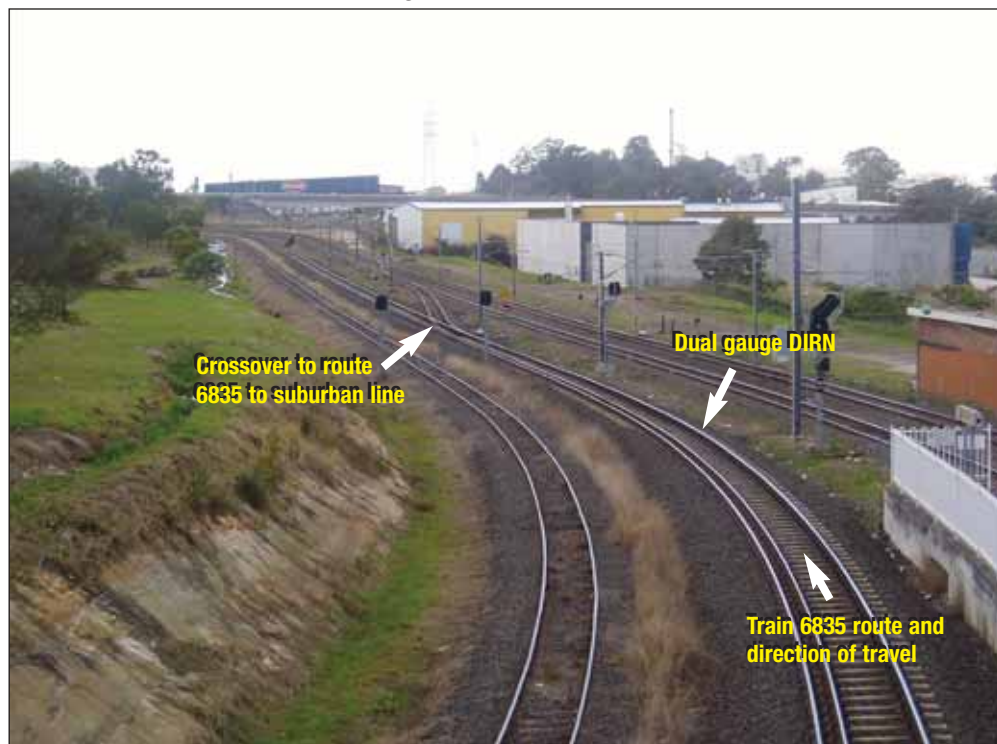
FIGURE 1: Crossover at Murarrie looking east

Train 6835 was part of the way through the crossover to the suburban line at Murarrie as train Y245 approached signal MR5. At 1931:55 train Y245 was recorded as having passed signal MR5 at stop and at 1931:57 a SPAD alarm activated at the Mayne Control Centre. Sixteen seconds later, at 1932:13, an exchange between a train controller at the UTC2 workstation and the driver of train Y245 occurred. This exchange ceased at 1932:27.

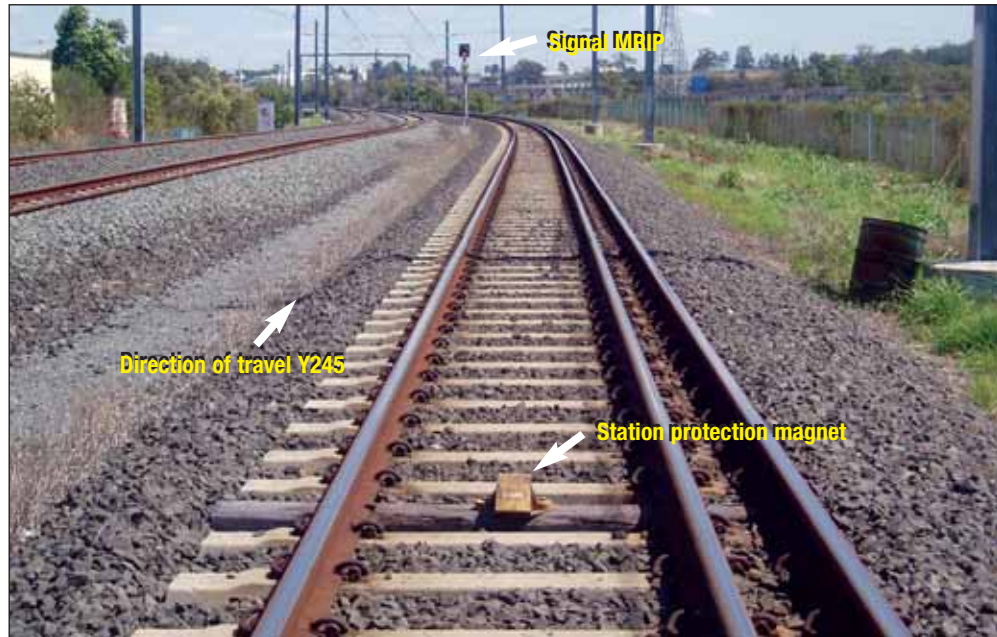
FIGURE 5: Station protection magnet and warning signal MR1P

The requirement for these and other secondary protection measures are specified in QR STD/0076/SWK 'Safeworking Principles' (See 2.5.3 of this report).

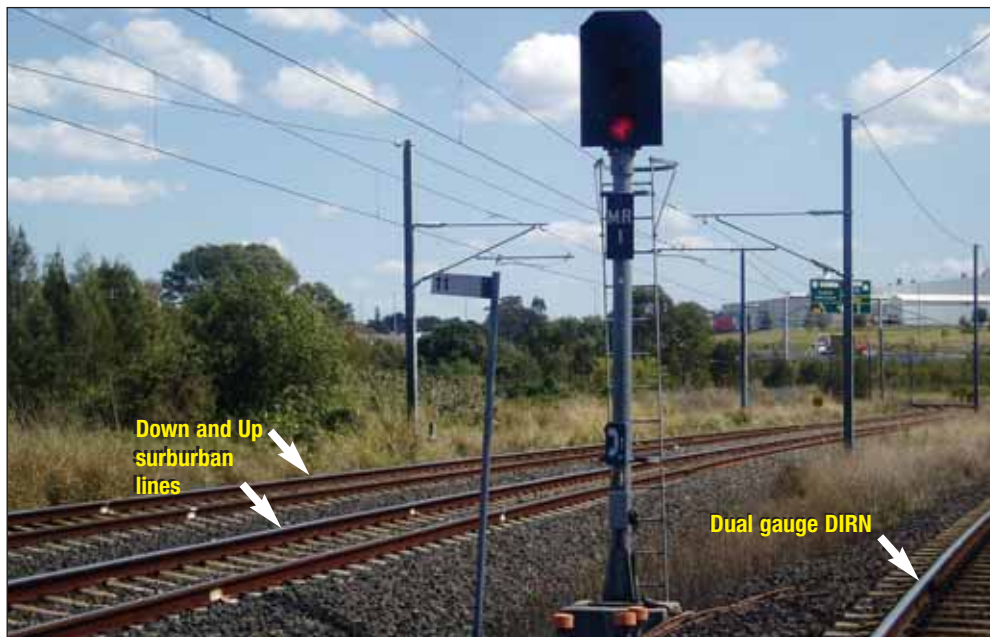
FIGURE 6: Signal MR1

Signals encountered on the approach to signal MR5 are MR1P and MR1. Signal MR1P is two-aspect approach signal that displays yellow if signal MR1 is at stop (red) or green if signal MR1 is displaying either a yellow or green aspect. Signal MR1 is a three-aspect controlled signal capable of displaying either a red, yellow or green aspect. Signal MR1 displays a yellow aspect when signal MR5 is at red. Signal MR5 is a controlled signal also capable of displaying either a red, yellow or green aspect. In addition, signal MR5 has a position light signal mounted below the main signal head that, when illuminated, authorise movement no further than the next signal or as far as the line is clear.

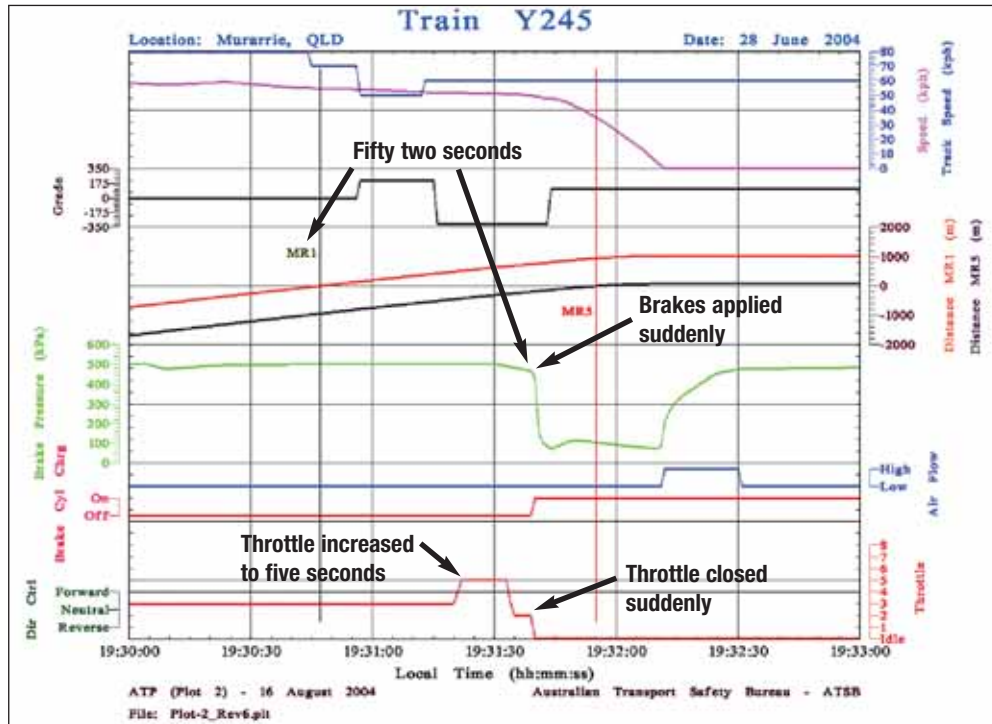
FIGURE 17: Time between MR1 and MR5

A re-enactment of the radio hand-set falling to the floor and being retrieved by a person positioned in the drivers seat showed that this task could be done from the seated position and took no longer than five seconds. The time frame from when the radio hand-set fell from the cradle (shortly before signal MR1) until the brake application was about 52 seconds. Therefore, the driver did not prepare the train for a stop at signal MR5 where it could or should have been but rather when the red light itself was recognised.

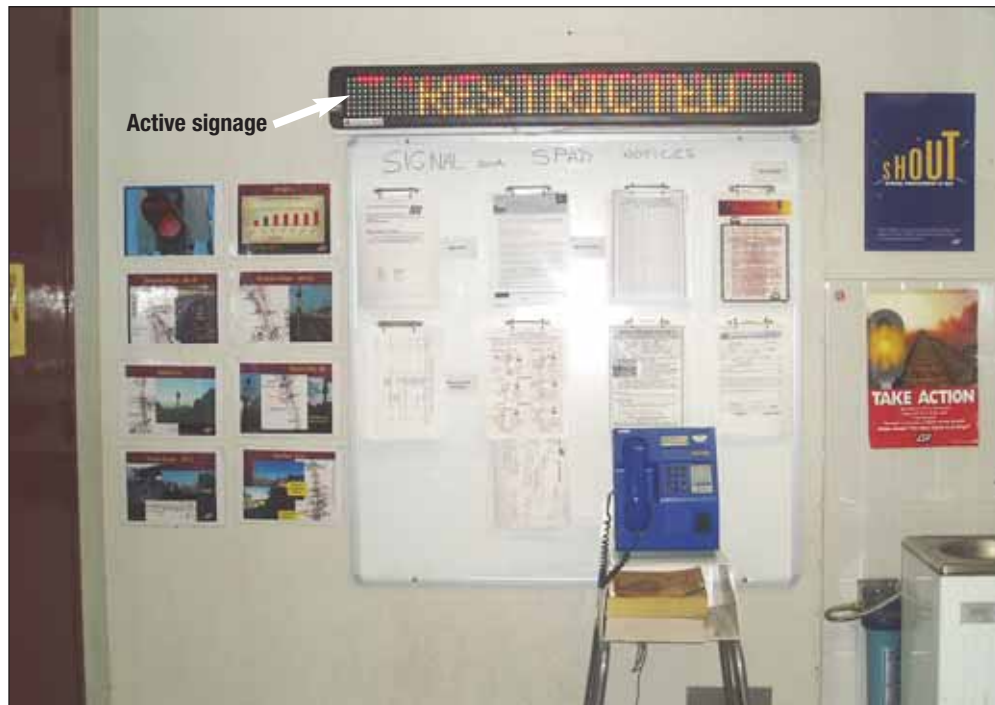
FIGURE 19: Acacia Ridge Depot SPAD notice board

Other initiatives included the 'active' SPAD notice boards that were installed at the majority of freight sector depots (figure 19), the promulgation of the business instruction 'Safe Driving Techniques' and the appointment of management positions whose primary task is to coordinate and deliver the Coal and Freight Services Group's response to the QR SPAD Management Program.

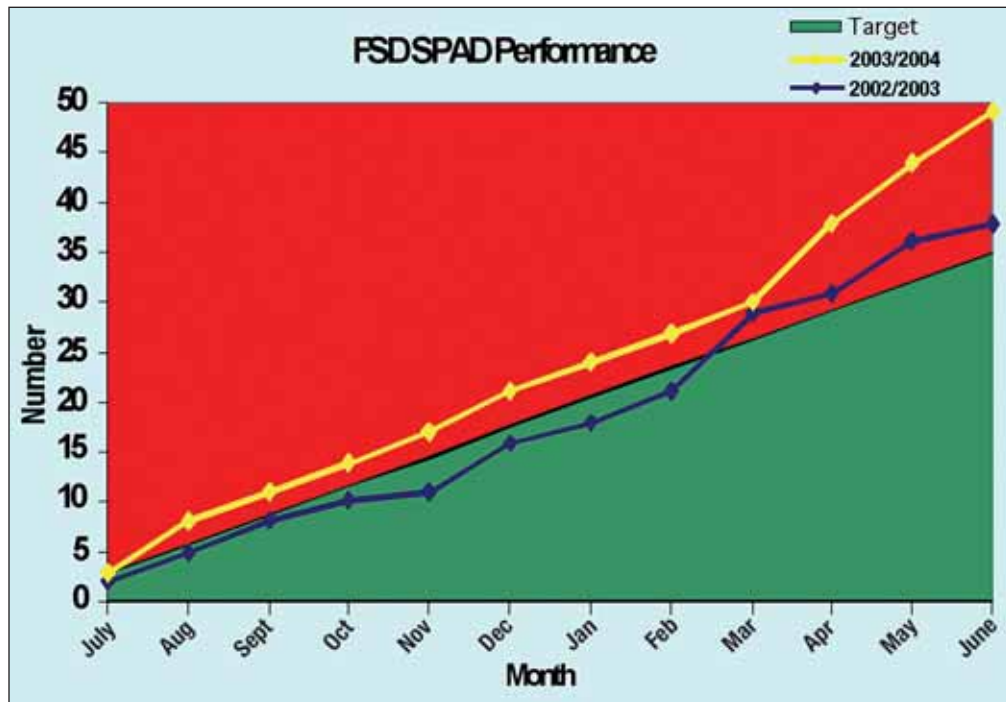
FIGURE 20: Freight sector SPADs (running total), Coal and Freight Services Group 2002/2003 and 2003/2004

The instances of SPADs within the freight sector of the Coal and Freight Services Group, from March 2003 to July 2003 and during the financial year July 2003 to June 2004, continued to be above the target set by the Corporate SPAD Reduction Committee. Of the freight sector train crew depots, Maryborough had the highest instance of SPADs.
