RAIL SAFETY INVESTIGATION
2004/002

Derailment of Freight Train 6SM9V

Alumatta, Victoria
15 March 2004

Rail Safety Investigation into the Derailment of Train 6SM9V

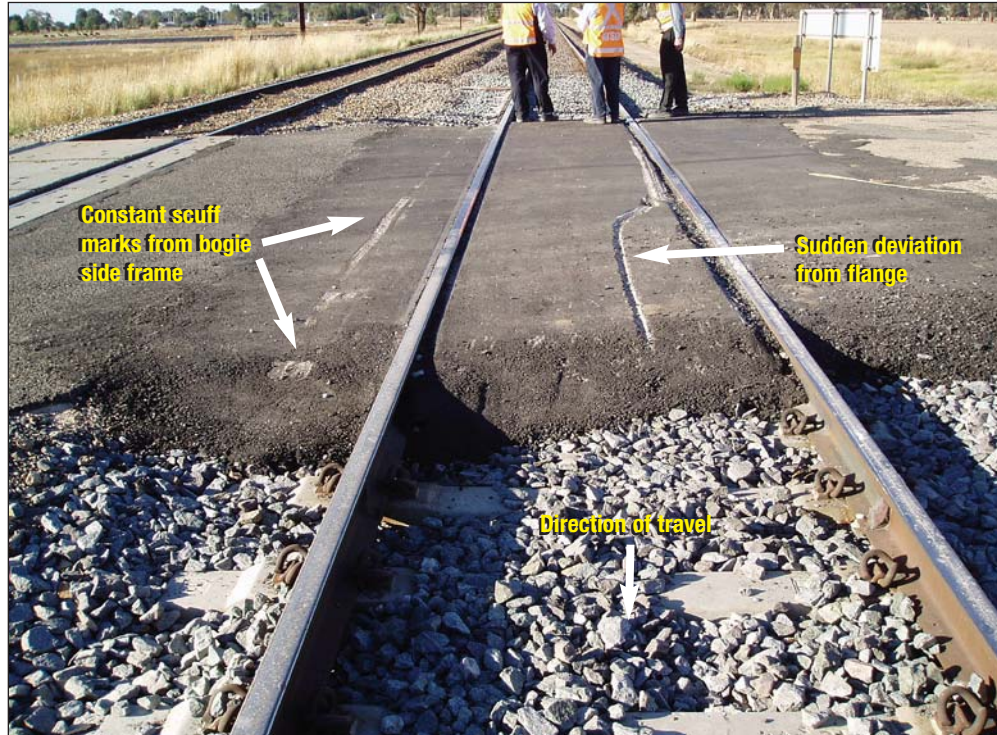
FIGURE 6: Gravel Pit Road looking north

At Gravel Pit Road there was only one flange marking visible and this was on the western side of the left rail. About half way along the asphalt crossing this flange marking took a sudden deviation to the west but the scuff mark from the bogie frame maintained a constant line to the western side of the right rail.

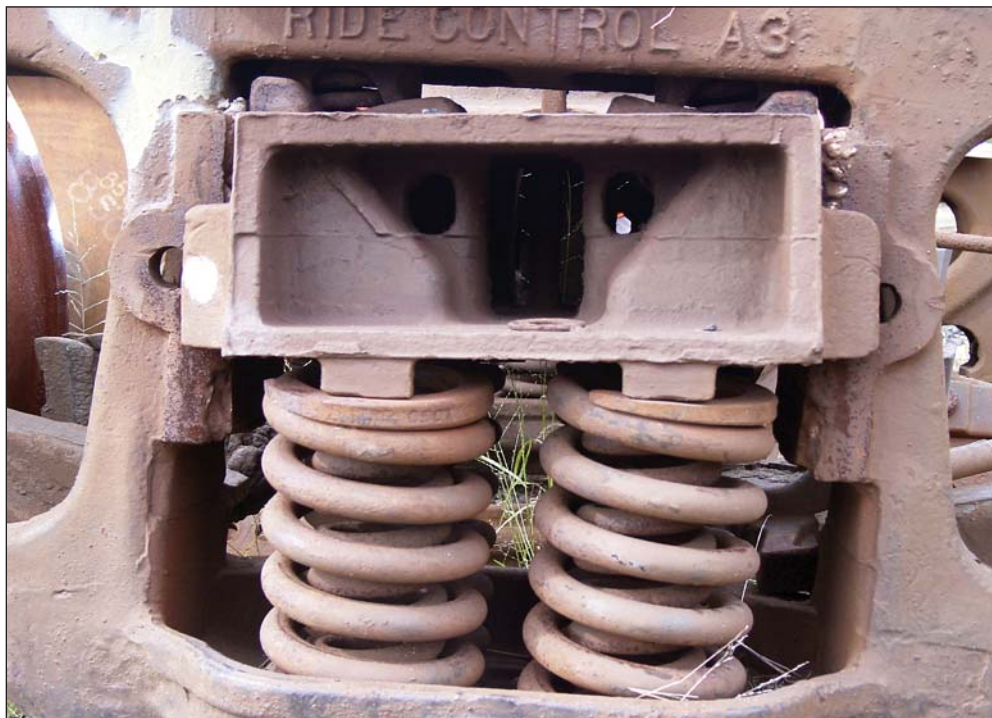
FIGURE 13: Typical bogie spring nest showing inner and outer springs

In addition, an inspection of the leading bogie of wagon VQCY 850X was conducted at Dynon. This inspection was conducted visually and the wagon body was not lifted from the bogie. One broken spring from the centre nest on the right side of the wagon (in the direction of travel) was found.

If both the previously broken springs were present in the bogies of wagon VQCY 850X, one would have been in the lead bogie (as found) and one in the trailing bogie. The ability of the bogies of wagon VQCY 850X to steer through the turnout at Alumatta may have been inhibited. In addition, if the springs that were not recovered were missing from the trailing bogie of this wagon, then further impediments to bogie steering could have emerged. However, it is considered more probable that the missing springs were simply not recovered or misplaced during the recovery operations.

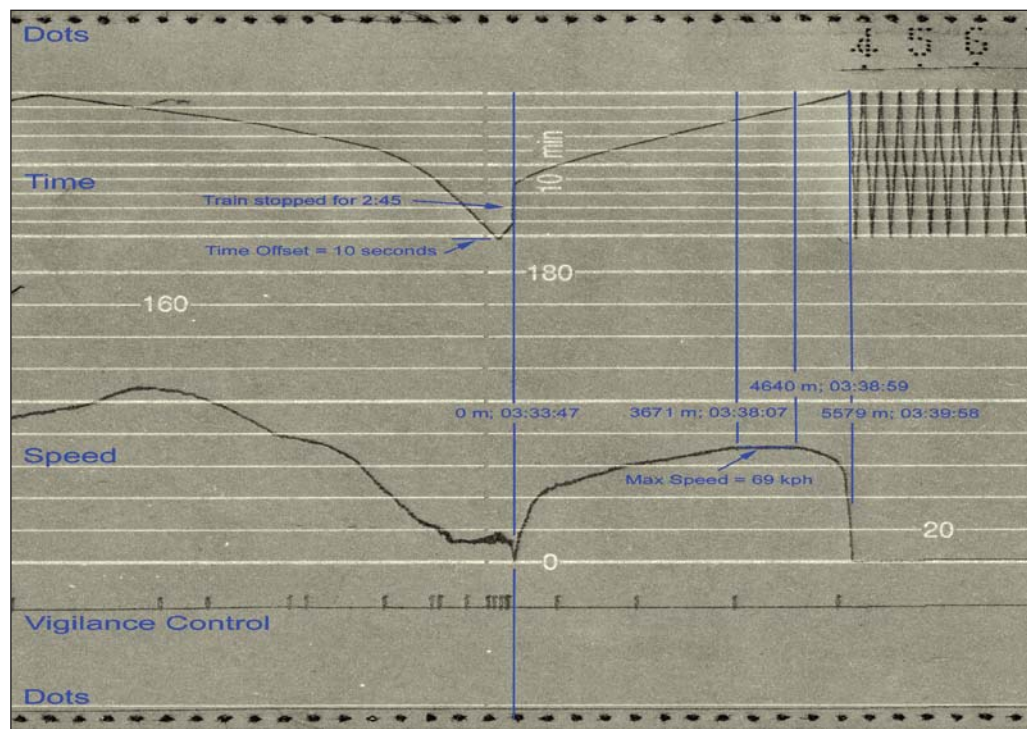
FIGURE 17: G533 Hasler data normalised at wheel size 965 mm

With the data logger from G533 this is a factor of 0.964. Therefore the actual distance travelled if the wheels were 965mm diameter was calculated to be 5579 metres. This is 47 metres (or about 2.5 locomotive lengths) further than the distance travelled if the locomotive was stopped four locomotive lengths from the home departure signal at Alumatta.

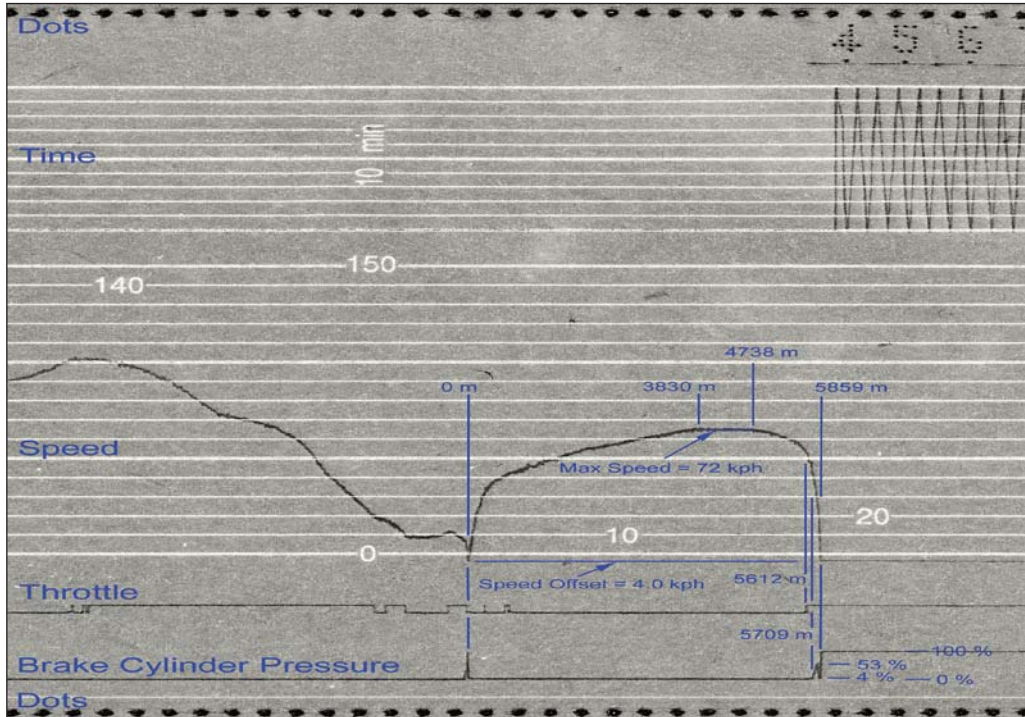
FIGURE 18: X51 Hasler data normalised at wheel size 965 mm

With the data logger from X51 this recalibration is a factor of 1.05. Therefore the actual distance travelled if the wheels were 965 mm diameter was calculated to be 5859 metres. This is 327 metres further than the distance travelled if the locomotive was stopped four locomotive lengths from the home departure signal at Alumatta.

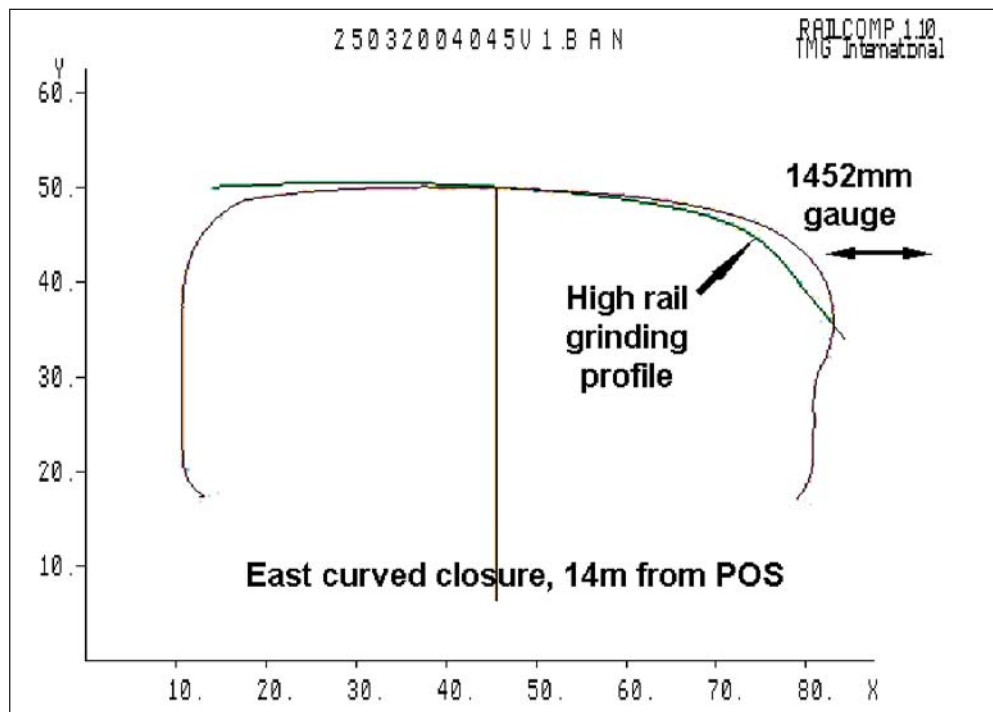
FIGURE 20: Typical curve closure rail profile

The measurements taken by the Miniprof Wheel instrument revealed that the rail profiles of the east point blade were heavily worn and had not been ground in many years. Figure 20 shows the actual profile of the east curved closure rail as measured compared with a theoretical profile had the rail been ground in recent times. The red trace shows the rail as measured, the green trace as if it had been ground.

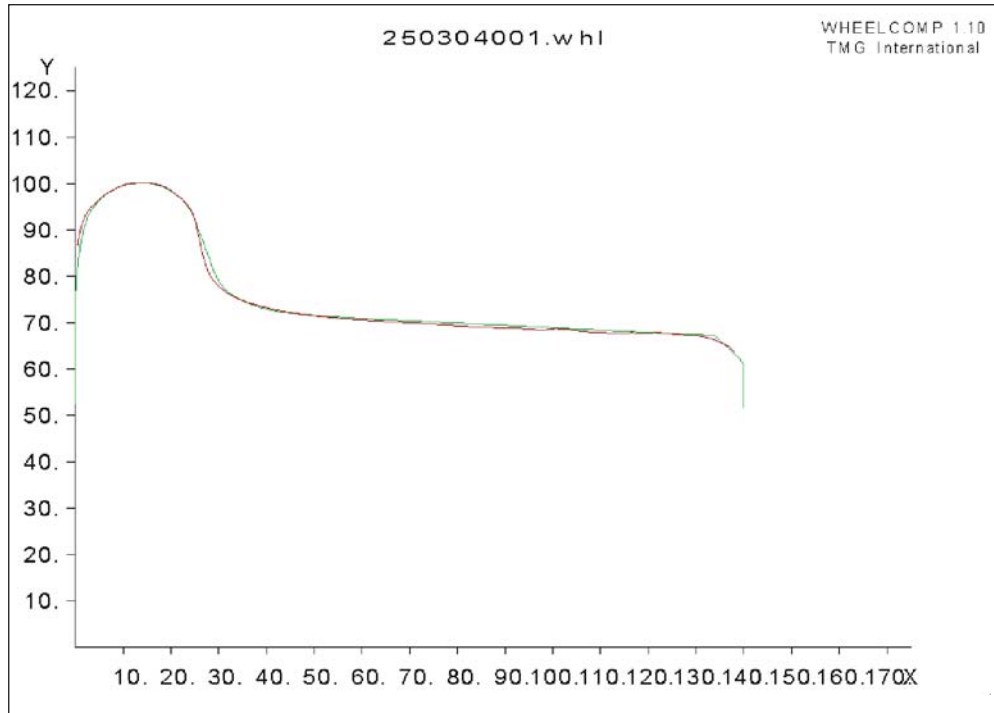
FIGURE 21: Profile comparison, the first wheel to derail

Notwithstanding the impediments caused by the damaged condition of the wheel when measured, it can be seen that the wear data is quite benign and therefore not considered a factor in this derailment. Figure 21 below is a comparison of this wheel with a theoretical new wheel of an ANZR2 profile. The green trace represents the new wheel.

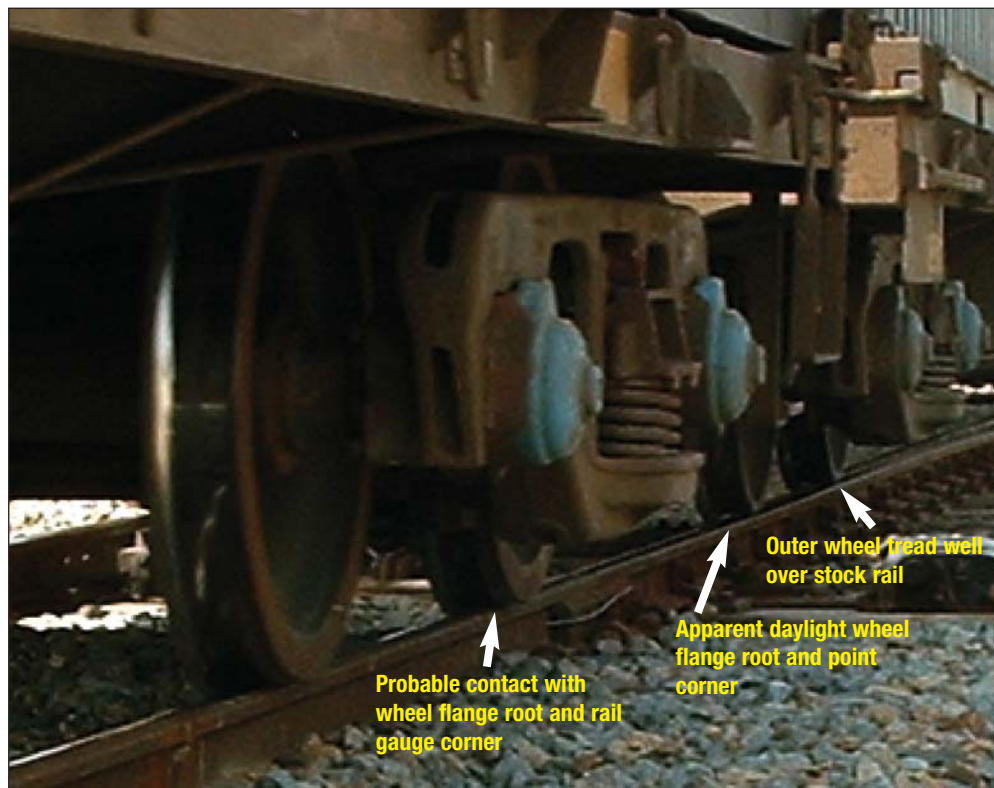
FIGURE 24: Wheels passing over the point of derailment, cripple siding Alumatta

The photo in figure 24 was taken on site at the point of derailment and illustrates this point. The left arrow shows the wheels well over towards the rail, with probable full contact between the wheel flange root and the rail gauge corner. The right arrow shows the side of the wheels well over the head of the stock rail, meaning the flange would be very close to, or in contact with, the point blade gauge face while, near the point of the switch, there is daylight visible between the wheel flange root and the point blade corner.

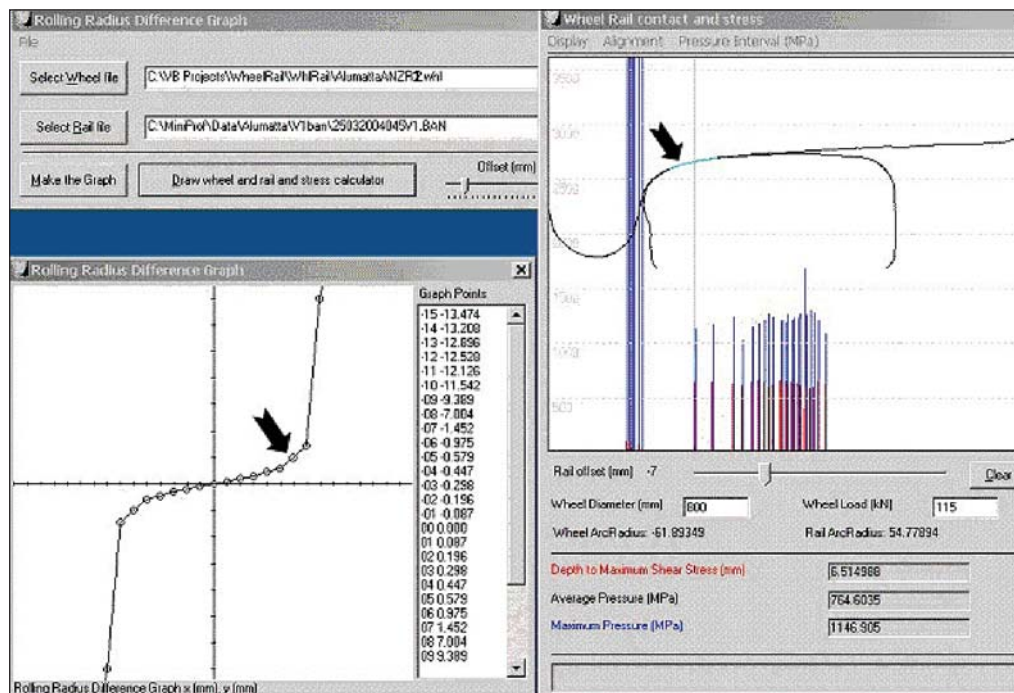
FIGURE 25: Conicity at east point blade

The right graph in figure 25 shows the wheel very close to making contact with the flange at the toe of the point blade. The left graph shows the change in the rolling radius as the wheel moved across the rail. Importantly, immediately before flange contact (shown in both graphs by the black arrows) the effective conicity¹⁸ is high and the angle of contact is low. High conicity can have beneficial and negative effects as the wheel steering can be improved but stability can lessen. A degradation of stability means that a relatively low lateral force would result in wheel climb according to the 'Nadal' formula.
