Aviation Occurrence Investigation – AO-2007-052

Uncontained Engine Starter Failure

General Electric CF6-80E1-A3

Airbus A330-300

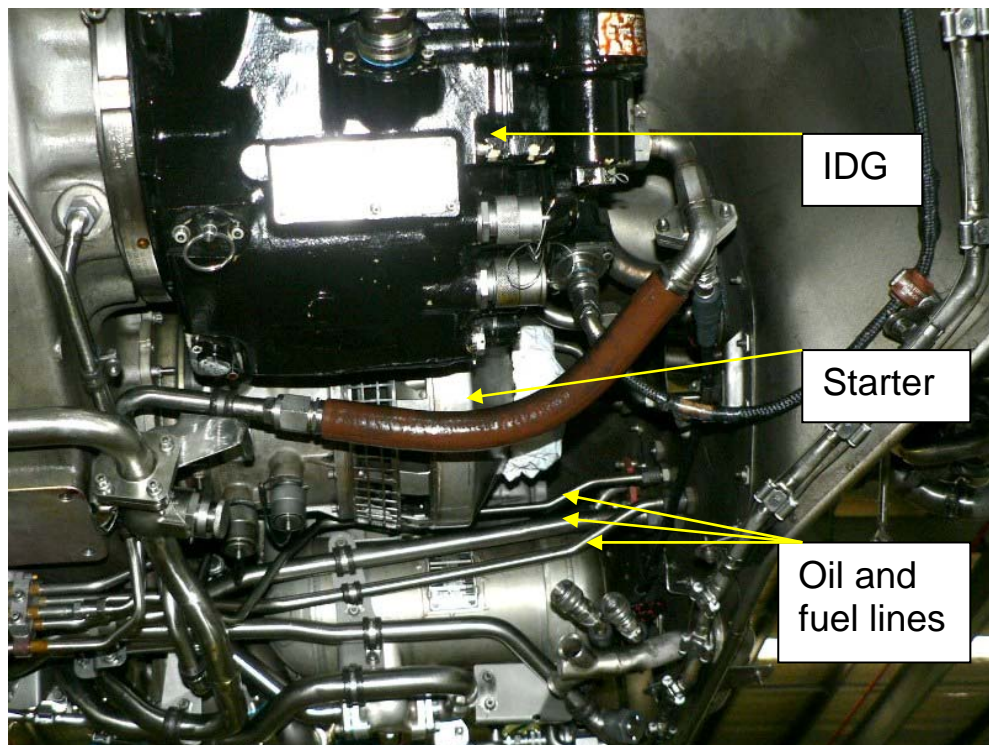
Figure 2: Starter installed

The starter, part number 3505468-4, was mounted in the CF6-80E1-A3 turbofan engine as shown in Figure 2. Immediately adjacent to the starter was the IDG and oil and fuel lines, shown in more detail in Figure 3. The accessory gearbox containing the starter was separated from the hot section of the turbine by a heat shield.

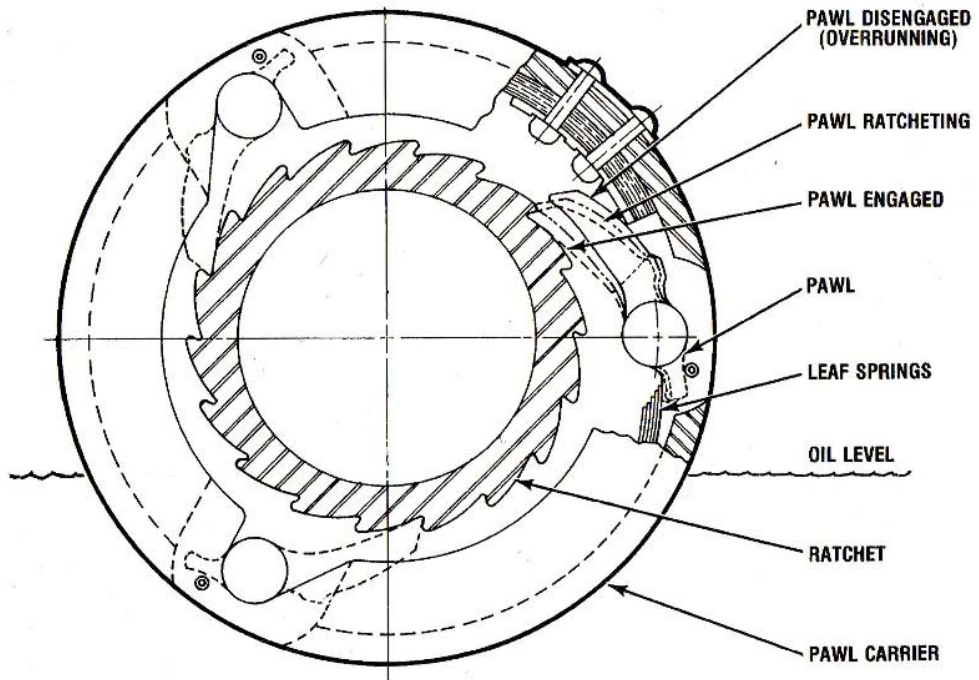
Figure 4. Example of a pawl clutch assembly

The high-speed, low-torque from the starter is converted to a lower-speed, high-torque via reduction gearing. The engagement mechanism for the drive shaft of the 3505468-4 starter consisted of a ratchet and pawl type clutch (Figure 4), such that at low engine speeds, the pawl springs force the pawls to engage with the ratchet on the drive shaft. When the engine speed exceeds that of the drive hub, the pawls act as fly weights and become completely withdrawn from the drive hub.

The starter manufacturer's internal investigation report of the uncontained starter failure, found that the damage sustained by the starter components was consistent with a crash engagement. Crash engagements are described in the report as follows:

Crash engagements can occur when during a start cycle the pneumatic supply to the starter is temporarily interrupted (this could be caused by commanding other pneumatic devices "on" during a start cycle, or from pneumatic power supply irregularities). The interruption would allow the clutch to disengage. When the power is re-applied the starter will accelerate to free-run speed, while the clutch will always rotate with engine starter pad speed. As the engine decelerates the clutch will eventually try to re-engage, crashing into the high-speed ratchet of the free-running starter.

Crash engagements result in significant damage to the clutch and can also damage the overrunning bearing and lead to further starter damage. The likely failure scenario proposed by the manufacturer is described below and illustrated by Figure 5:
