ATSB TRANSPORT SAFETY INVESTIGATION REPORT

Aviation Occurrence Report – 200503722

**In-flight upset event
240 km north-west of Perth, WA
Boeing Company 777-200, 9M-MRG
1 August 2005**

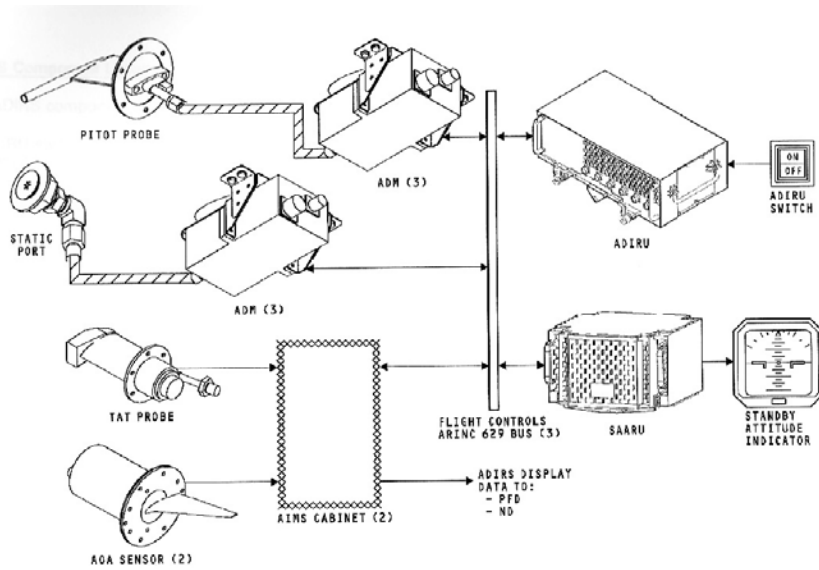
Figure 2: Air data inertial reference system

The function of the ADIRU was to provide air data and inertial reference data to several systems on the aircraft, including the primary flight control system, the autopilot flight director system and the flight management system. Components within the air data inertial reference system included (figure 2):

- the ADIRU
- the secondary attitude air data reference unit (SAARU)
- the air data modules (ADM)
- the pitot probes
- the static ports
- the total air temperature (TAT) probe
- the angle of attack (AOA) sensors
- standby attitude indicator.

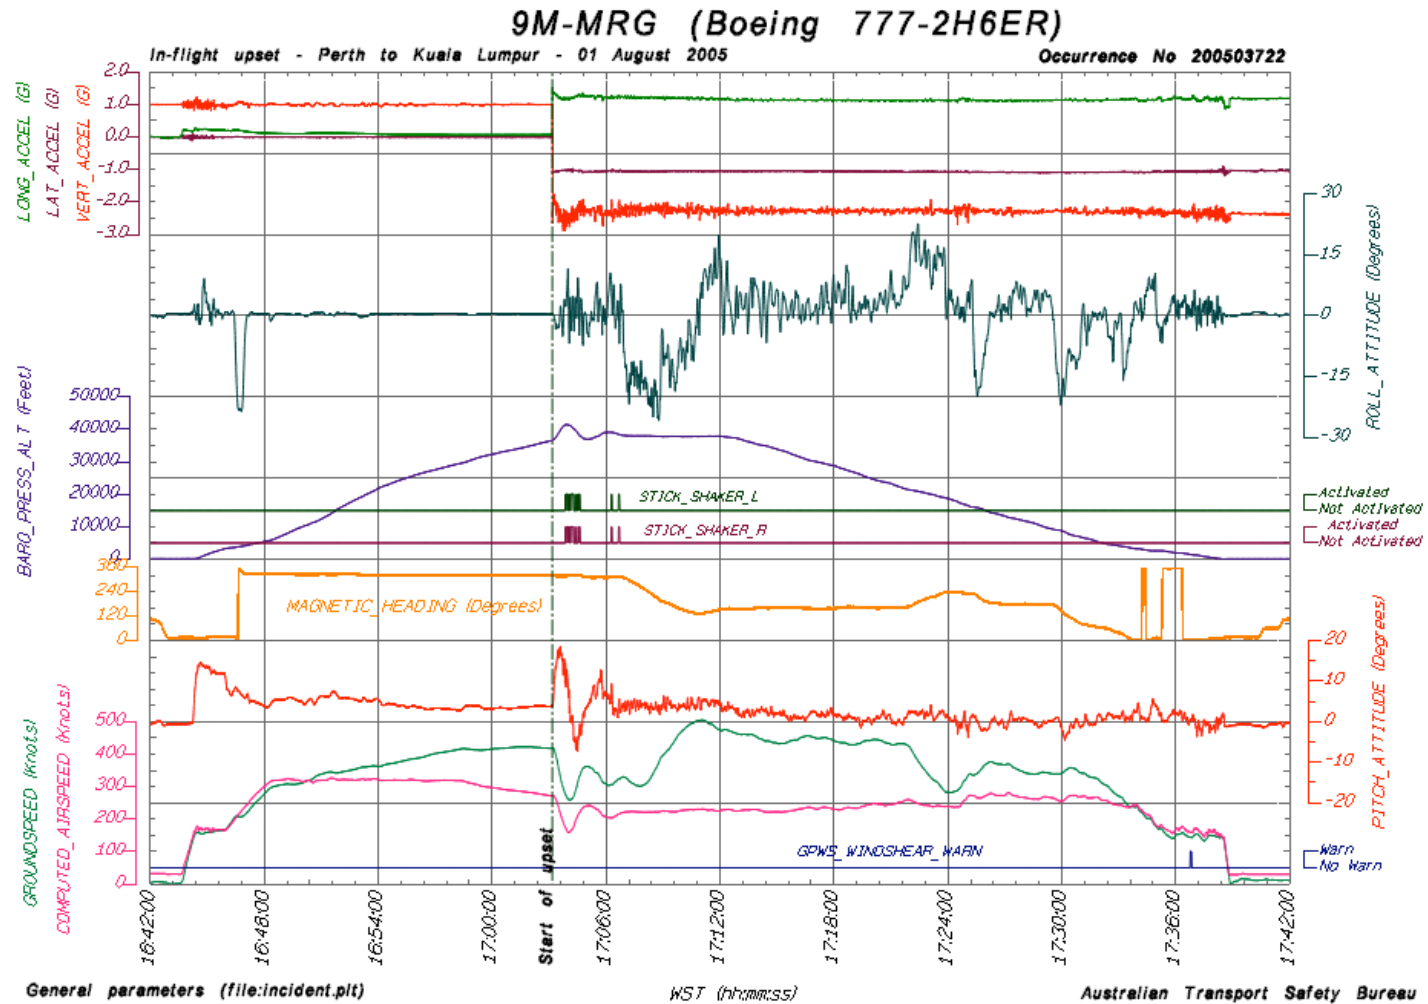
Figure 6: General parameters over sixty-minute period

General parameters over a 60-minute period containing the entire incident flight are displayed, see figure 6. Other relevant parameters are displayed over a 5-minute period incorporating the upset event, see figures 7-10.

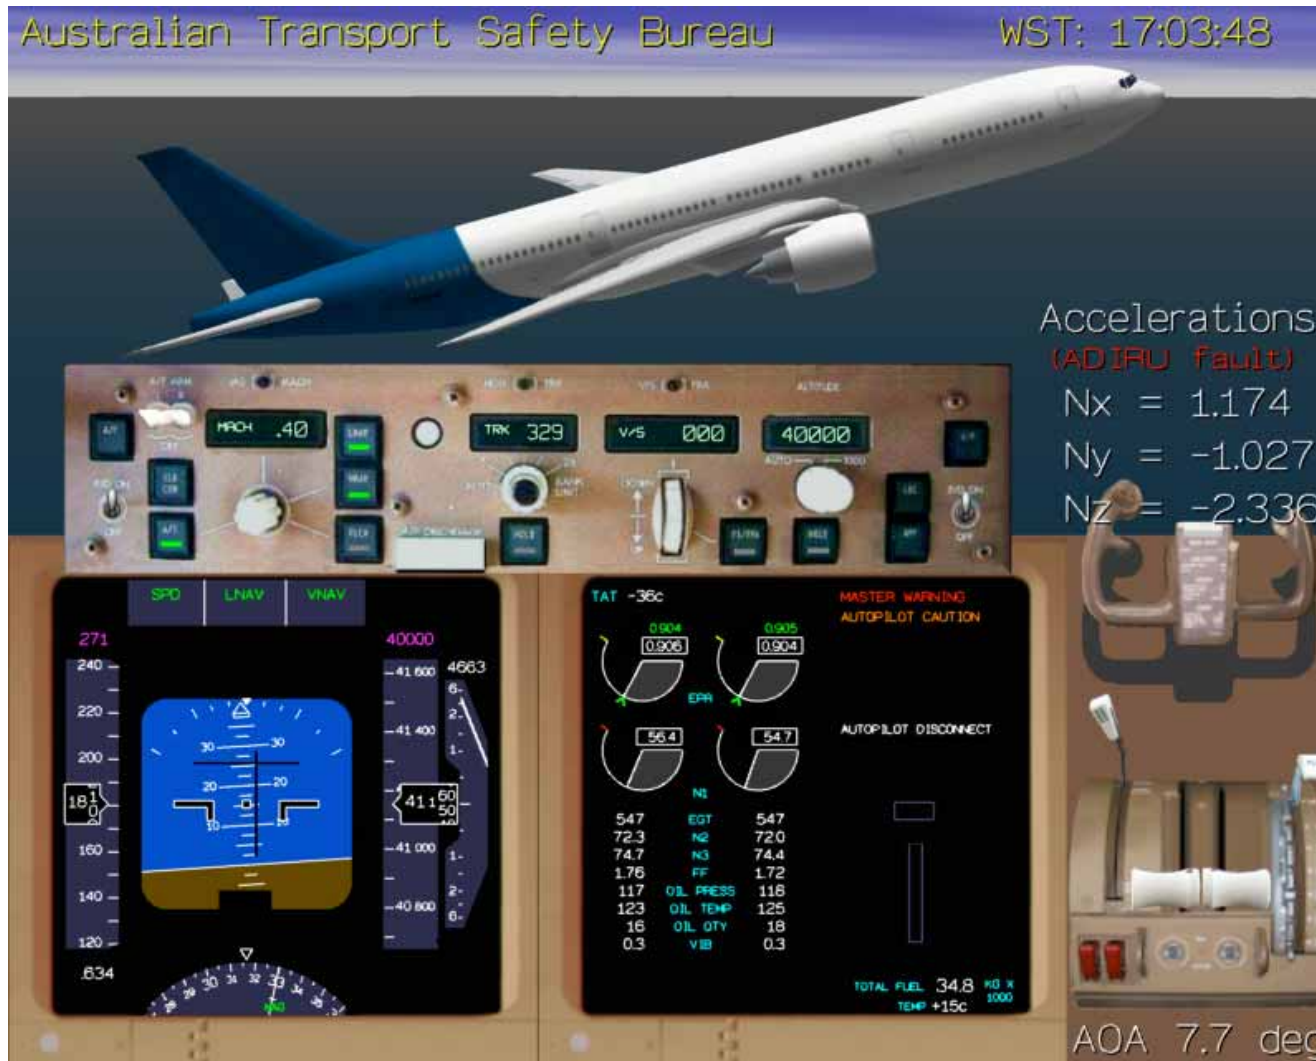
Figure 11: Screen capture of 9M-MRG animation

An animation of the incident was prepared using Insight Animation™ software and is part of this report. A file containing the animation in Insight View™ format (.isv) is available for download from the ATSB website. This file requires the installation of an Insight Viewer that can be downloaded from www.flightscape.com/products/view.php at no charge. A still screen capture of the animation is shown at figure 11.
