BASI Report B/885/1005

**Bell 214ST Helicopter VH-LAO
100 km north-west of
Troughton Island WA
28 March 1988**

ACCIDENT INVESTIGATION REPORT
B/885/1005

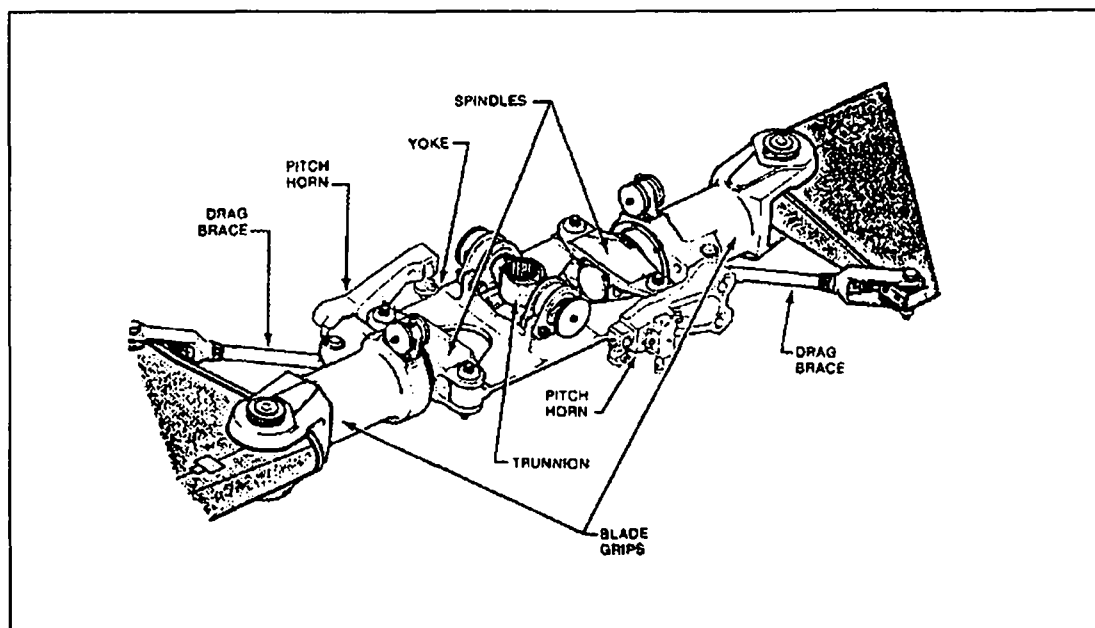
Figure 2. Layout of rotor head

The components and layout of the rotor head and drag brace assembly are displayed in figures 2 and 3.

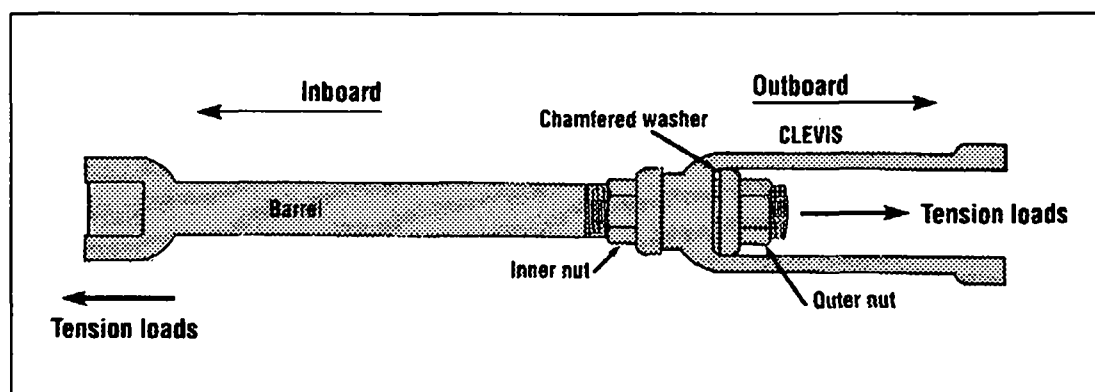
Figure 3. Layout of drag brace assembly

In order to adjust the sweep of each blade, the inner and outer nuts on each barrel are moved until the sweep is correct. The outer nut is held in position with a ring spanner while the inner nut is tightened with a torque wrench until the torque is between 375 and 425 ft lb. Several attempts are usually necessary to achieve the correct blade sweep coincident with final nut torque. Final installation is completed by the addition of a locking wire between the two nuts and the addition of corrosion preventative compound to the joint.
