Summary

On 19 January 1994, the Australian flag tanker *Oscro Star* was loading a cargo of petroleum products at No.2 Jetty of the BP Refinery at Kwinana, near Fremantle, W.A.

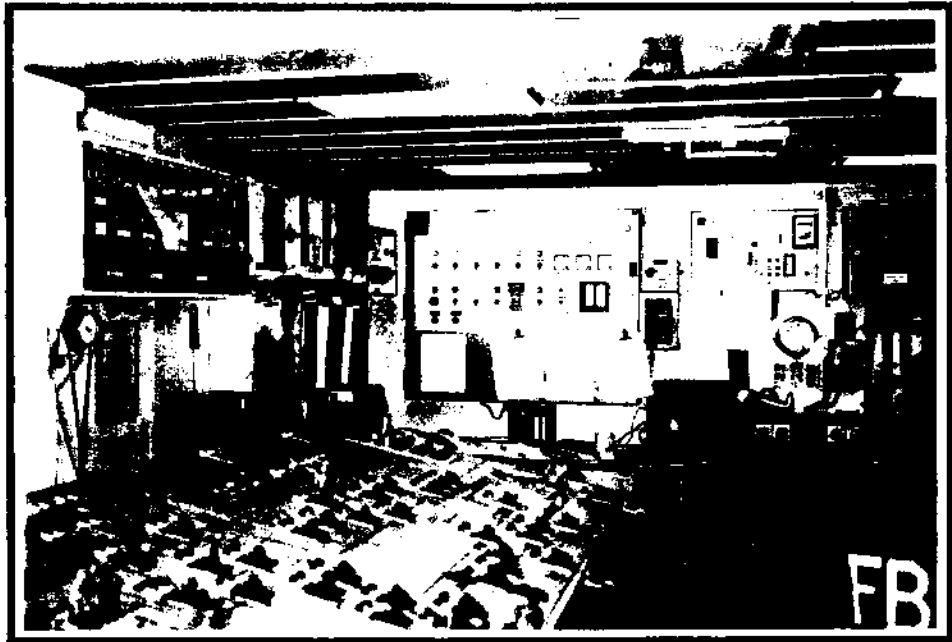
General view of cargo control room showing cargo control console (foreground) and Autronica computer terminal equipment (background)

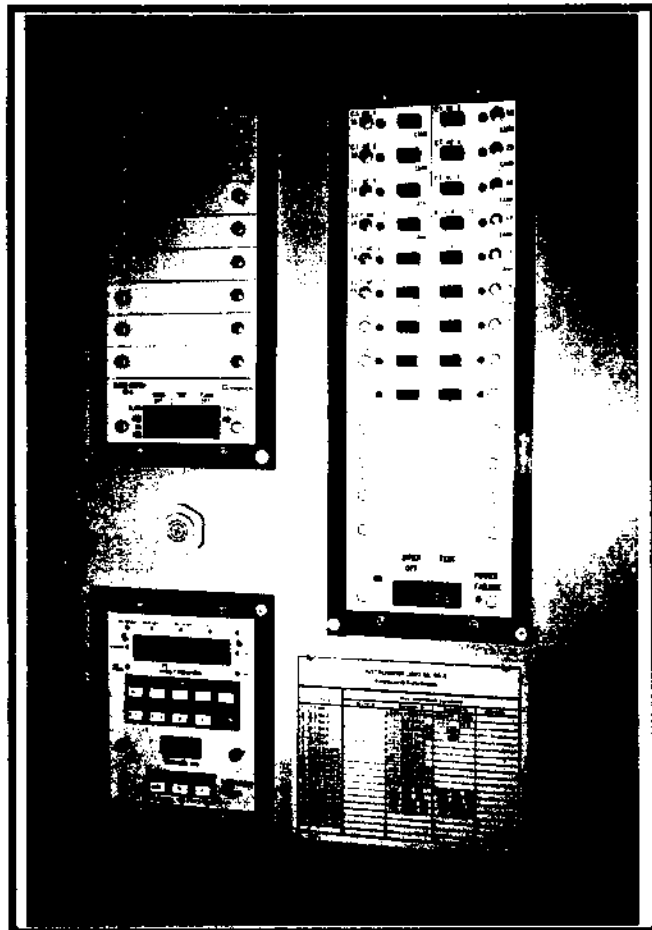
Autronica digital display units on after control room bulkhead
