RAIL INVESTIGATION REPORT

# **Collision between suburban electric passenger train 6369 and the empty express electric train 6371**

**Footscray, Victoria  
5 June 2001**

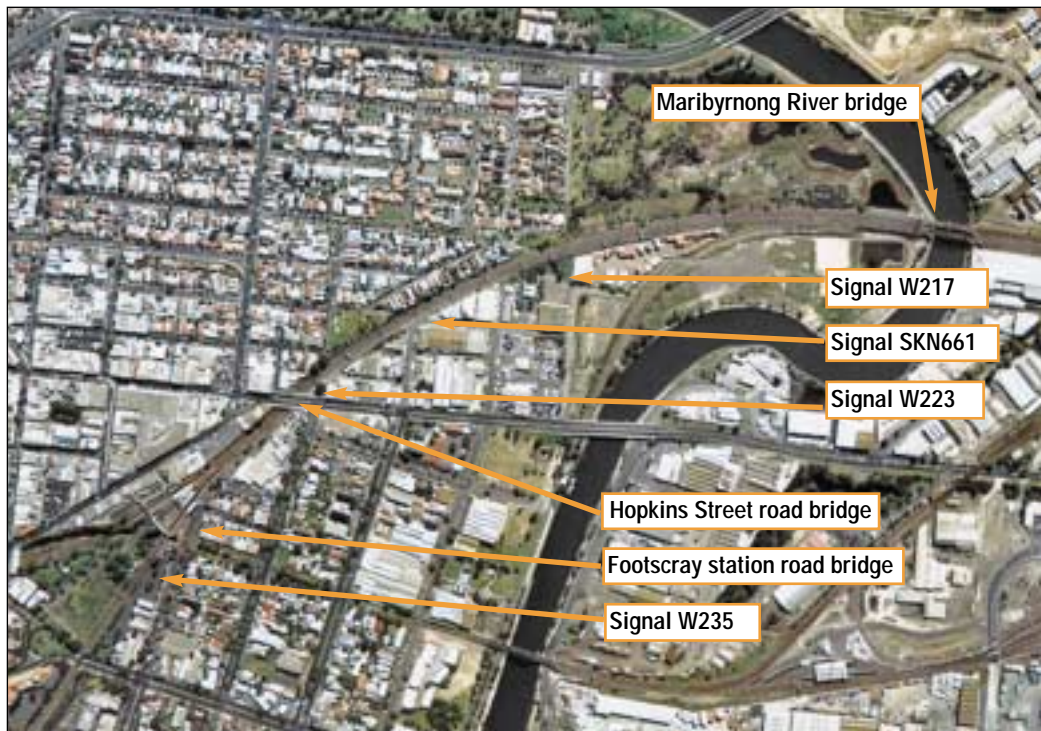
The approach to Footscray Station from Melbourne is mostly in a cutting where the line ahead is obscured by the curvature of the track, the retaining wall on the inside of the cutting and partially obscured by vegetation. Drivers approaching Footscray are unable to see the rear of a six-car train in the platform until the Hopkins Street overbridge, about 160 m from the eastern end of No.4 platform.

FIGURE 1:  
Aerial view of track between Maribyrnong River and Footscray Station

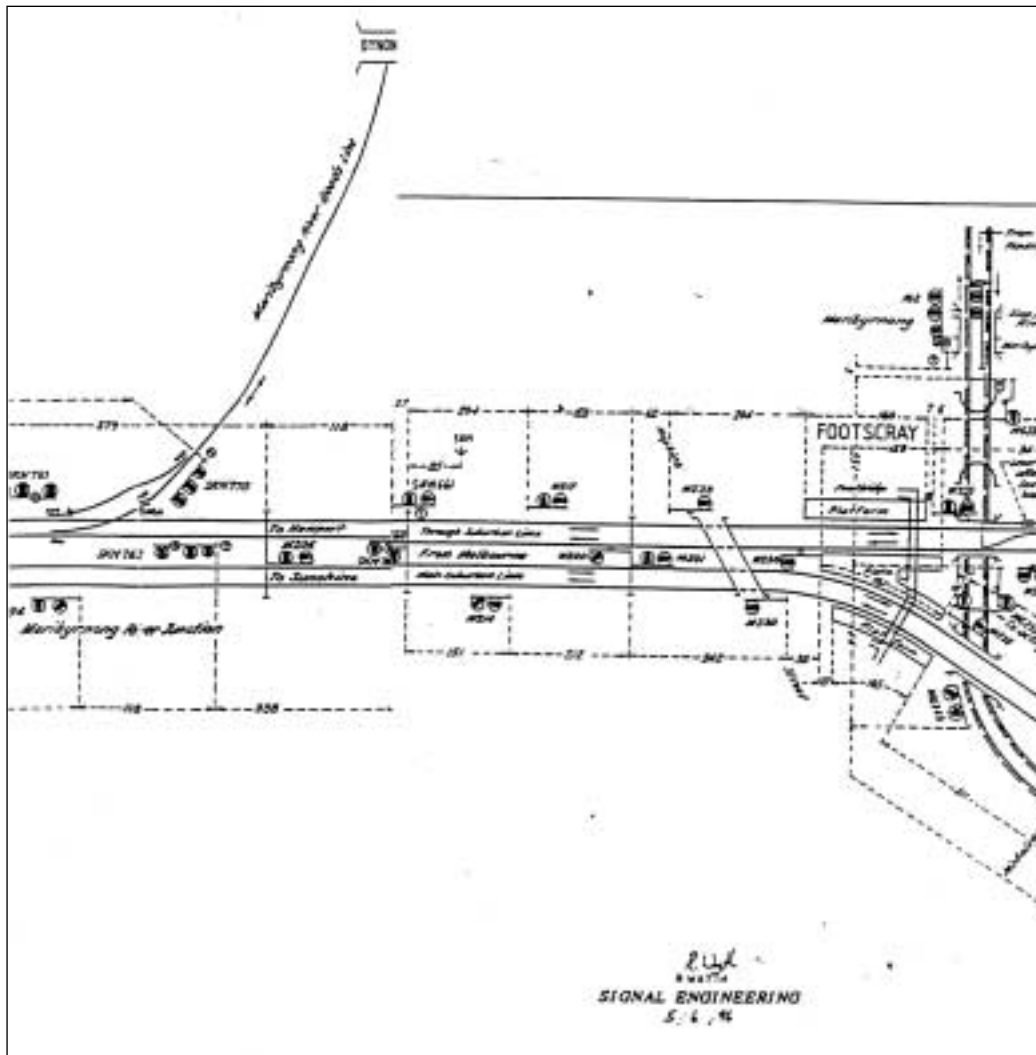
FIGURE 9:  
Schematic of track and signal layout east of Footscray station

The distance from the west bank of the Maribyrnong River to Footscray Station is about 1150 m. There are four sets of permissive signals on the down, through-suburban line: identified as SKN751; SKN661; W217; and W223. The signal at the western end of No. 4 platform Footscray is W235. The distances between the relevant signals are:
