**ATSB TRANSPORT SAFETY REPORT**

Aviation Occurrence Investigation – AO-2006-006

**Loss of control  
21 km NE Mount Gambier, SA  
20 December 2006  
Kawasaki KH4  
VH-LFK**

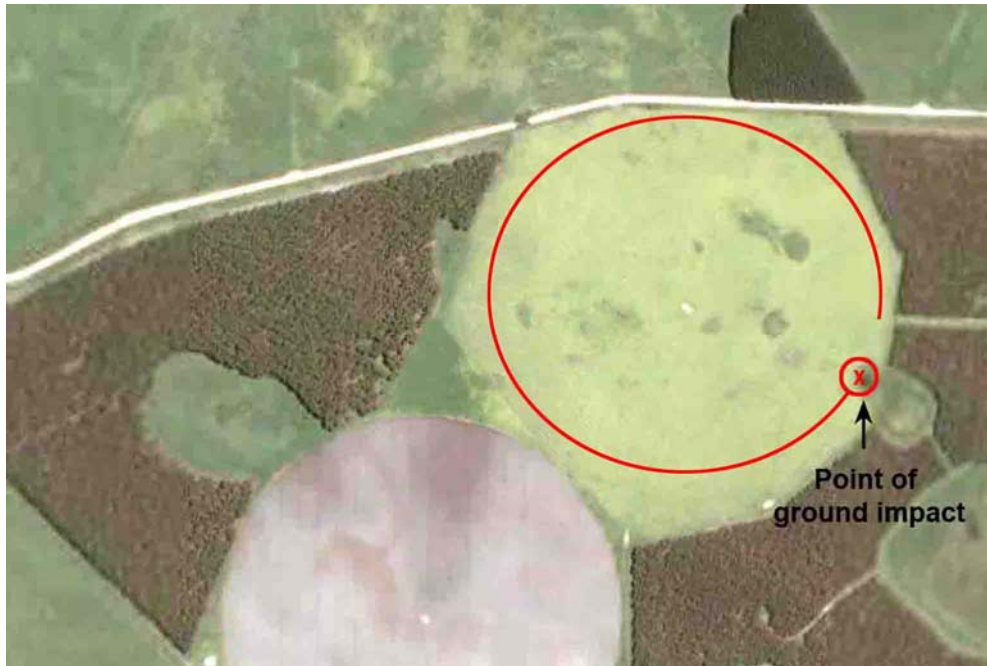
**Figure 1: Satellite image of the paddock that was being sprayed, overlaid with LFK's reported track prior to impacting the ground**

The pilot reported that he first encountered control difficulties while turning at about 20 ft above ground level during the final phase of a clean-up run<sup>2</sup> around the potato crop that he had been spraying (Figure 1). A loud bang was heard followed by airframe vibration and a complete loss of the helicopter's collective pitch control. At that instant, the helicopter immediately began to descend. The pilot was able to guide the helicopter as it descended using inputs to the cyclic control stick and the tail rotor control pedals. The helicopter landed heavily, tail first, and was substantially damaged from exposure to ground impact forces.

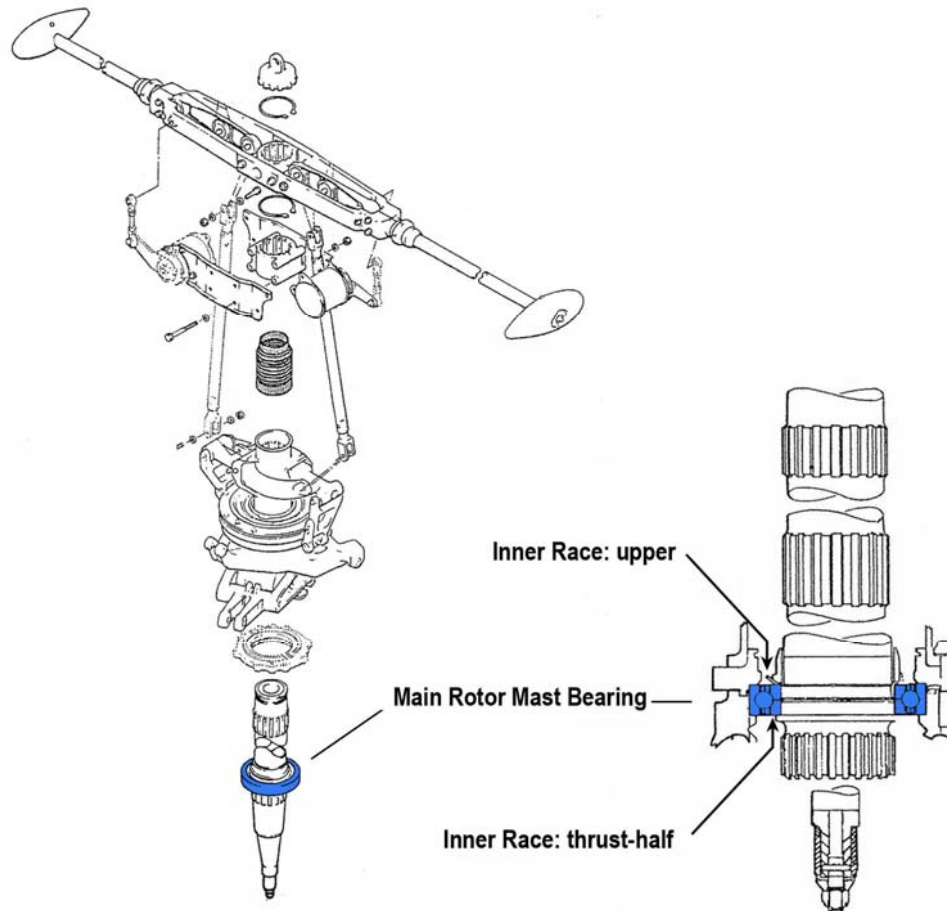
**Figure 6: Illustration of the KH4 mast controls showing the main rotor mast and the mast thrust bearing in detail**

Proper alignment of the bearing identifiers indicated that the mast bearing had been installed in accordance with the manufacturer's instruction. Figure 6 illustrates the KH4 mast controls and the position of the mast bearing.

Note: LFK was not fitted with a stabiliser bar
