MARINE SAFETY INVESTIGATION
No. 202

**Independent investigation into the
engine room flooding of the
Panamanian registered bulk carrier
Harmonic Progress
in the Coral Sea on
16 April 2004**

March 2005

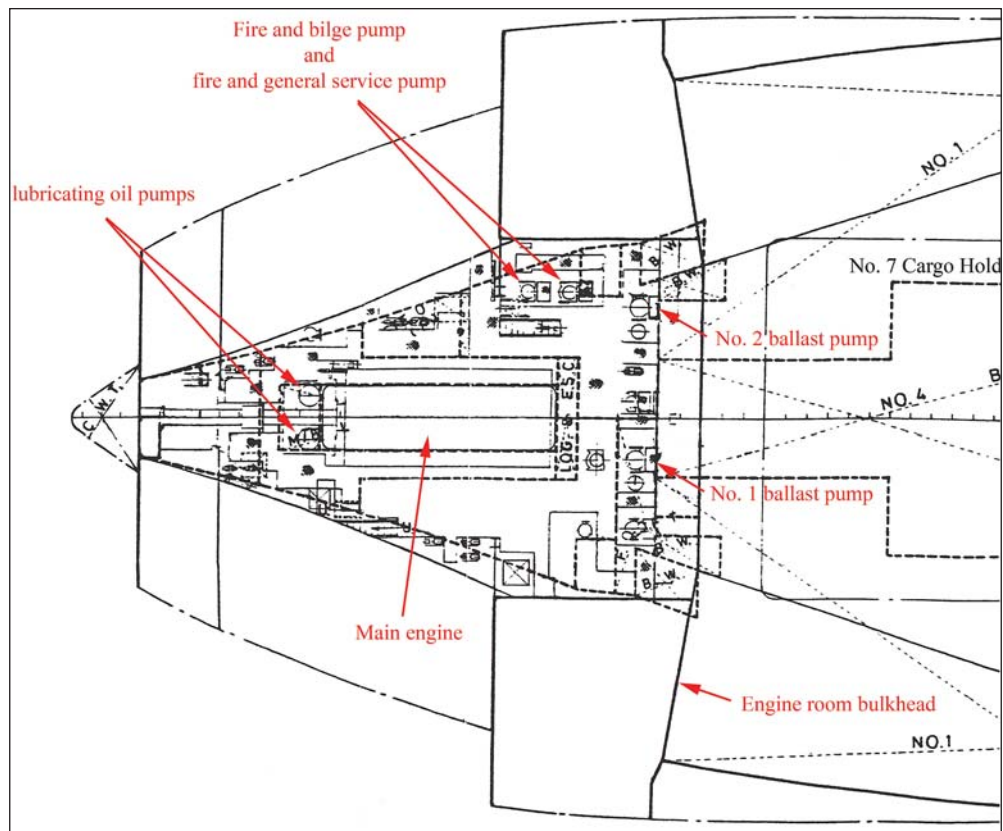
FIGURE 1:
Engine room layout

All of the ship's main pumps are located on the lowest level of floor plates. Two ballast pumps, each with a capacity of 1000 m³/h, are located at the forward end of the engine room, just aft of the bulkhead separating the engine room from number seven hold. Number one ballast pump is located on the starboard side of the engine room, with number two ballast pump located on the port side (Fig. 1). Both ballast pumps have discharge/suction lines which terminate at sea chests. An eductor for stripping the water ballast tanks is located aft of number one ballast pump.

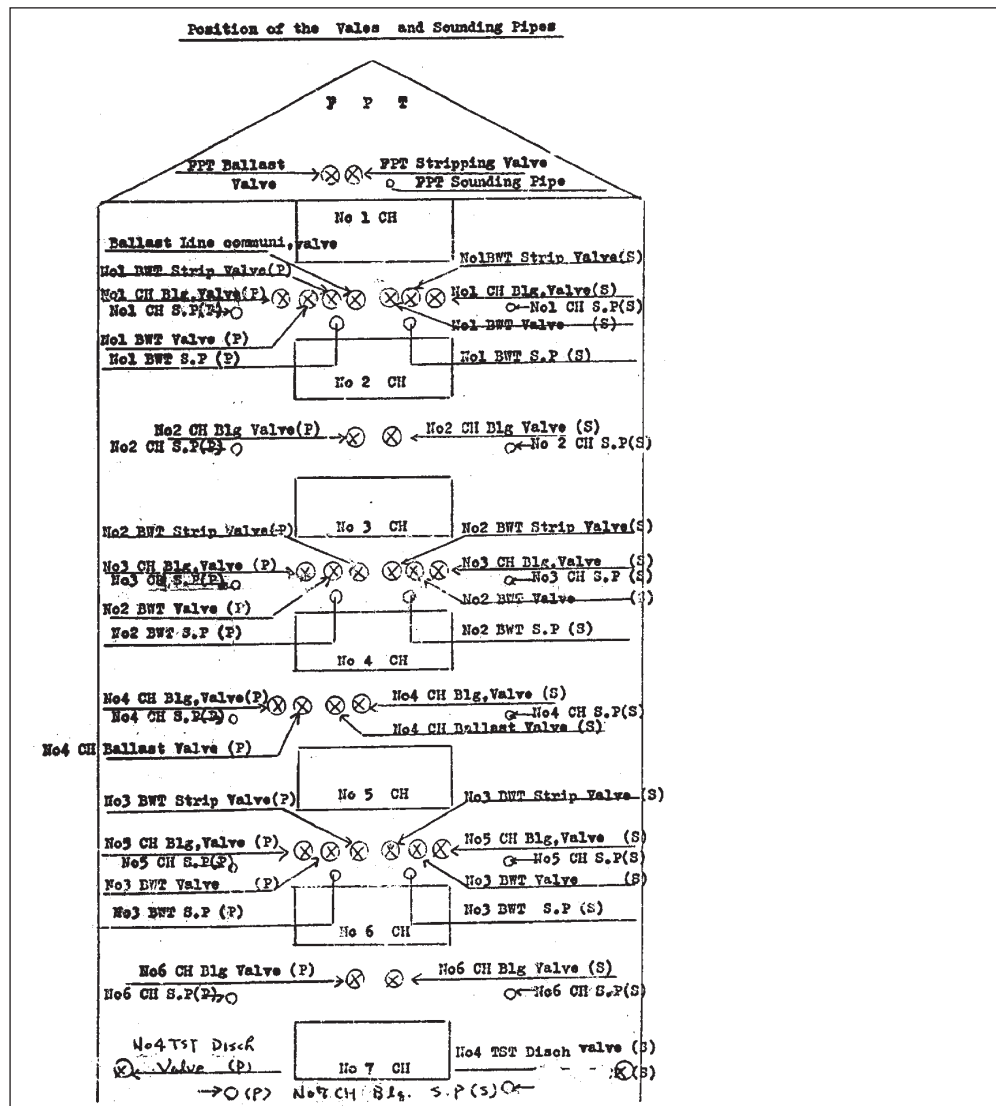
FIGURE 7:
Mate's plan of ballast tank valves and sounding pipes

Harmonic Progress's engine room staff carried out the ballasting at the request of the mate. At the time of the incident, the mate had some typed instructions that stipulated which valves to open to fill particular tanks and the locations on the main deck of the valve spindle handles and sounding pipes (Fig. 7). These instructions also briefly explained which ballast pumps to use, when to use gravity to fill tanks and which valves in the engine room to use to ballast or deballast the ship (Fig. 8). There were no specific operating procedures that the crew could reference to correctly operate the ballast system.
