OUTLINE OF INCIDENT

The Philippine registered bulk carrier SINGA SEA, a ship of 26586 tonnes deadweight and some 175 metres in length overall, loaded a mixed bulk cargo of mineral sands and copper ore at the West Australian ports of Geraldton and Bunbury between 27 June and 2 July. At 0915 hours Western Standard Time (WST)\* the ship sailed for Rotterdam via Cape Town, where it was expected to take on bunker fuel.

5. The ship sank after breaking in two in heavy seas at about 0300 GMT on 4 July 1988, in approximate position 35°00'S 106°00'E.
6. The reasons for the failure of the ship's structure are not known, but they are not considered to be attributable to the quality or physical characteristics of the cargo as loaded in Geraldton and Bunbury.

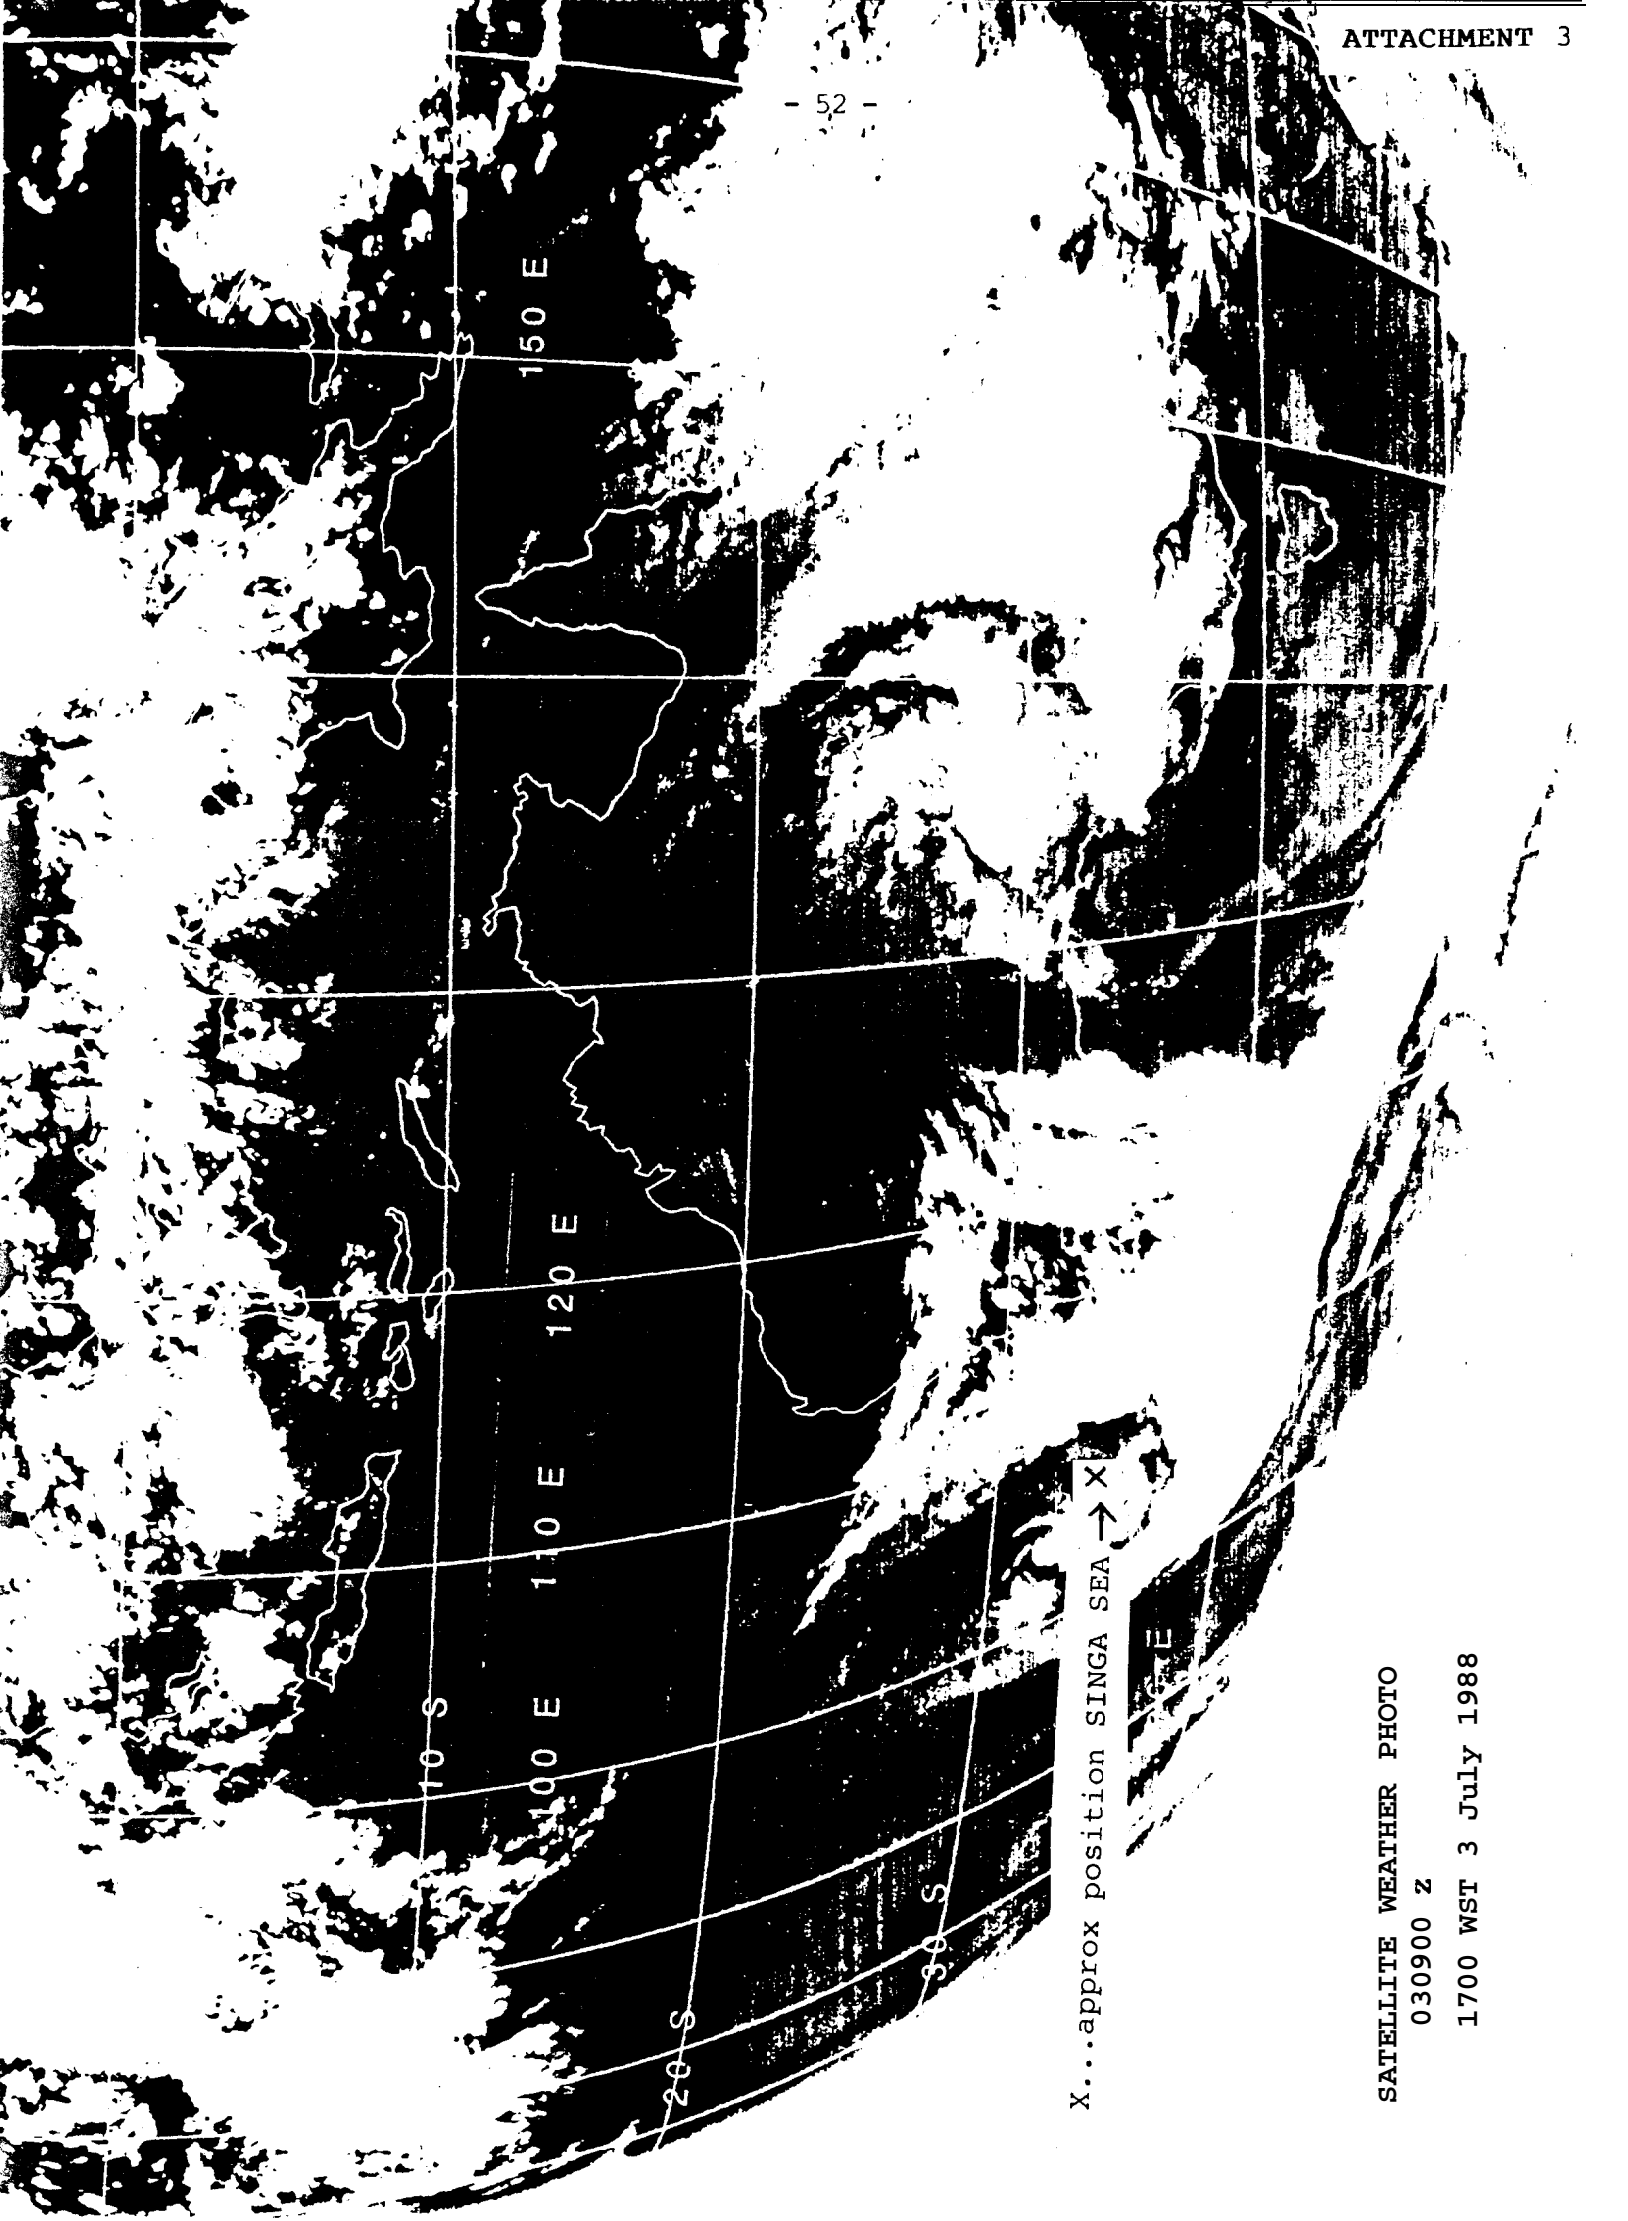
SATELLITE WEATHER PHOTO  
030900 Z  
1700 WST 3 July 1988

X...approx position SINGA SEA -> X

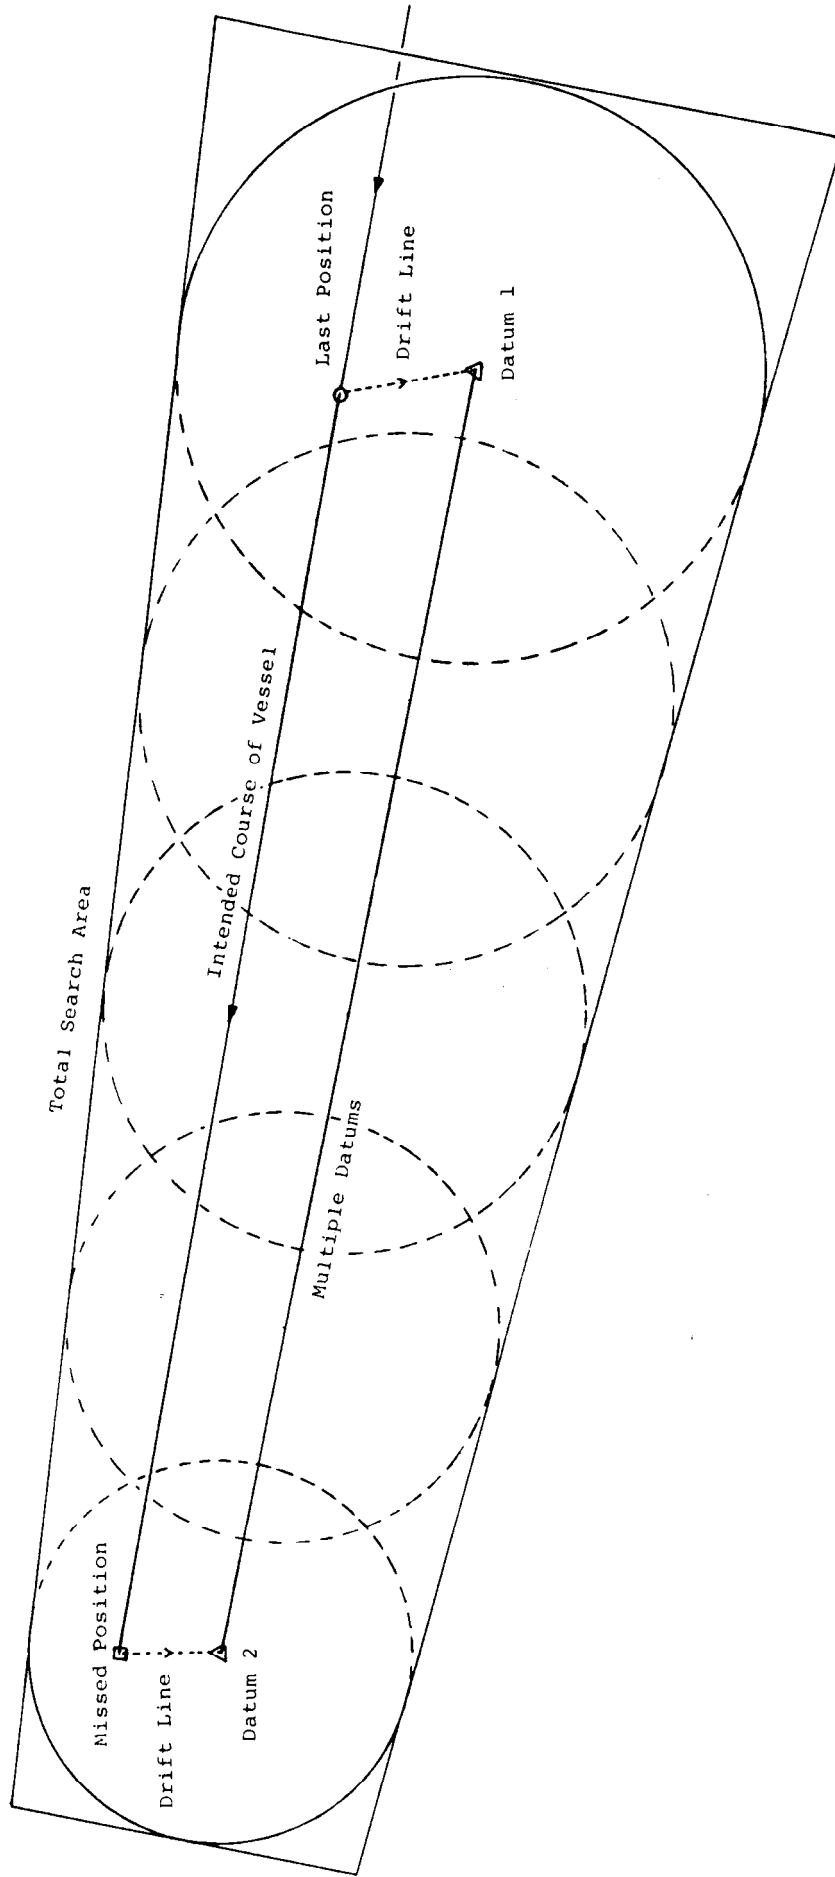
EXAMPLE OF LAST REPORT-MISSED  
REPORT SEARCH AREA

Having taken all these factors into account, the SARMC calculates a search radius around the datum point to find the possible search area. In the case of SINGA SEA there were two datum points and two search radii calculated from the last position/missed position points but also there were numerous datums along a line joining the two datum points, and also numerous search radii. This is shown in diagrammatic form below.
