ATSB TRANSPORT SAFETY INVESTIGATION REPORT

Aviation Occurrence Report – 200501977

Interim Factual Report No. 2

**Collision with Terrain
11 km NW Lockhart River Aerodrome
7 May 2005
VH-TFU
SA227-DC (Metro 23)**

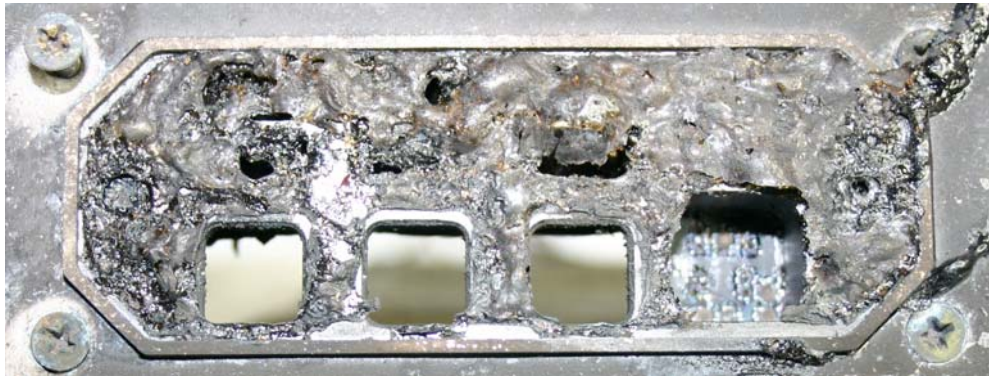
Figure 18: MD-41 annunciation/control unit

Examination of light globes from the GPS annunciator/control unit indicated that the aircraft system was receiving electrical power at impact. The three switches that formed part of the unit were not located in the wreckage (Figure 18).
