**ATSB TRANSPORT SAFETY REPORT**  
Aviation Occurrence Investigation – AO-2010-089  
Preliminary

**In-flight uncontained engine failure  
overhead Batam Island, Indonesia  
4 November 2010  
VH-OQA  
Airbus A380-842**

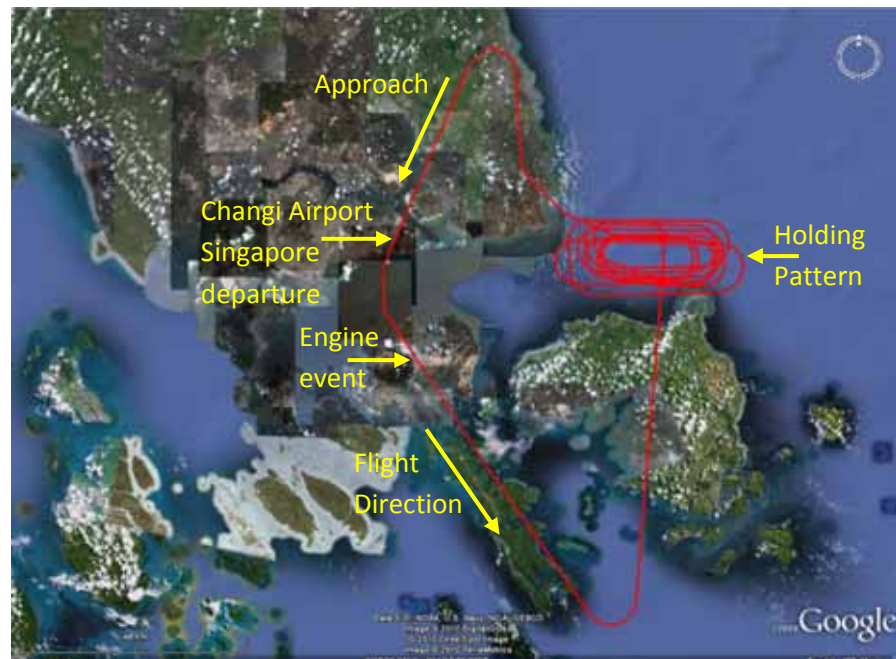
**Figure 2: Aircraft's flight path, showing the departure from Singapore, the holding pattern to the east of Singapore and the approach to Changi Airport**

The aircraft's departure track from Singapore, the holding point and pattern and approach to Changi Airport are shown at Figure 2.

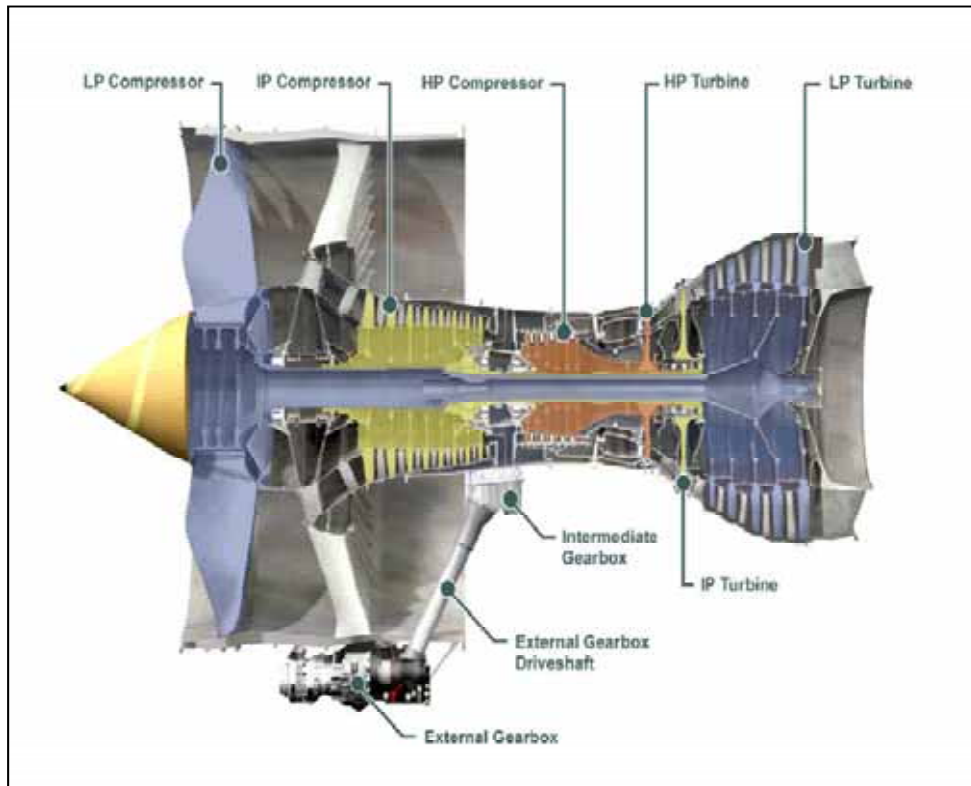
**Figure 6: Trent 900 engine component layout**

The Rolls Royce plc Trent 900 engine is a three-shaft, high by-pass ratio turbofan with low pressure (LP), intermediate pressure (IP) and high pressure (HP) compressors that are driven by turbines through co-axial shafts (Figure 6).

<sup>18</sup> N3 vibration is the vibration level of the HP spool comprising the HP compressor and HP turbine. Similarly, N1 vibration is the vibration level of the LP spool, comprising the LP compressor and LP turbine. N2 vibration is the vibration level of the IP spool, comprising the IP compressor and IP turbine (refer Figure 6).

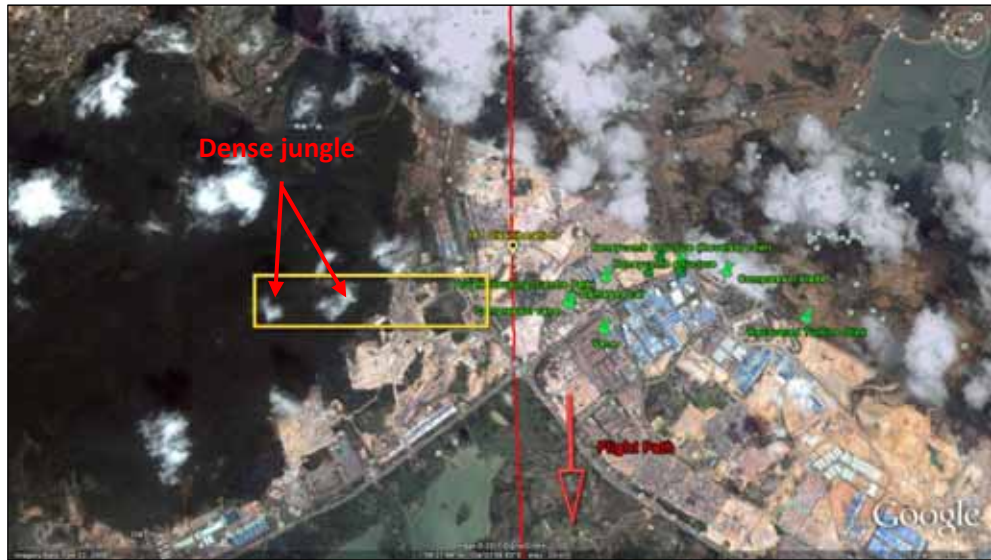
**Figure 12: Estimated location of the missing disc segments (search area in yellow, including the area of dense jungle)**

Trajectory analysis was undertaken to localise the search area based on a number of aircraft and engine parameters immediately prior to the failure, and on the location of the recovered segment of the IP turbine disc. On that basis, it was estimated that the missing disc segments should be located to the right of the aircraft's flight path, most likely in an area of steep, dense jungle (Figure 12).

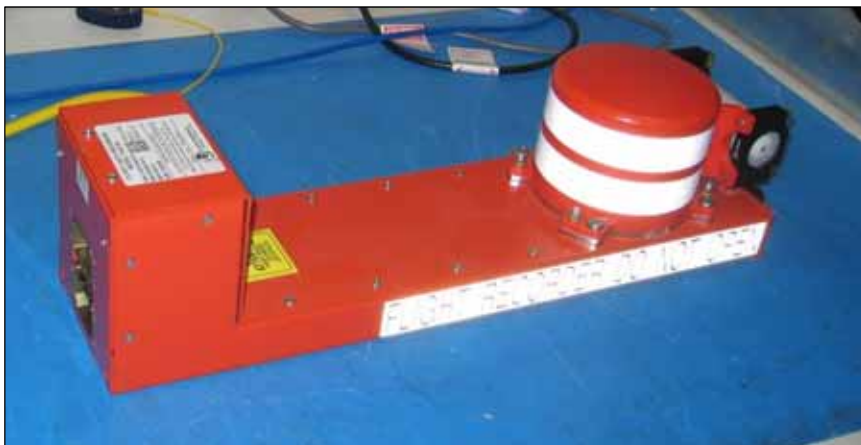
**Figure 17: Flight Data Recorder**

The FDR was removed from the aircraft under the supervision of the Air Accident Investigation Bureau of Singapore and transported to the aircraft operator's Sydney base (Figure 17). The ATSB supervised the download of the recorded data on 5 November 2010.

The FDR contained 77 hours 16 minutes of recorded aircraft operation. The data was of excellent quality and included the accident flight and over five previous flights.

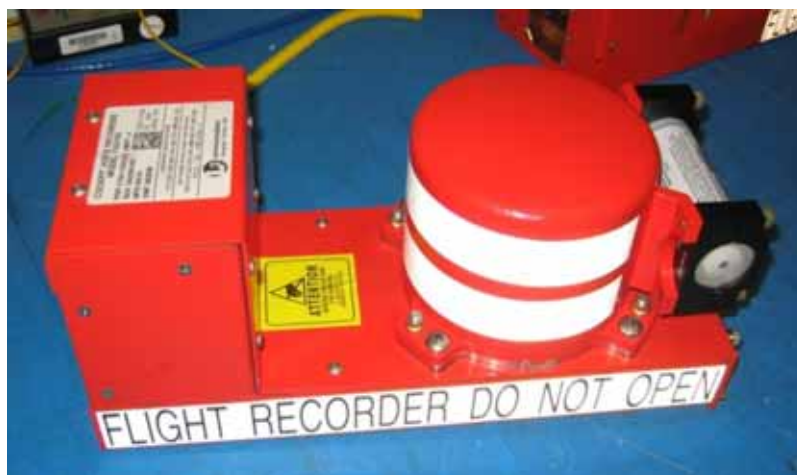
**Figure 18: Cockpit Voice Recorder**

The CVR was returned to the ATSB's technical facilities in Canberra for download and analysis (Figure 18).

The CVR contained over 2 hours of cockpit audio but, due to the continued running of the No 1 engine in Singapore, the audio at the time of the disc failure was

overwritten. The available audio commenced during the landing approach and continued during the subsequent ground operations.

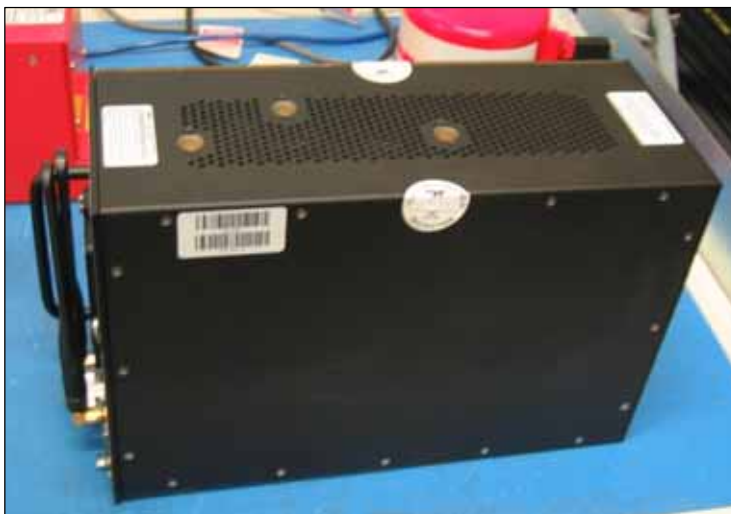
**Figure 19: Wireless DAR**

The wireless digital ACMS recorder (WDAR) stored a continuous record of about 1,000 different aircraft and engine system parameters in a custom format that was defined by the operator in conjunction with the aircraft and engine manufacturers. That recorder contained additional engine parameters at a greater resolution and sampling rate than the FDR (Figure 19).

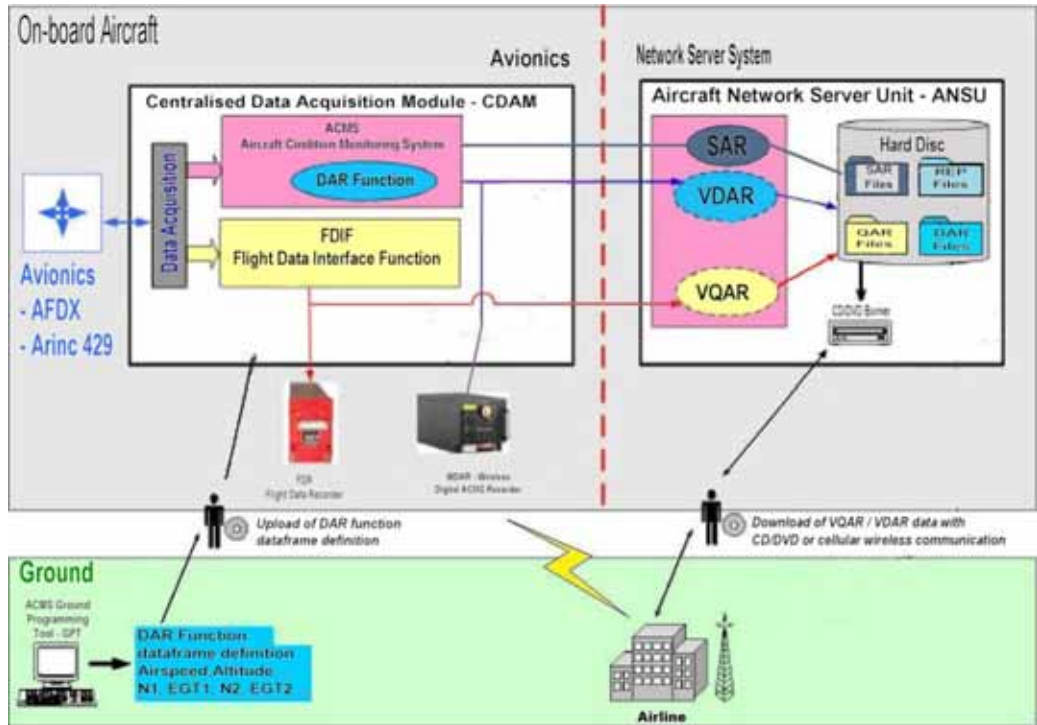
**Figure 20: Simplified schematic of the aircraft's data acquisition and recording system**

The aircraft was fitted with main and backup aircraft network server units (ANSU-OPS1 and ANSU-OPS2). A copy of the FDR information was stored as the virtual quick access recorder (VQAR) within the unit. In addition, a copy of the DAR information was stored as the virtual digital ACMS recorder (VDAR). The Smart ACMS Recorder (SAR) information and the aircraft system reports (REP) were also recorded in ANSU-OPS1 and 2 (Figure 20).
