Investigation Report 510/08

Very serious marine casualty

Fatal accident on board the CMV CHICAGO EXPRESS during Typhoon "HAGUPIT" on 24 September 2008 off the coast of Hong Kong

1 November 2009

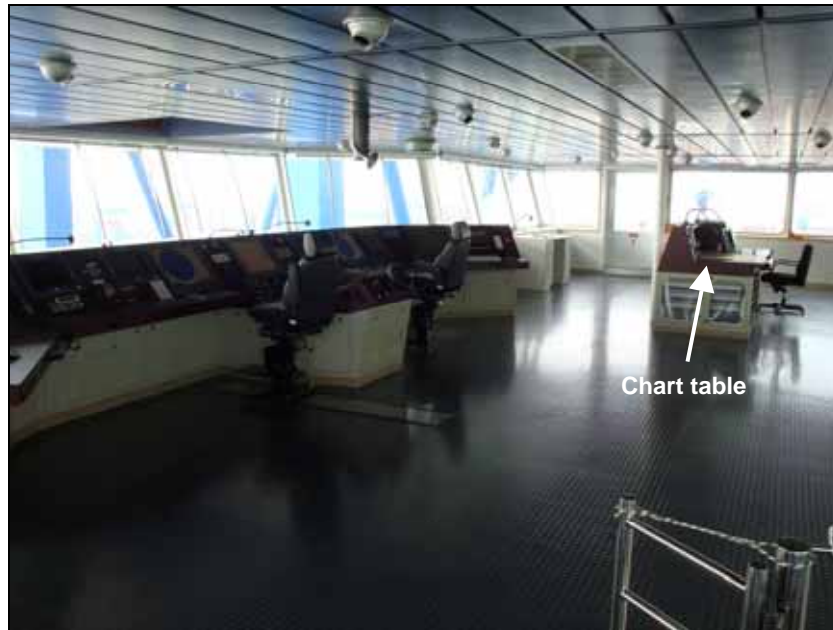
Figure 4: Bridge (1)¹³

At the time of the accident, at about 0245, the Master was reportedly situated at the right of the two radar screens integrated in the bridge console and the Second Officer on Watch was at the chart table. The AB who was acting as Lookout was reportedly situated at the GMDSS¹² station (see Fig. 4 and 5).

¹³ Note: The AB was found close to the companionway handrail, which can be seen in the foreground of the photo, which points to starboard (see also Fig. 5).

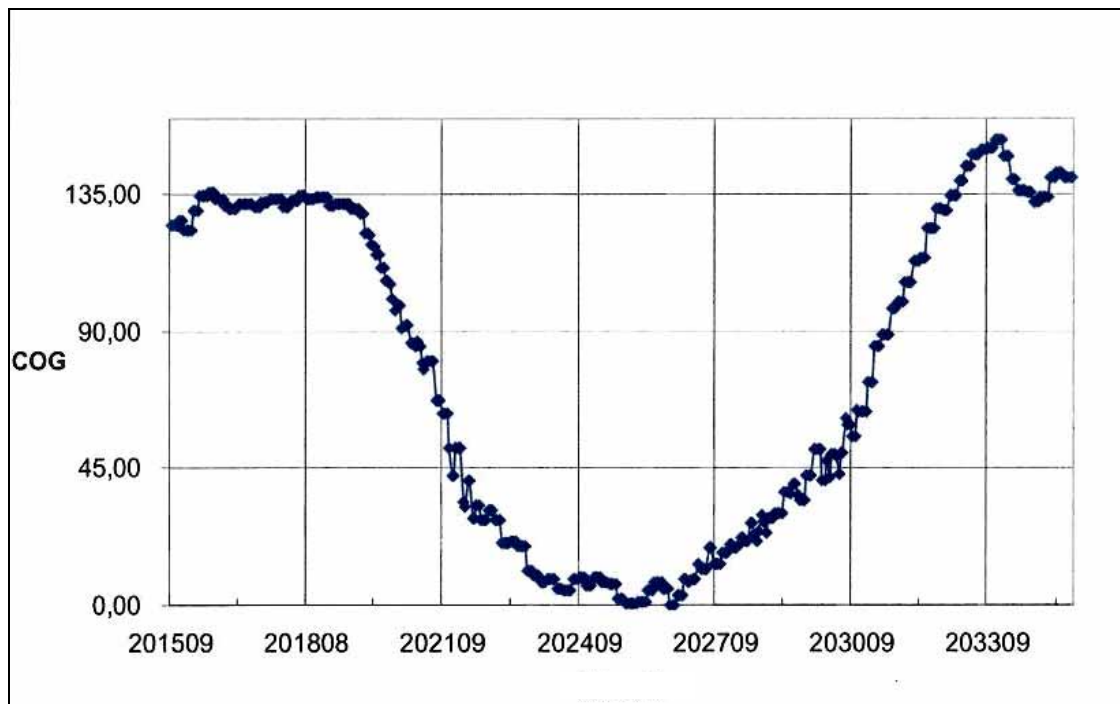
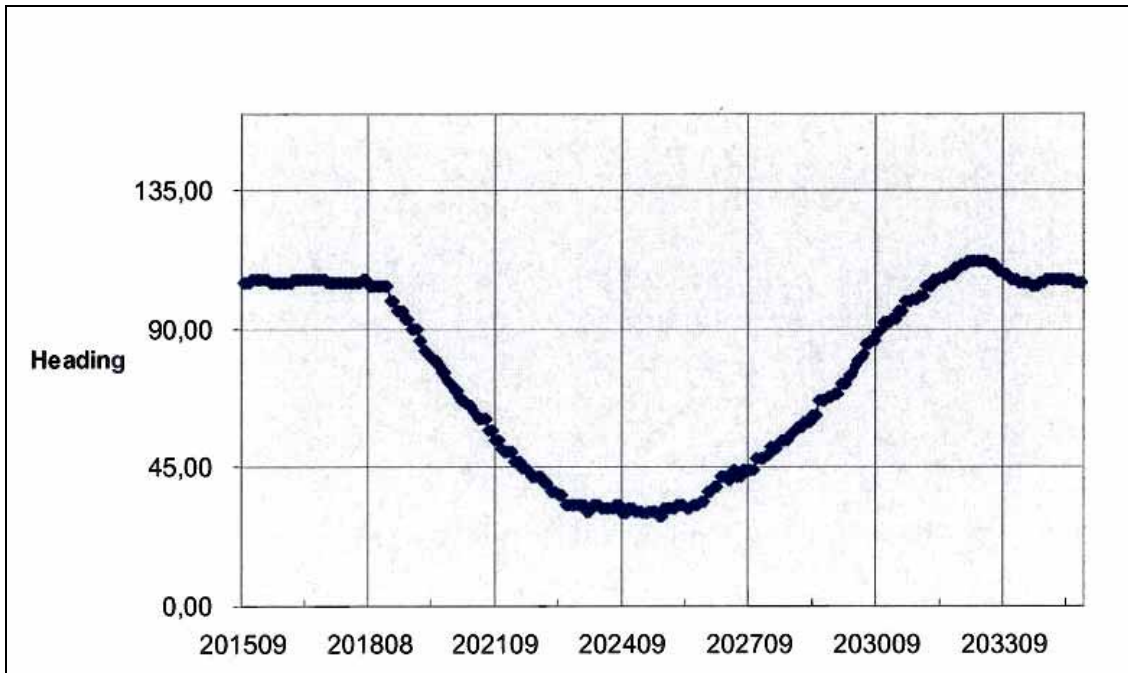
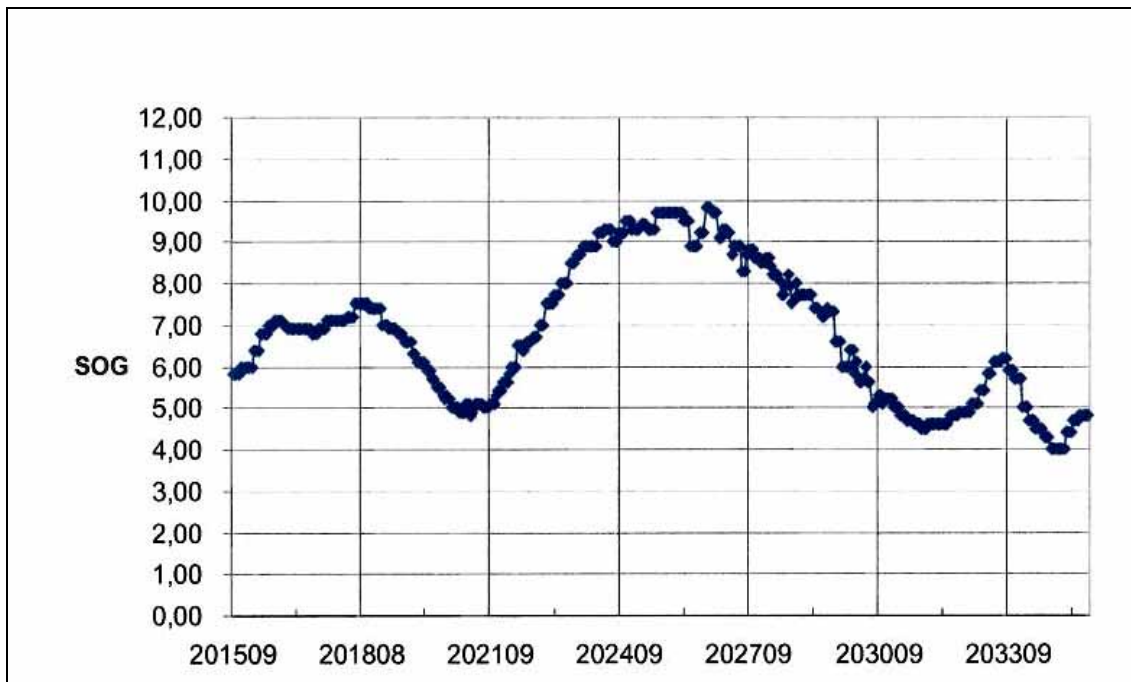
It was thus possible, for example, to clearly trace the failed attempt by the ship's command to put the CHICAGO EXPRESS on a northerly general course towards Ningbo at about 2018 (see **Fig. 8 to 10**).

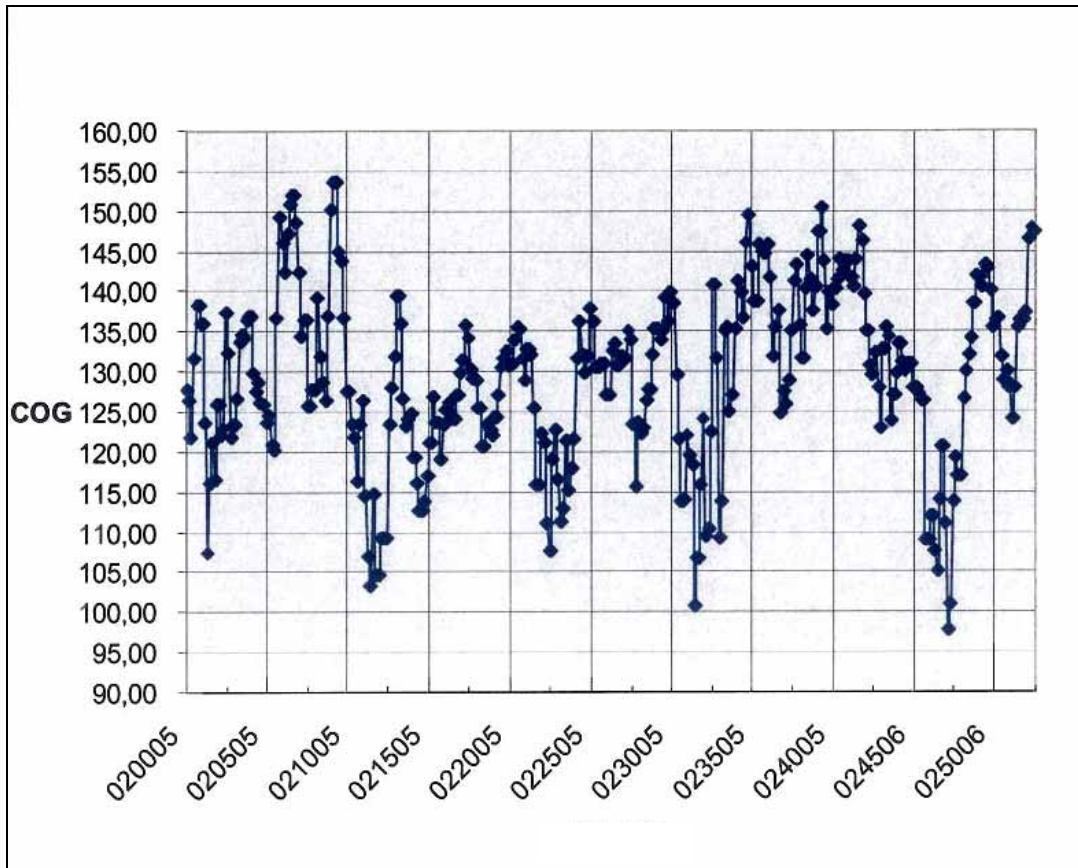
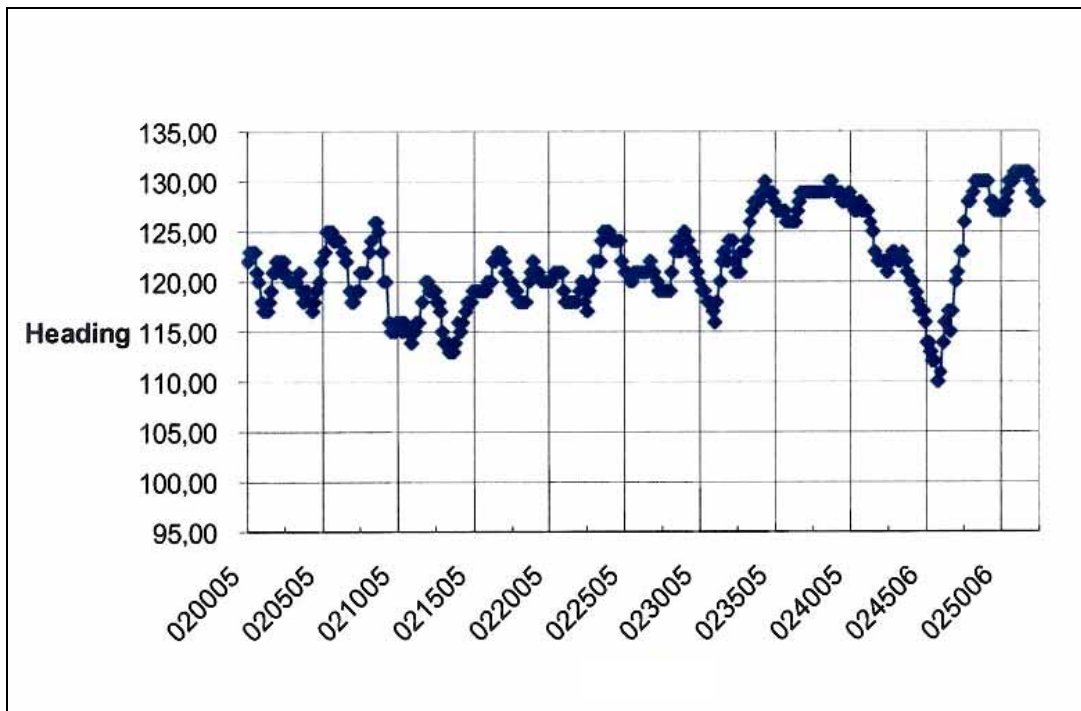
The repeated attempts by the ship’s command during the ensuing hours to reduce the severe effects on the CHICAGO EXPRESS of the wind and swell by adjusting the course and/or the speed are also shown very clearly by the AIS data. The final 45 minutes before the accident saw fluctuations in the course over ground of between 100° and 155° and in the heading of between about 100° and 130° (see **Fig. 11** and **12**).

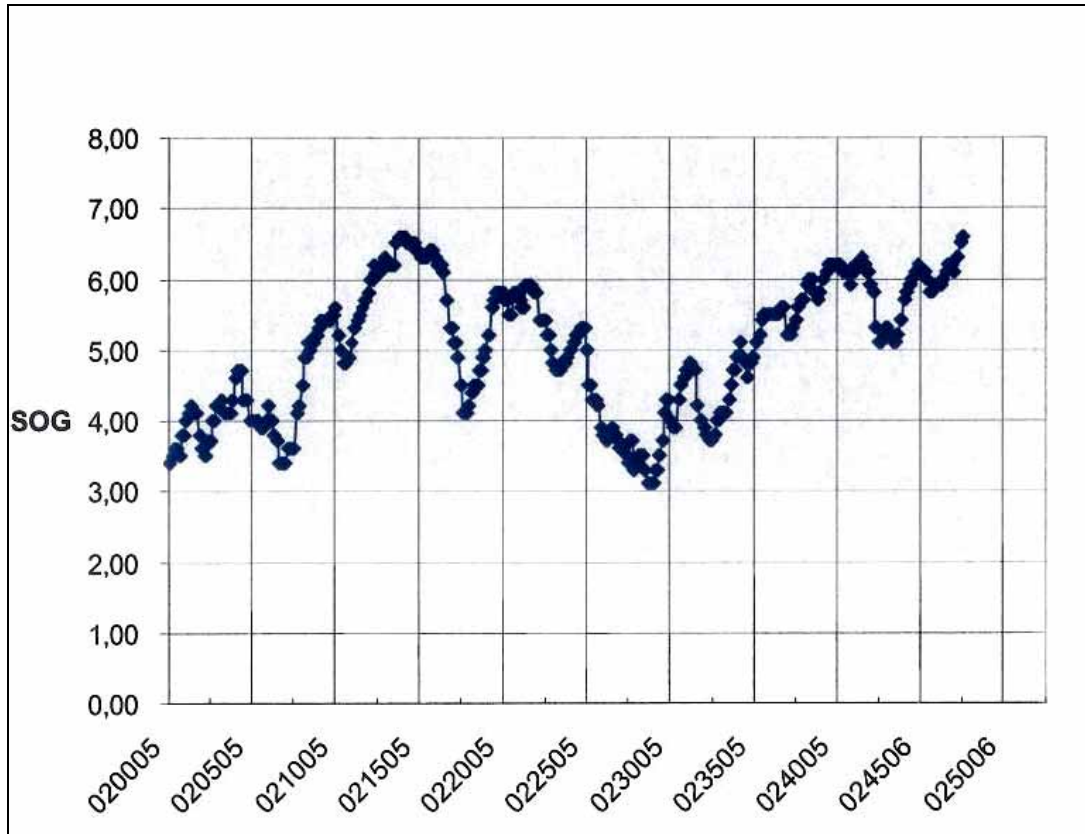
Figure 13: Speed over ground between 0200 h and 0250 h

The speed over ground in the final hour before the accident was also changing constantly (see **Fig. 13**); however, these changes were moderate and in a range of between about 3 and 6.5 kts. These fluctuations are likely to have been caused only by the external factors and not changes in the speed ratings.

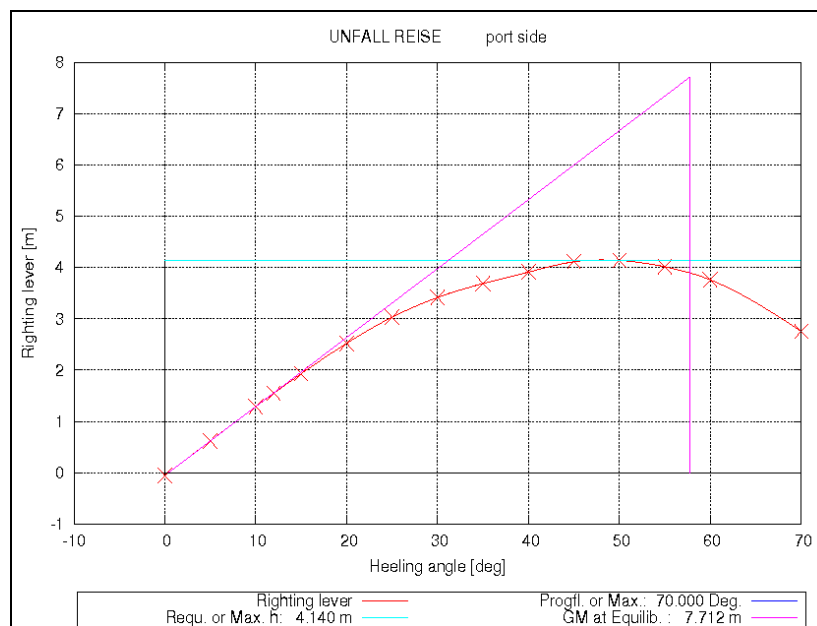
Figure 27: Righting lever curves for still water

The righting lever of the vessel calculated by the expert is shown in the usual manner for still water in **Figure 27** below. According to that, the stability in itself is more than sufficient, and saturation of non-weather-tight sealable openings is not evident.

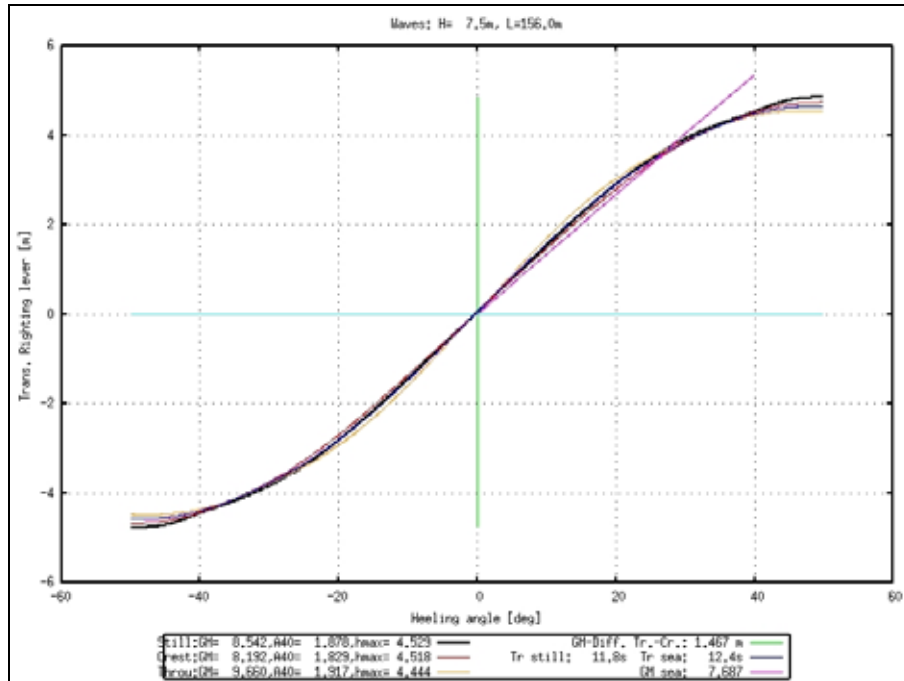
Figure 28: Righting lever curves in swell

To examine the overall risk of parametrically excited rolling oscillations, by way of example the righting lever was also calculated using an equivalent-wave concept for the conditions "main frame at the wave trough" and "main frame at the wave crest". A sine wave of 156 m in length (about 10 s) and 7.5 m in height was chosen for the equivalent-wave. This corresponds more or less to the accident situation. The associated righting lever is shown in **Figure 28**. It can be seen in this figure that the curves practically coincide, which means that the differences between crest and trough are very small, especially in comparison with the stability in calm water itself. At first glance, this result appears to be unusual because it means it is unlikely that the parametric rolling is the primary cause of the accident; for parametric excitation

presupposes sufficiently large fluctuations of the righting lever at sea. However, in this case this is clearly not evident, even though the type of vessel involved in the accident is known for this kind of roll excitation.

In the opinion of the expert, the cause of the low righting arm fluctuations – and thus the only minor parametric excitation – emerges from the fact that the draught of the vessel was much shallower than in the design. The draught aft was only about 9 m; however, the centre of the transom did not contact water until about 14 m. The fluctuations of the waterline section in swell decline because of this partial immersion aft, thereby reducing the fluctuations of the righting lever induced by the swell. These considerations suggest from the outset that parametrically excited changes in stability do not constitute the main cause of the accident, rather, the excitation moments induced by the swell in general.

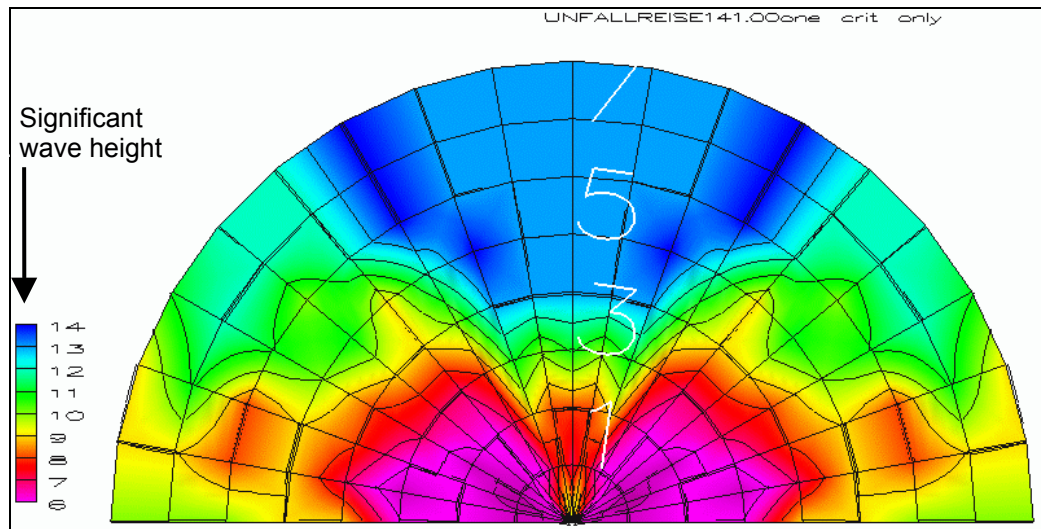
Figure 30: Calculated significant wave heights at a roll angle of 35 degrees³²

Figure 30 shows the results of the calculations in the form of a polar coordinate diagram. This shows the respective significant wave height highlighted by colour for a natural swell for a period of 9.5 s, which at the different speeds and courses would lead to a roll angle of at least 35 degrees. The significant period of 9.5 s corresponds to a situation equal to that also calculated in the weather expertise from the DWD. The calculations permit some interesting conclusions about the accident. It clearly follows that for a situation which corresponds roughly to the prevailing conditions at the time of the accident an extremely large roll angle must have occurred. This is the case if the vessel is slower than a certain minimum speed while there is a sufficiently quartering head sea. In that respect, the calculations are clear. This also shows that in other situations, in which the vessel's speed is much higher, such a large roll angle cannot have occurred because the significant wave height required for this would be much higher. At the same time, the calculations also show that such large roll angles cannot be reached at lower speeds precisely at those times when it is possible to keep the vessel sailing sufficiently accurately against the sea.

On the basis of these considerations, the cause of the accident can already be seen quite clearly with a probability bordering on certainty. The crew did everything in its power to steer the vessel against the sea. In the process, the vessel was rolling constantly. If the speed was slightly increased and/or if the vessel was sailed more accurately against the sea, the rolling motion decreased slightly. Eventually, the crew must have encountered a situation whereby the speed was reduced to below a critical limit while **simultaneously** the sea approached strongly from one side. If one or several waves were then slightly higher, a corresponding rolling motion was immediately induced. According to the expert, this enables the accident to be explained very plausibly. To support these results, other situations were calculated.

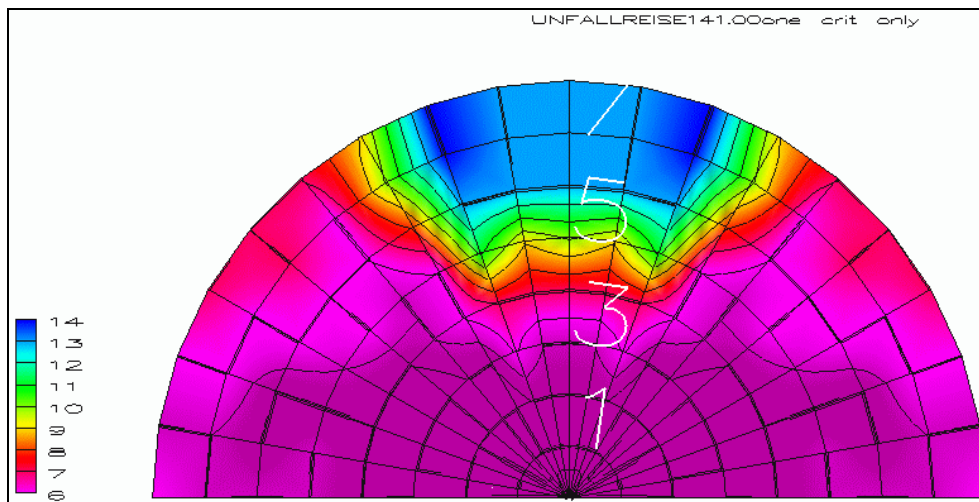
Figure 31: Calculated significant wave heights at a roll angle of 25 degrees

Figure 31 shows a diagram similar to **Figure 30**, but now for a roll angle of 25 degrees. It can be seen immediately that a roll angle of about 25 degrees occurs in virtually every situation below roughly 5 kts. At more than roughly 5 kts, the expected roll angle then decreases slightly if the vessel is steered relatively accurately against the sea. That corresponds very well with the statements of the crew that the vessel ran at speeds of 3-5 kts on various courses and was constantly subjected to rolling of at least 20 degrees, sometimes more violently, sometimes less violently.

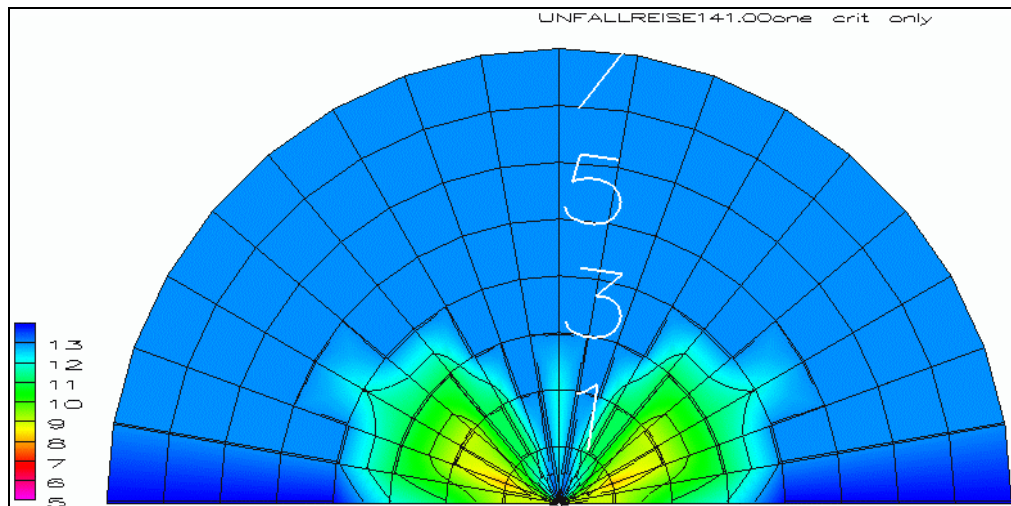
Figure 32: Calculated significant wave heights at a roll angle of 45 degrees

Figure 32 now shows the same situation for a roll angle of 45 degrees. We see very clearly that this roll angle can only occur in the specified situation, i.e., the speed is less than 3 kts and the course is at about a 60 degree angle to the waves.³³ Assuming that the significant wave height was actually less than or equal to the 8 m specified, then a large roll angle of 44 degrees would certainly have been reached in a situation where the speed was less than about 1 kt and the angle to the sea was about 60 degrees. If one assumes that such a roll angle was actually reached, it would have been possible in exactly this situation. If the roll angle is less than 44 degrees, which based on the above investigations is very likely, then the critical speed for reaching this roll angle would be higher.

The graphically presented calculations show that the aforementioned cause of the accident is correct with a probability bordering on certainty.

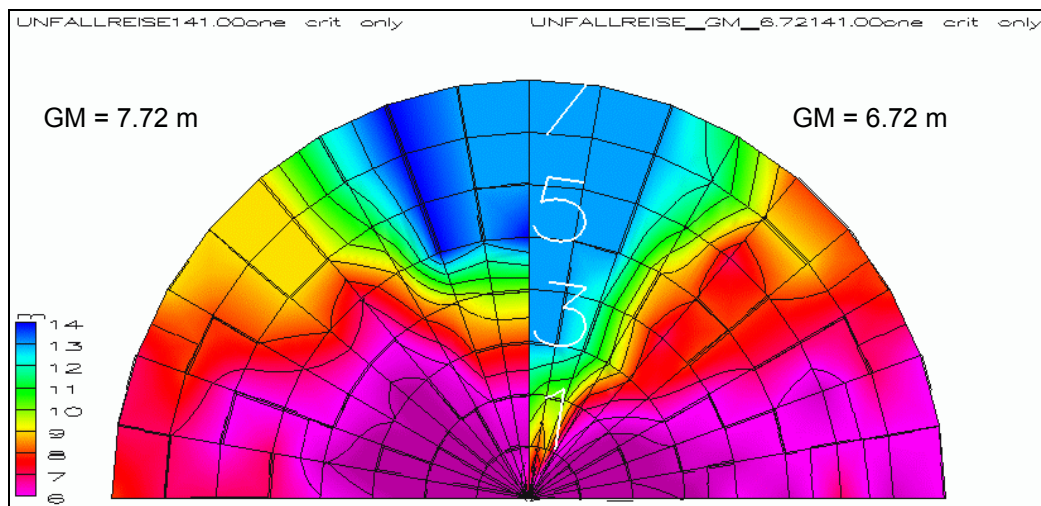
Figure 33: Calculated significant wave heights at a roll angle of 30 degrees

Figure 33 shows the significant wave heights that lead to a maximum roll angle of at least 30 degrees. The left side shows the stability situation of the accident condition and on the right side a GM value reduced by 1 m was applied for the calculation (6.72 m instead of previously 7.72 m). Under the circumstances that led to leaving the port, this GM reduction would have been practically impossible. However, we see that this would not have improved the situation. The risk shifts to a situation in which the sea would have to come from slightly more abeam. This is logical, because it results in the excitation moments increasing. Nevertheless, with parameters similar to those of the accident situation, the vessel would have also been exposed to an extremely large roll angle with these stability factors. Decreased stability thus improves the situation somewhat, but not fundamentally.

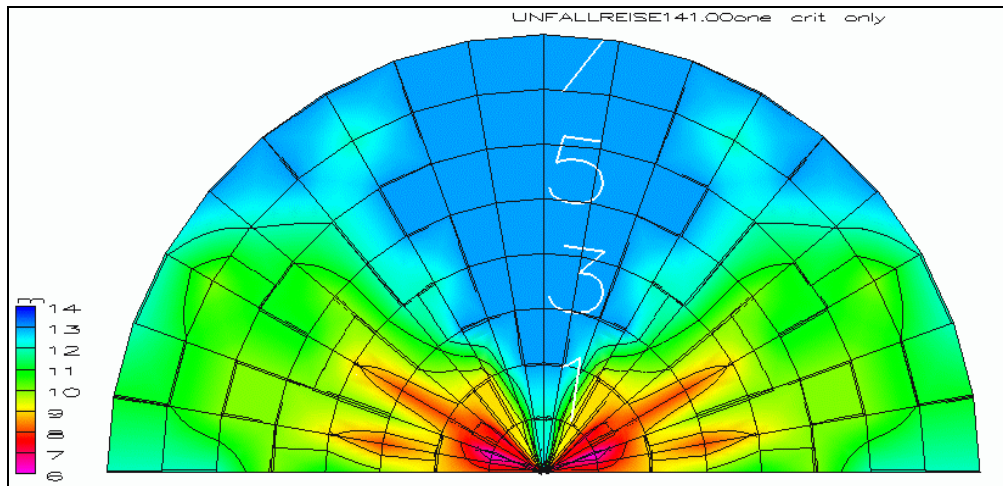
Figure 34: Calculated significant wave heights; roll angle = 30 degrees, GM = 4.2 m

To demonstrate the impact of stability changes, another calculation was carried out with a stability change about three times as great (see **Fig. 34**). The GM was reduced to 4.20 m, i.e. by about 3.50 m. We now see that the wave height necessary for reaching a maximum roll angle of 30 degrees increases considerably in similar situations. Accordingly, even in this situation a roll angle of 30 degrees would have occurred if the vessel was sailing at about 1 or 2 kts at an angle of about 60 degrees to the head sea. The fundamental threat therefore remains latent, which is also logical because it is not a matter of parametric excitation, but a forced oscillation with low damping.

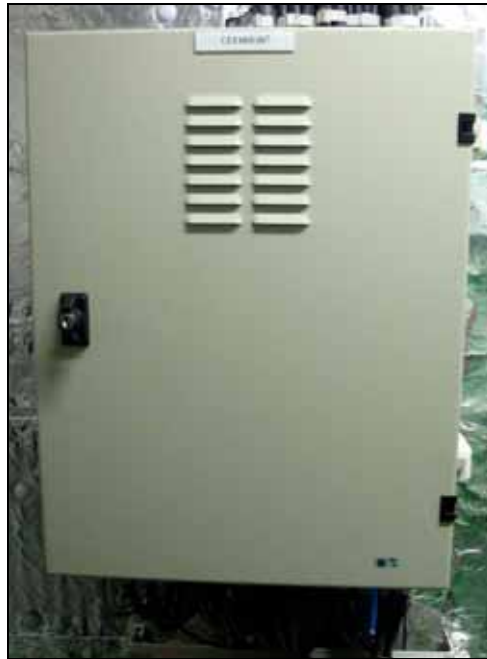
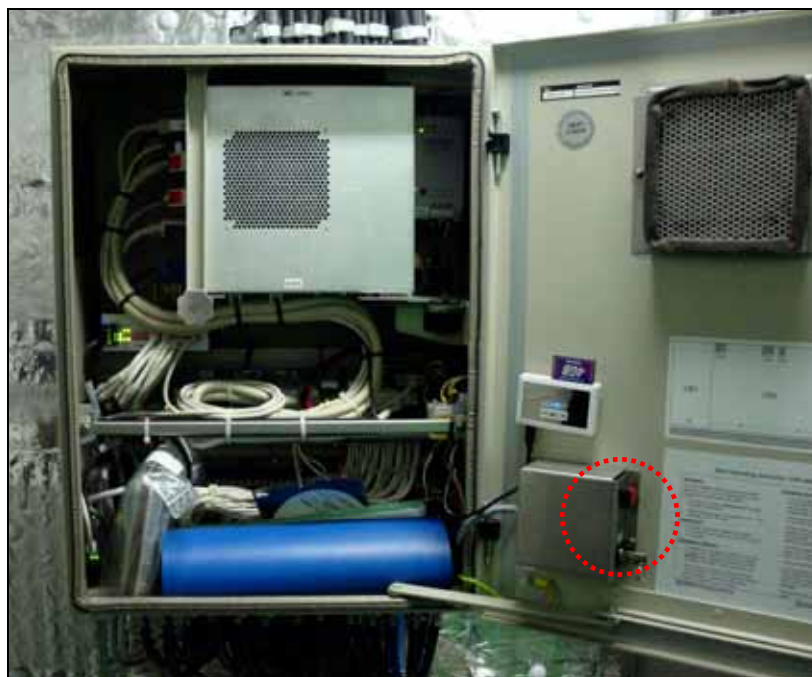
Finally, although rather improbable, the possible failure of both radar screens after an accident opposes integrating the questionable operator interface in them. However, with the type used here, there is also the possibility of operating the incident backup directly on the VDR's so-called "Main Unit" (Fig. 40 and 41), but this is locked and is in turn located in an area below the bridge deck, which is also locked. Only the Master has access to the key.
