Investigation Report 391/09

**Very Serious Marine Casualty**

**Fatal accident on board  
the CMV CCNI GUAYAS  
during Typhoon 'KOPPU'  
on 15 September 2009 in the  
sea area off Hong Kong**

**(Including analysis of  
Serious Marine Casualty 520/09  
Pilot injured on board  
the CMV FRISIA LISSABON  
on 16 October 2009 west of  
Borkum on the Westerems)**

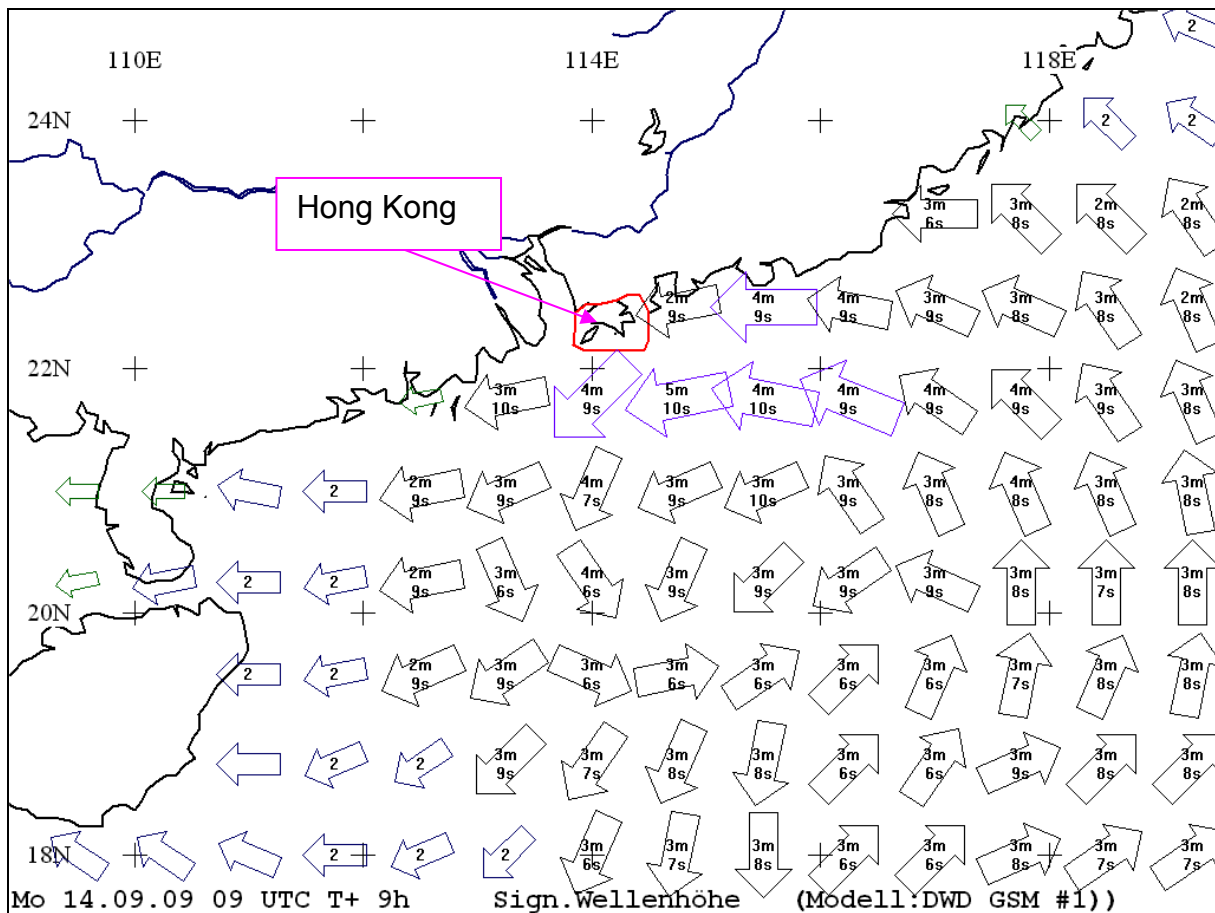
Figure 5: Wave heights and periods

The wave heights and wave periods for the sea area around Hong Kong at 0100 local time on 14 September 2009 are shown on the above chart.

In the early morning of 15 September 2009, the heaviest wind forces came from the east at 10 to 11 Bft with gusts of 12 Bft and the highest significant wave height was 6.70 m, with individual waves exceeding a height of 10 m.

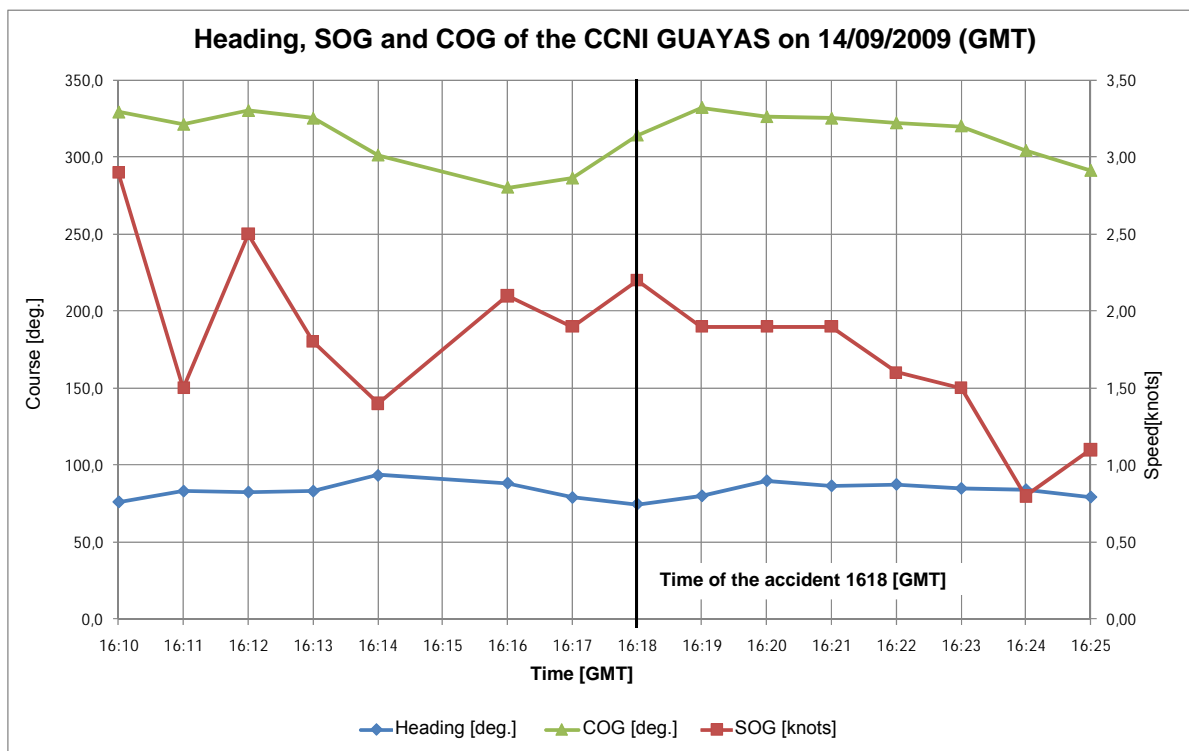
Figure 7: Analysis of the VDR data

From the exported VDR data it is apparent that the vessel was proceeding at a very low speed of about 2 kts over ground at the time of the accident. The times are stored in the VDR in GMT/UTC. The time of the accident 1618 (GMT) is equal to 0018 local time (Fig. 6).

The heading and the course over ground (COG) differ substantially from each other, in the order of 90°-100°. This means that the vessel must have had considerable problems in actually keeping her course. On the following chart, Figure 8, the heading is marked as a solid line and the course over ground (COG) as a dashed line. These variations can be explained by the load condition. The vessel had no cargo on board and sailed with ballast; due to the low draught, her immersed surface area was minimal in relation to her windage area. Added to that, due to the immersion of the vessel the semi-balanced rudder offered little effective rudder area, respectively, left the water at times, due to which a propeller flow was virtually absent. It was necessary for the vessel to steer a particular course for practical reasons; however, this was not steerable and could not be maintained.

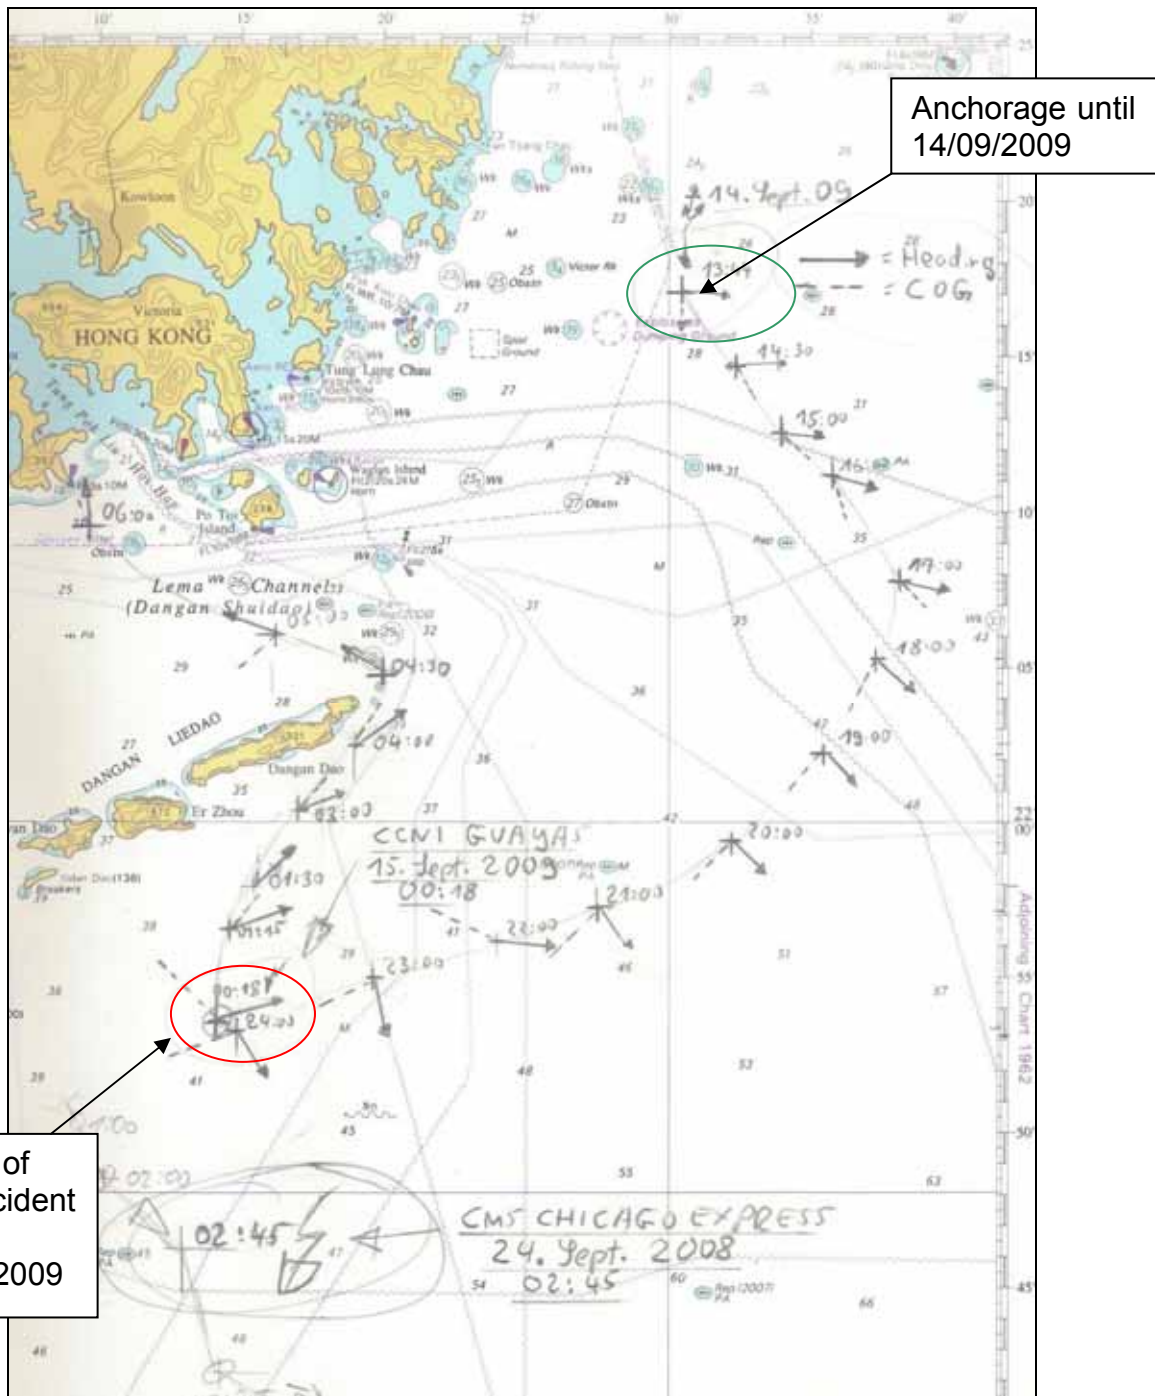
Figure 8: Positions and courses of the CCNI GUAYAS

No irregularities are visible in the recorded data at 0018, the time of the accident. Since no roll angles are recorded in the VDR, the data provide no direct information about the course of the accident. The fact is that the vessel sailed at an extremely low speed, had problems keeping her course and according to statements given rolled very heavily.

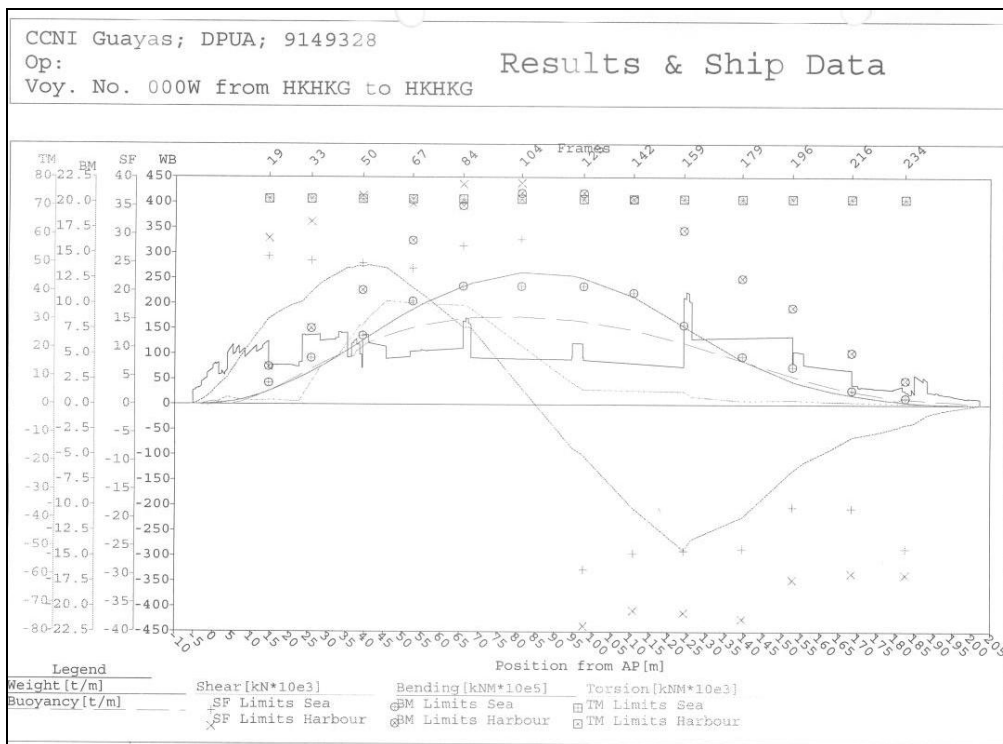
Figure 13: Longitudinal strength and bending moments

The accuracy of the shape of the vessel and load condition were recorded sufficiently via the simulation and, as with the load computer, the calculations of the TUHH have revealed that the longitudinal bending moments at frames 104 and 125 are significantly exceeded. Accordingly, in formal terms the vessel should not have set sail. The permissible loads were adhered to for the port condition, but not for the so-called 'sea-going condition'. To maintain the longitudinal strength, the vessel should have taken on additional ballast water; however, this would have meant that her stability would have been even higher. During the calculation, special emphasis was placed on the interaction between longitudinal strength and stability, especially when the vessel was moving with ballast. At the same time, an examination was to be made on whether practicable technical possibilities exist at all for ballasting a modern container vessel without cargo so that a seaworthy condition is established from the perspective of stability.

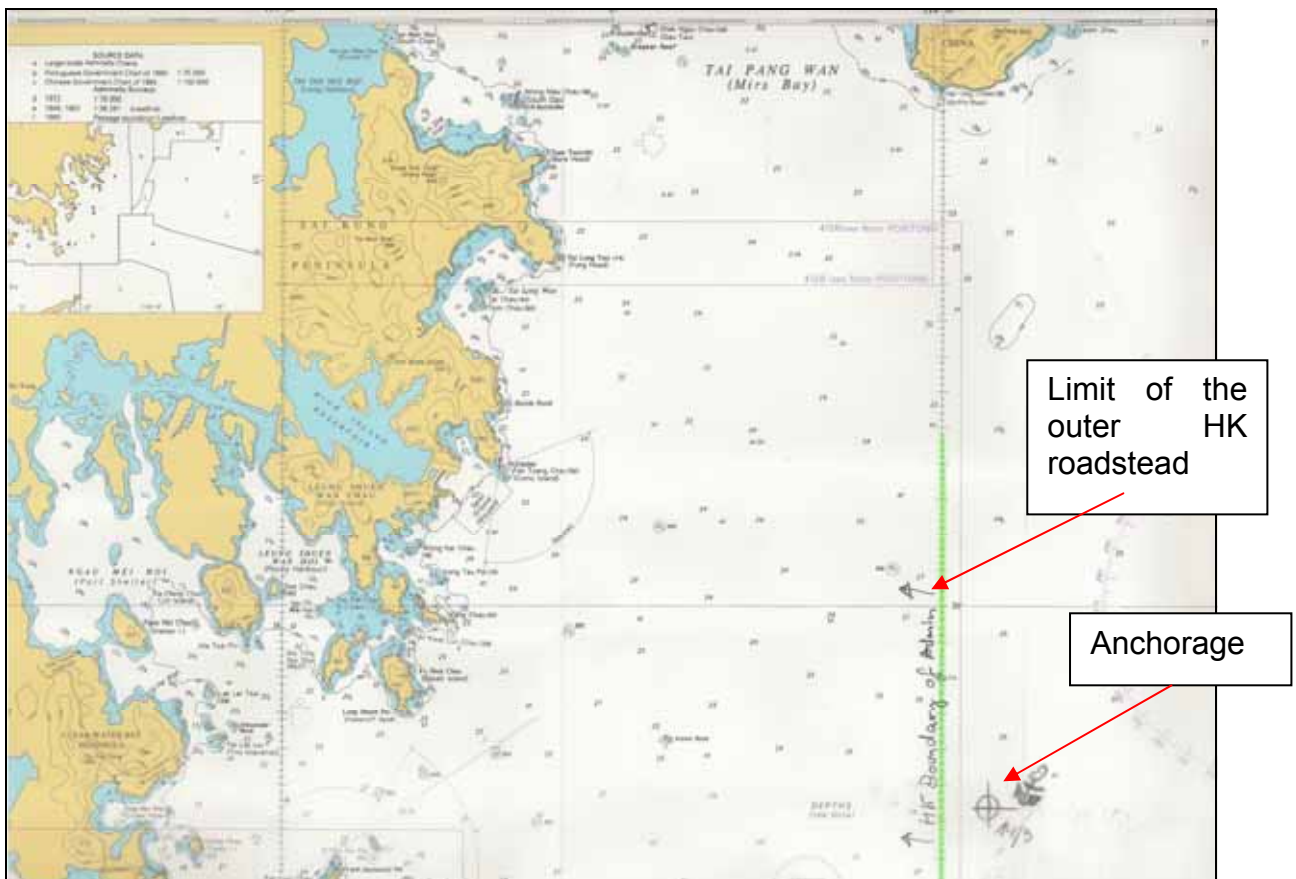
Figure 33: The outer roadstead of Hong Kong

The anchorage of the CCNI GUAYAS until 14 September 2009, at the position 22° 17.2'N and 114° 30.4'E, was about 8 nm away from the nearest land at a depth of about 30 m. According to the charts and sailing directions, this position is about 7 cables outside the outer roadstead of Hong Kong, which run to the meridian 114° 30' E. The investigating authority in Hong Kong, the Marine Accident Investigation Section of the Hong Kong Marine Department, confirmed that the CCNI GUAYAS had anchored outside the Hong Kong roadstead during the period 31 July to 14 September 2009, and as such also outside the jurisdiction. Therefore, the rules of MARDEP do not apply and as coastal State the Hong Kong authorities are not responsible for the manning of vessels anchored on the open sea, as it were.

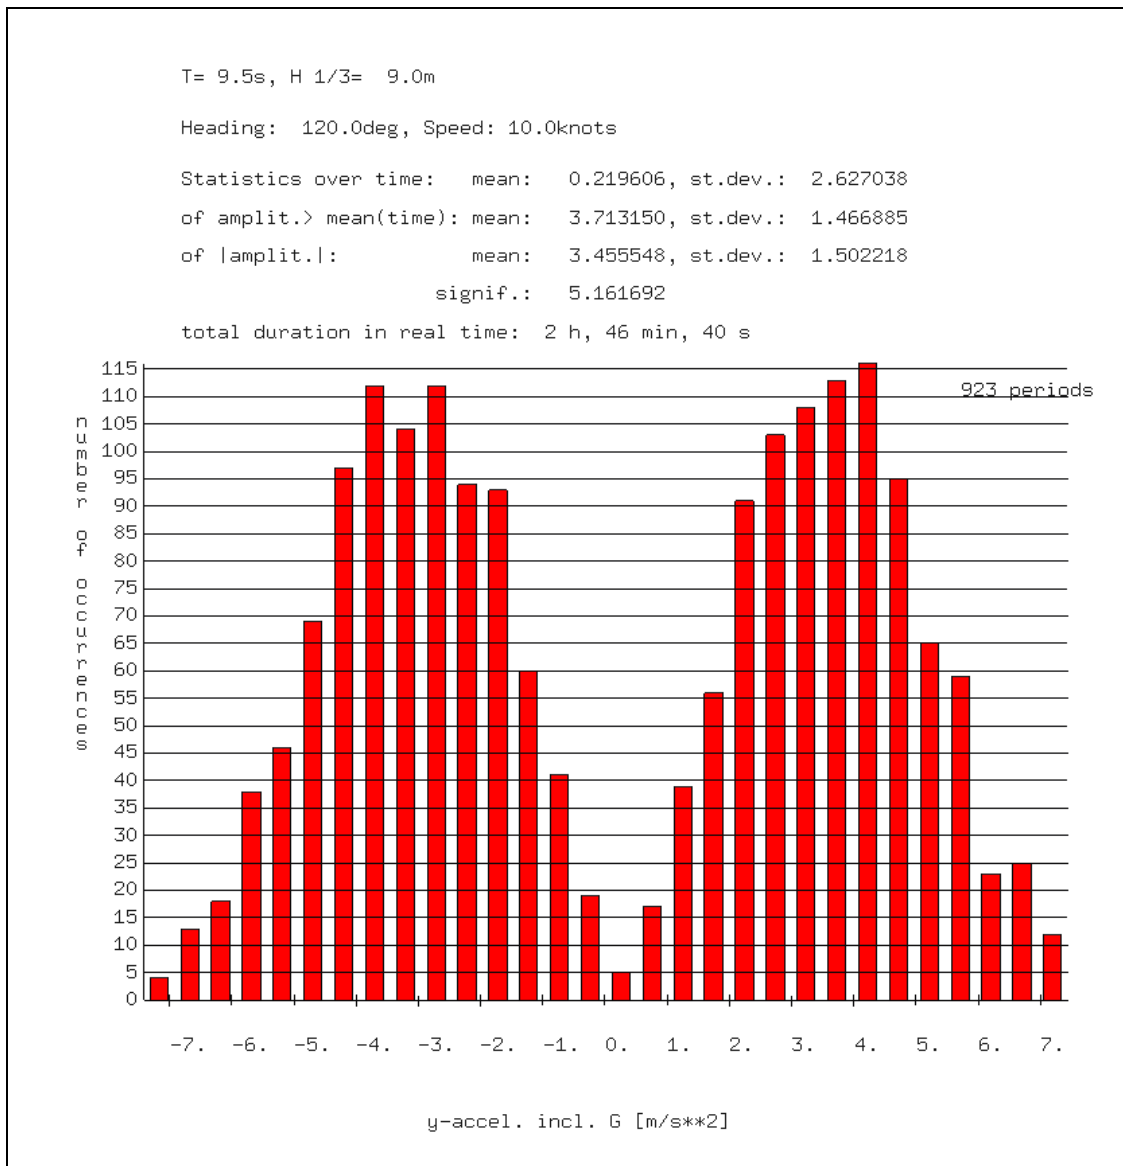
Figure 43: Frequency distribution of transverse accelerations on the bridge at a speed of 10 kts

The transverse accelerations acting on the bridge were calculated for the accident situation. The maximum value stands at 1g, which is quite similar to the cases off Hong Kong since in the case of the FRISIA LISSABON the waves were much higher.
