ATSB TRANSPORT SAFETY REPORT
Aviation Occurrence Investigation
AI-2009-008
Final

Reliability of Piper PA-31-350 aircraft engine turbocharger units

AI-2009-008, Reliability of Piper PA-31-350 aircraft engine turbocharger units

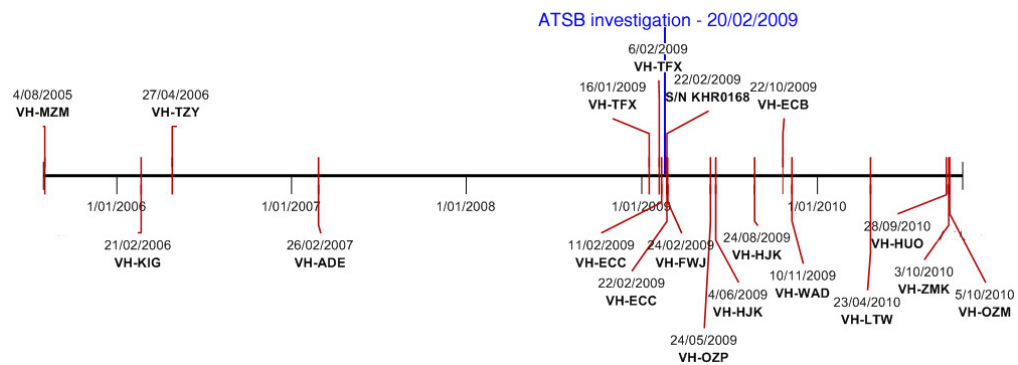
Figure 1: Timeline of turbocharger events recorded for Piper PA31-350 aircraft

The occurrences above the line involved separation of the turbine wheel from the shaft. Those below the timeline were occurrences where failure occurred for other reasons and separation of the turbine wheel had not occurred. The ATSB did not examine the turbochargers from the majority of the failures and relied upon the engineering reports submitted by the involved parties. The failed turbochargers from VH-MZM and VH-TZY had previously been investigated by the ATSB (report 200601367).

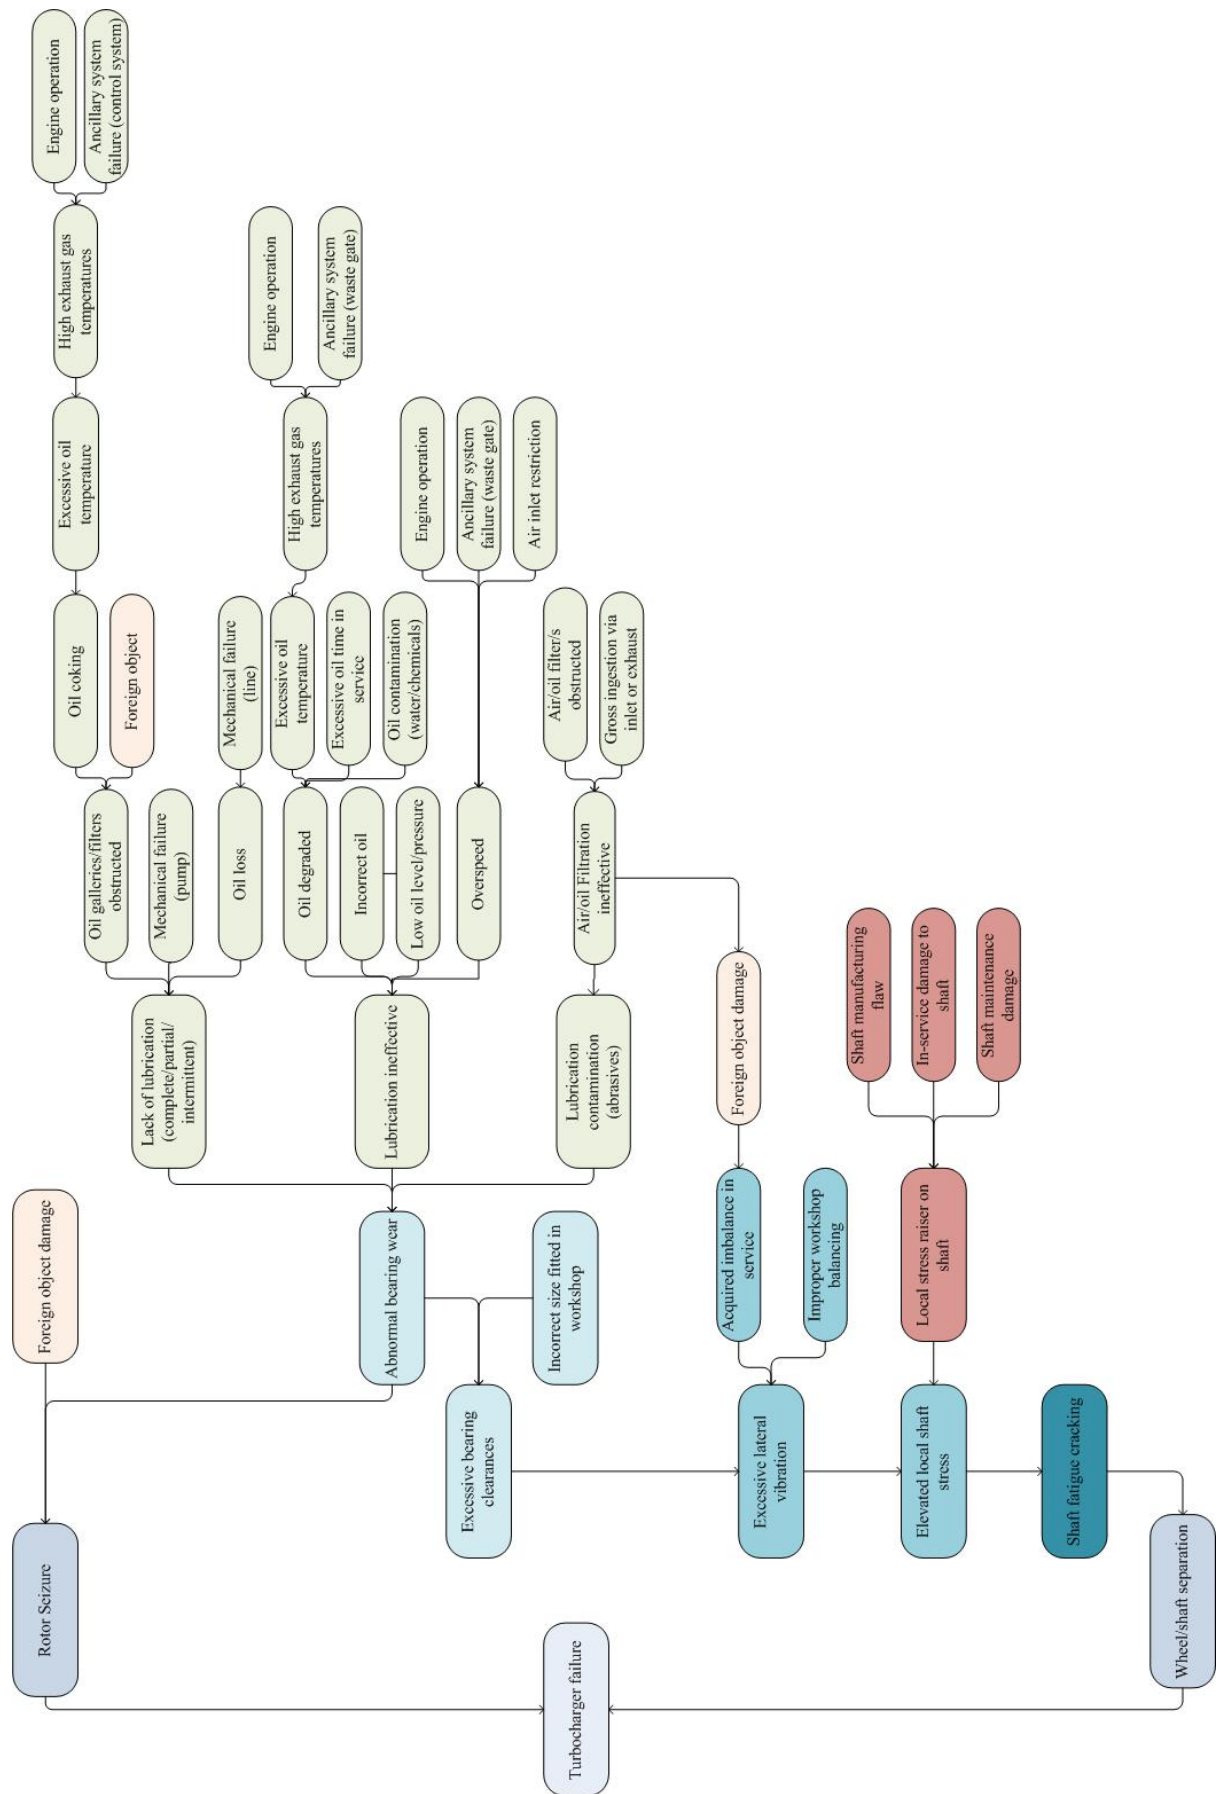
Figure 4: Potential contributing factors to turbocharger failure.

In addition to the above observations, it was also determined that the nature of the turbocharger system was such that there appeared to be two common failure modes; seizure of the turbocharger following wheel contact with the housings, or wheel/shaft failures. Not only could these failures result from a variety of contributing factors, but the same contributing factor could lead to a different outcome, as shown in Figure 4. The example shown on the following page is not an exhaustive list, but is presented to demonstrate the number of influences which may produce a similar failure.

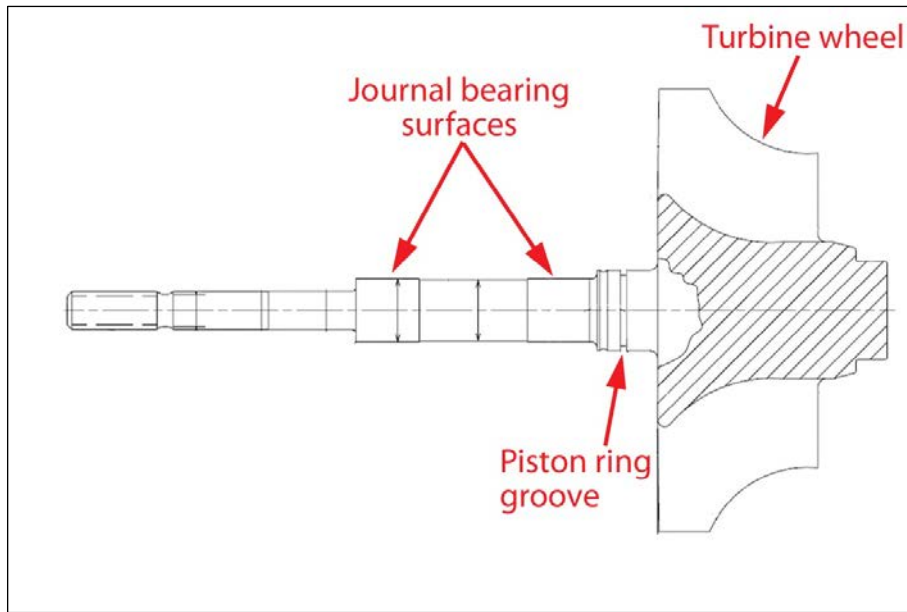
Figure 6: Schematic representation of the turbine wheel and integral shaft

The TH08A turbine wheel (part number 406787-10) consisted of shaft and wheel components, friction welded⁶ at a location approximately 12.5 millimetres from the rear face of the turbine wheel (Figures 2 & 3). The friction welding process included a machining stage to remove the external weld flash, and a post-weld heat treatment to relieve the induced residual stresses.

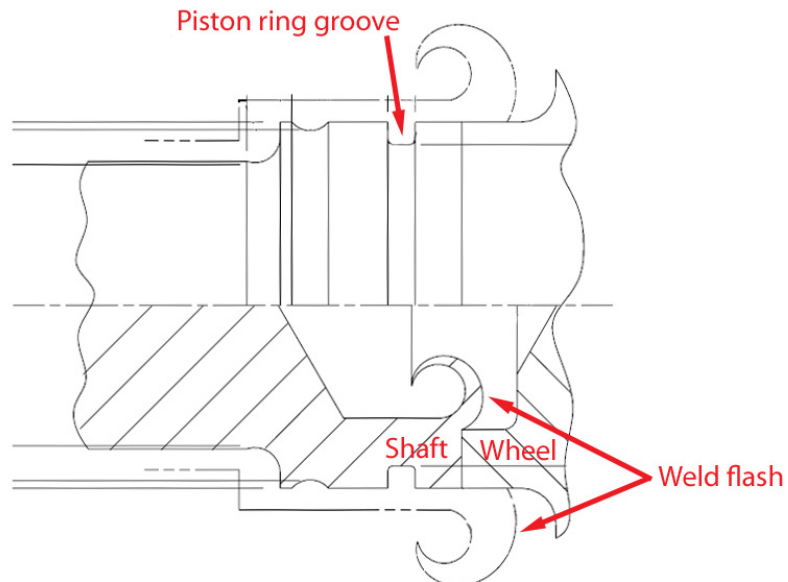
Figure 7: Magnified view of turbine wheel showing location of weld

The turbine wheel had fractured from the shaft at a similar location on all three samples examined. The fracture was approximately 5 mm below the underside of the wheel (Figures 4 to 7).

In all cases, the fracture had occurred transverse to the principle axis of the shaft, at a location coincident with the bottom of the piston ring groove (Figures 2 and 3).

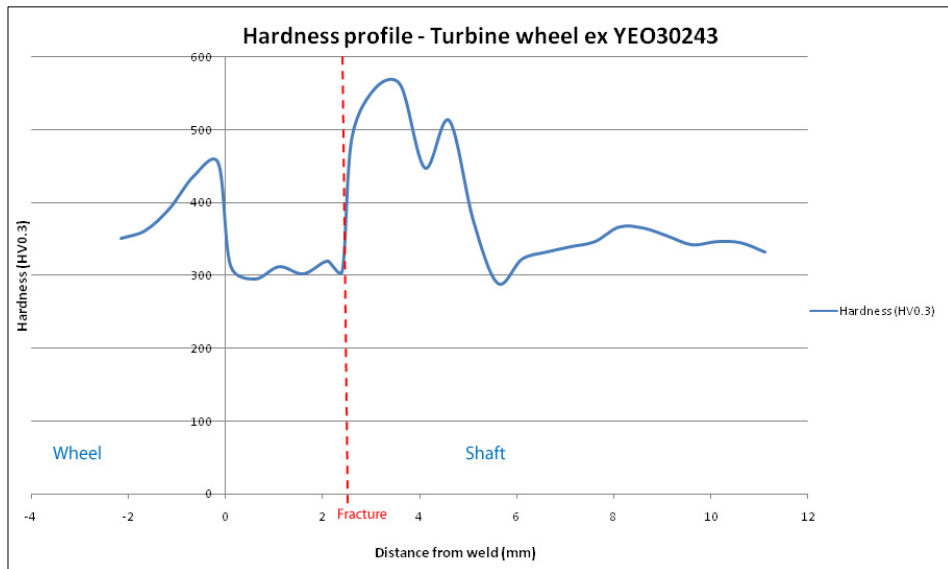
Figure 19: Hardness profile across weld and fracture.

A hardness traverse was conducted across both halves of the shaft fracture face, through the weld, into the turbine wheel. The testing was performed in accordance with *AS1817.1 Vickers hardness test*, using a 300 g load. The results are given in Figure 15; the location of the fracture is shown by the red dotted line, and the zero position on the x-axis indicates the weld line.
