Foundering of the general cargo ship *Tycoon* at Christmas Island 8 January 2012

Abstract

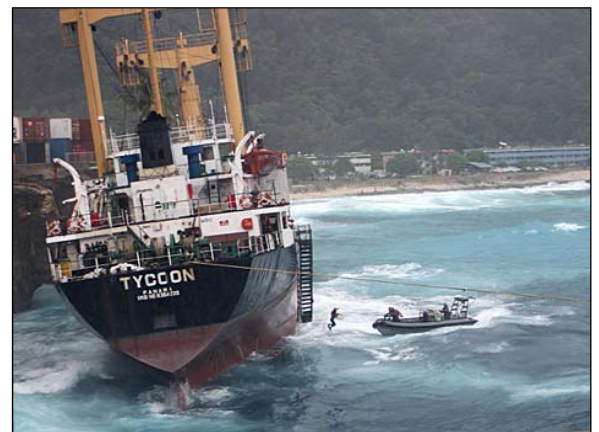
Figure 6: Crew member jumping from the ship

Tycoon's crew lowered the starboard accommodation ladder and then gathered together in lifejackets on the deck adjacent to it. At 1031, the first crew member climbed down the ladder and jumped into the sea (Figure 6). He was quickly pulled on board the RHIB which had come in close to the ship's side.
