Final Report of the Investigation into
the anomaly of the HyShot Rocket at
Woomera,
South Australia on 30 October 2001.

Neville McMartin
Senior Transport Safety Investigator
Australian Transport Safety Bureau
18 June 2002

TECHNICAL ANALYSIS REPORT No: 08/02

*Examination of launch vehicle debris
from the HyShot ‘Scramjet’ Flight
Program*

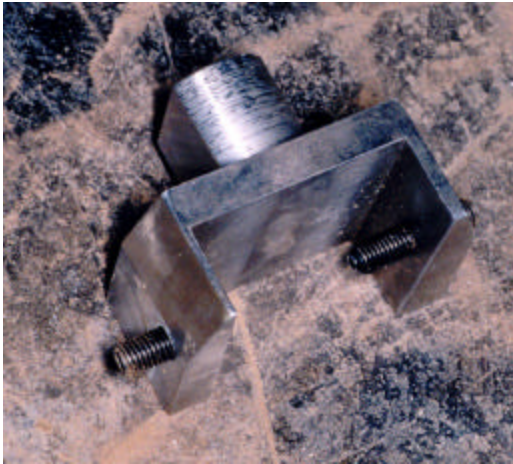
Because of differences between the design of the Nike fins and the Terrier fin support structure, each of the fins was fitted with an adaptor on the spindle post to suit the journal socket diameter. Additionally, four fin locating studs fitted with cup-point set-screws were used to secure and set the fin incidence angle (figure 5). These studs affixed to the aft section of the fin base rib by clamping down on the U-section from both sides (figure 6). The original Nike design provided a reinforced region on the forward rib section for that purpose, however the area on the fin, was not used because of design incompatibilities between the Nike and Terrier components.

Fig. 5. Fin securing lug, as manufactured for the Terrier vehicle to suit the Nike fins.

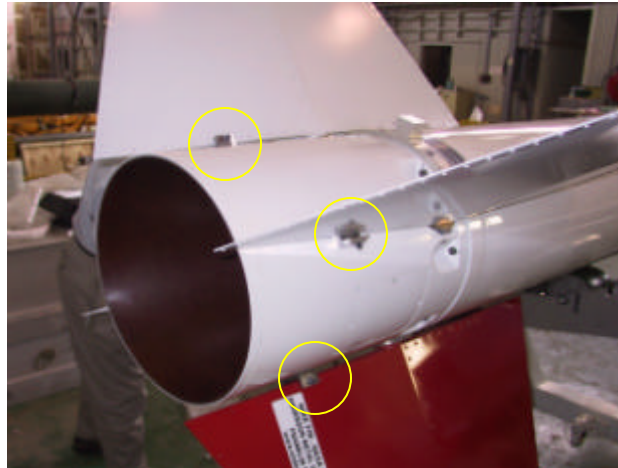
Fig. 6. Fin securing lugs (circled) installed with Nike fins on a Terrier vehicle. Note the trailing edge of the fins extending past the exhaust nozzle.

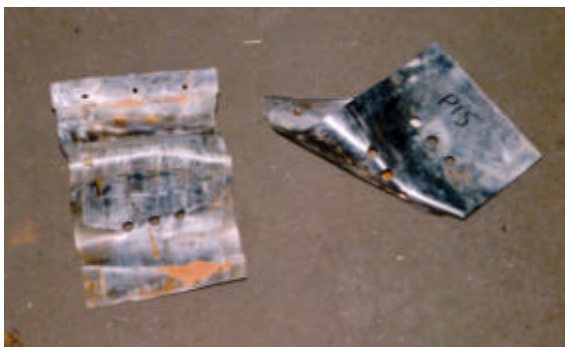
Fig. 10 (left). Scramjet exhaust port covers (muffs) recovered with the payload debris.

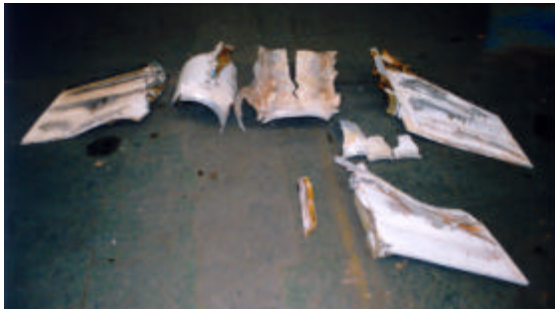
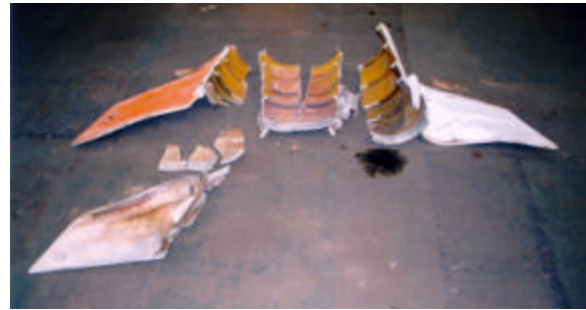
The Orion tail can unit was a cylindrical casting, affixed to the base of the motor casing and carrying the four vehicle fins. As recovered, the can had fractured longitudinally in four locations, producing three large sections and several smaller pieces (figures 11 – 14). The nature of the longitudinal fractures was consistent with the tail can impacting the ground in a sideways fashion and breaking open under bending loads from the attached fins. Of the four original vehicle fins, only three were found at the impact site. The remaining fin was not recovered despite a thorough search of the area. Of the recovered fins, two had fractured along the base of the mounting flange and the third remained attached to the tail can wall. A basic re-construction of the tail can and fin assembly was used to visualise the damage distribution.

Figures 11 & 12. Sides of the Orion tail can and recovered fins.

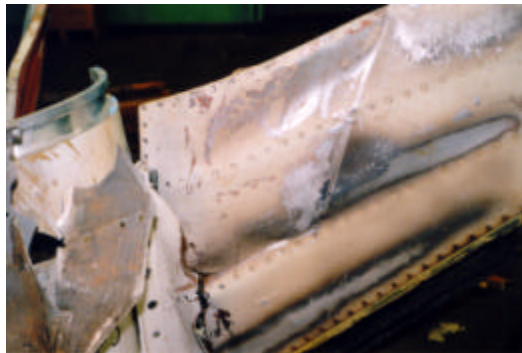
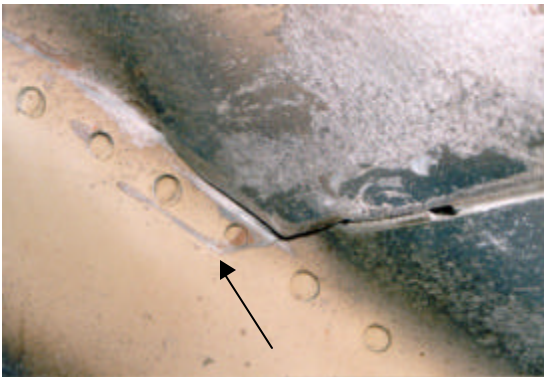
One of the Orion fin surfaces appeared to show witness marks to the impact with another component. The affected fin (facing the location of the missing fin) bore an angular impact mark that could be clearly attributed to forceful contact with the outer leading edge corner of the missing fin (figures 28 & 29). Contact marks at the corner showed an impression of the leading edge strip, which suggested the loss of the protective shroud (figure 30). Also evident were several impressions from rivet heads along the fin tip. The fin surfaces in the impact area showed a uniform band of aerodynamic heating, with the characteristic discoloured, flaking paint. Close examination showed that this heating had occurred before the impact, as much of the flaking paint had been removed and the exposed edges remained bright and unaffected. Had the impact occurred before the heating, thermal damage to the exposed metal edges and a less uniform heating pattern would have been expected.

Fig. 28 (top left). Re-assembled tail can and fins, showing the orientation between the missing fin and the impact mark on an adjacent fin (arrowed).

Fig. 29 (top right). Closer view of the impact mark on the fin surface – note the clearly defined edges.

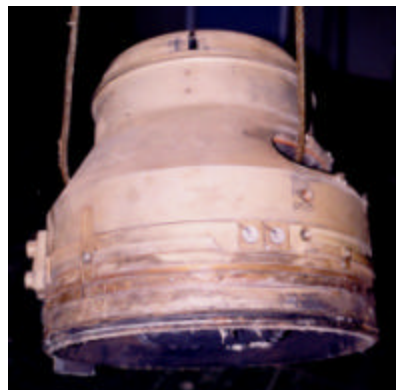
Fig. 35. Orion coupling area – note the missing key and the bands of axial scuffing. The angular band (arrowed) is indicative of misaligned vehicle separation.

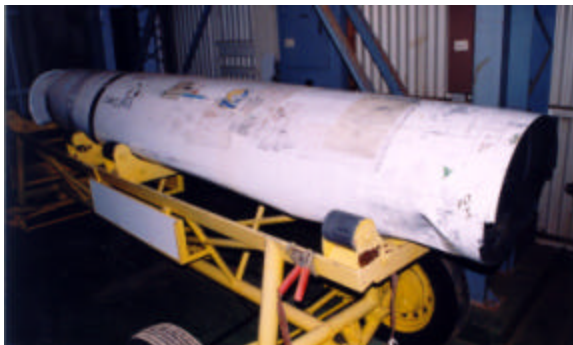
The Terrier booster motor body (figure 37) comprised a rolled, cylindrical vessel, to which the adaptor assembly was coupled at the top and the discharge nozzle and fin support structure affixed to the base. The separation of the adaptor from the motor body occurred from the angular ground impact, with all associated fractures of the motor body shell being consistent with that event. A small emission of combustion products was evident from a bleed hole in the upper motor casing (figures 38 & 39).

Fig. 37 (top left). Terrier booster body casing.

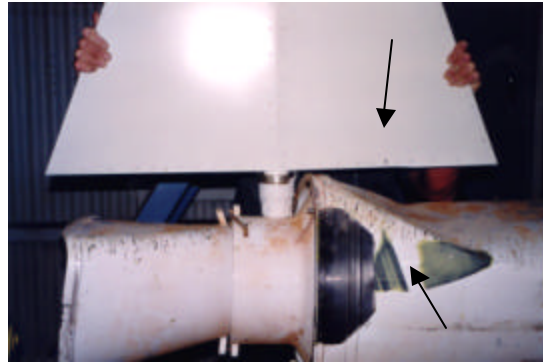
The base of the Terrier motor body displayed two angled abrasion marks that were witness to a glancing impact with one of the Nike fins (figure 40). The orientation and edge definition of the marks indicated an angled, downward movement of the fin when it struck the motor body. The undamaged area between the two marks also matched with the recessed area beneath the forward end of the fin rib (at the Nike fin incidence setting point, figure 41).

Fig. 41. New Nike fin held in place over the Terrier casing to illustrate the relation between the recess in the fin base rib and the abrasion mark.

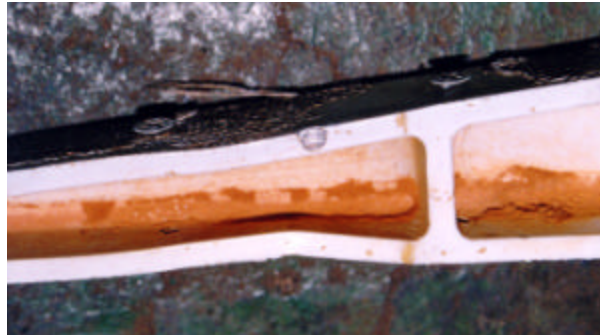
The angle of incidence of each fin was secured by a small block with set screws that clamped the fin at the appropriate angle. Specialist examination indicated that crushing damage of the rib sections beneath the set-screws was possibly pre-flight damage, which may have led to in-flight movement. It was also noted that the Nike fins were not designed for securing in the location used and contained no reinforcement or other strengthening features in this area. The Nike fins were designed to be secured on the leading side of the fin base, whereas the Terrier fins were designed to be secured on the trailing side of the fin base.

As mentioned in section 1.2, the adaptation of the Nike fins for use on the Terrier booster vehicle required the use of a securing / incidence setting lug on the trailing side of the fin base – opposite to the area designed into the Nike fins for this purpose. Evidence exists on several of the trailing rib sections of the cup-point set-screws seating irregularly against the surface of the fin (figure 53). Appreciable indentation and in one case, partial crushing of the fin rib had occurred (figure 54). While it was not possible to determine at what stage of the flight the damage occurred, the indications did highlight potential deficiencies with this method of securing the fins.

Fig. 54 (above). Crushing of the fin rib beneath the clamping point.

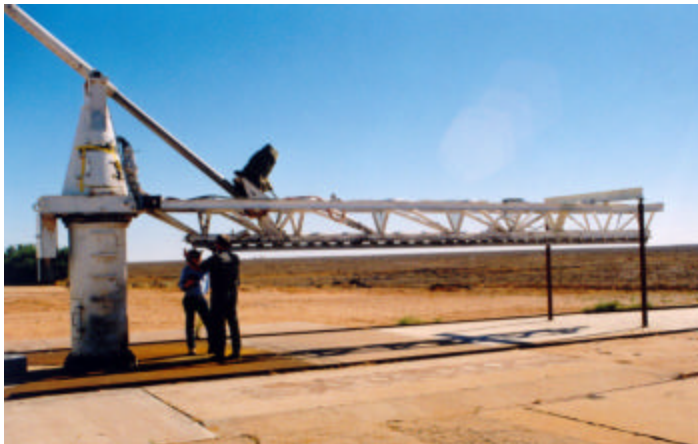
The HyShot vehicle was launched along a boom-mounted rail structure that was positioned at an appropriate azimuth and elevation before the launch (figure 55). The rail, boom and supporting pedestal were inspected on-site for any evidence of damage or failure that could have been contributory to the anomalous flight. The inspection noted that the base of the launcher pedestal was raised some twenty millimetres above the top of an underlying grout pad, with no evidence of re-grouting activities having taken place (figure 56). It was understood that hessian sandbags (figure 57) were used around the base of the pedestal in lieu of the grouting, to protect the control wiring passing down through the base of the pedestal.

Fig. 55 (left). General view of the launch rail structure.

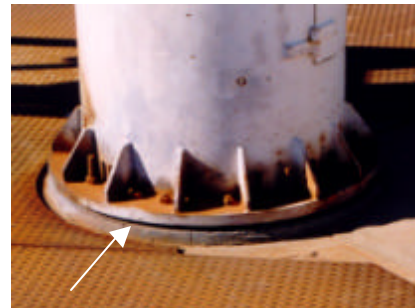
Fig. 56 (above). Base of the launch rail pedestal, showing the absence of grouting.
