Aviation Short Investigation Bulletin Fourth Quarter 2011

ATSB Transport Safety Report
Aviation Short Investigations
AB-2012-019
Final

AB-2012-019

AO-2011-056: VH-NXE, Engine failure

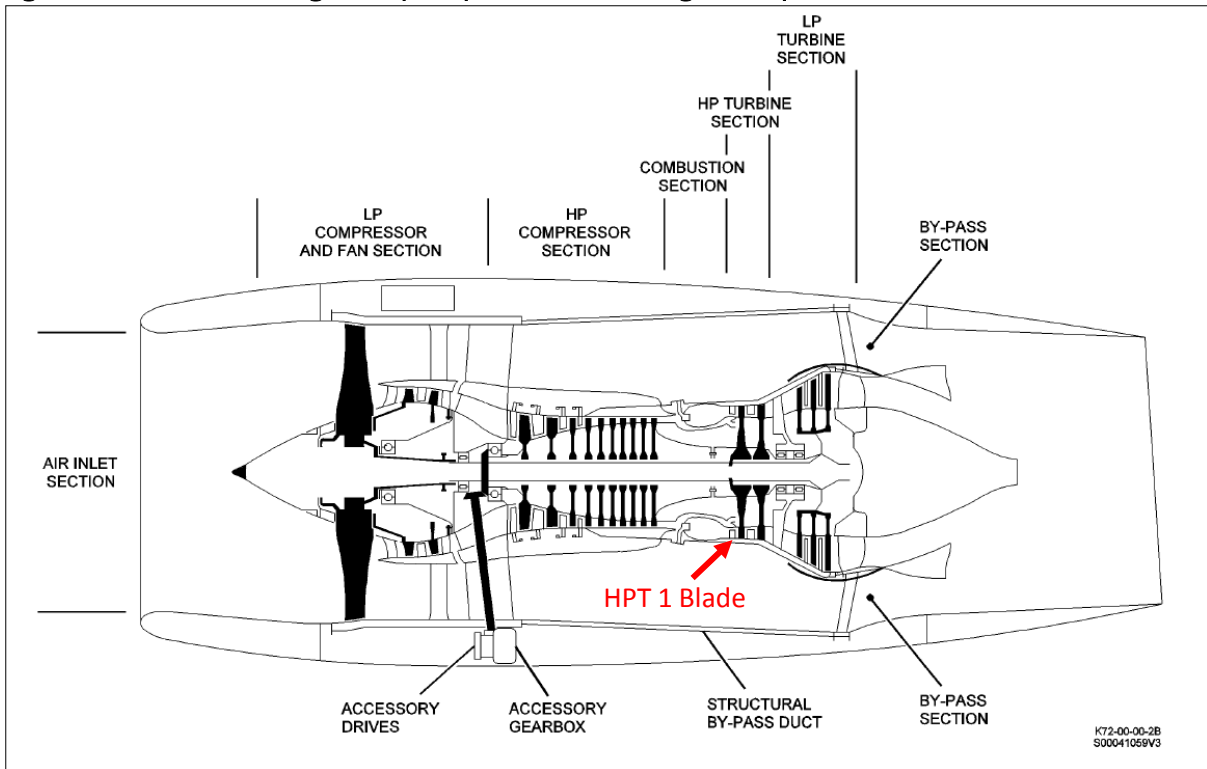
Figure 1: Schematic drawing of the principal BR 700-715 engine components

The aircraft was fitted with two Rolls-Royce BR 700-715 series engines. A subsequent examination of the left engine revealed metallic debris in the tailpipe and physical bulging of the high-pressure turbine (HPT) module. A detailed internal (borescope) inspection confirmed multiple failures of high-pressure turbine, stage-1 (HPT1) blades, with subsequent, downstream damage through to the third stage of the low-pressure turbine (LPT, Figure 1). Damage upstream of the HPT1 blades at the nozzle swirler inlet and nozzle guide vanes was also found. The engine was then shipped to the manufacturer for a teardown examination, which was witnessed by the BFU (German Federal Bureau of Aircraft Accident Investigation) on behalf of the Australian Transport Safety Bureau (ATSB).

During the teardown examination, the LPT section proved difficult to remove due to case deformation. In the HPT module, four of the second stage blades had failed at $\frac{1}{3}$ or $\frac{1}{2}$ their height. All of that stage's blade shrouds were missing. Examination of the first stage of the HPT module found all of the blades had fractured. Further observation identified that only one HPT1 blade had fractured below its root platform (Figure 2). Microscopic examination revealed that blade's failure had initiated at the inner shank wall on the pressure side⁴.

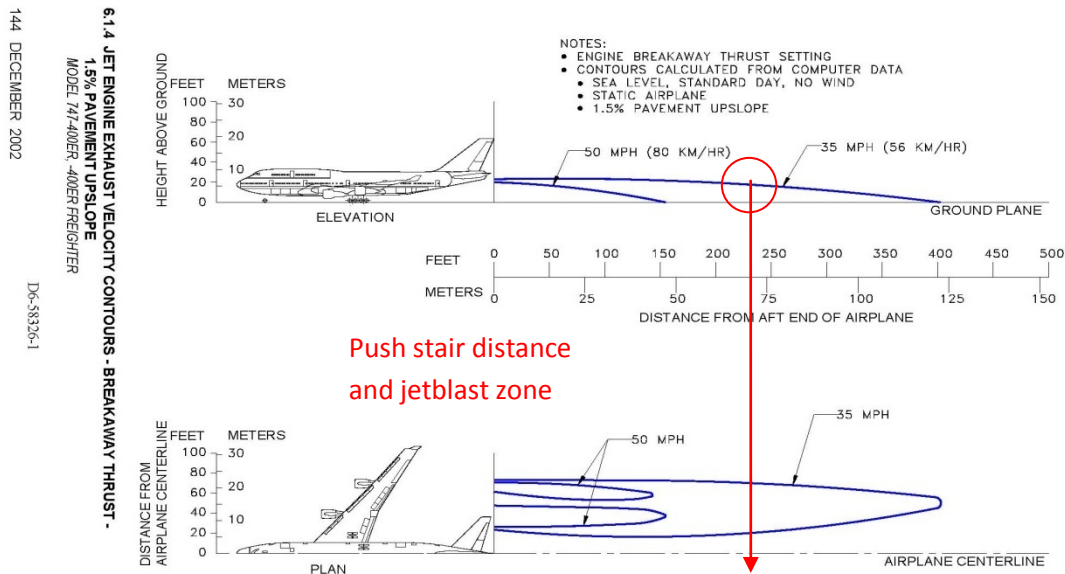
Figure 2: Jet Engine Exhaust Velocity Contours

The CASA, *Manual of Standards, Part 139 - Aerodromes, at 6.6.2 Jetblast and Propeller Wash Hazards*, recommended that the maximum jet engine exhaust velocity should not exceed 32 kts (60 km/h) where passengers are expected to walk or people are expected to congregate. Where personnel are working on an aircraft the recommended maximum exhaust velocity is 43 kts (80 km/h).

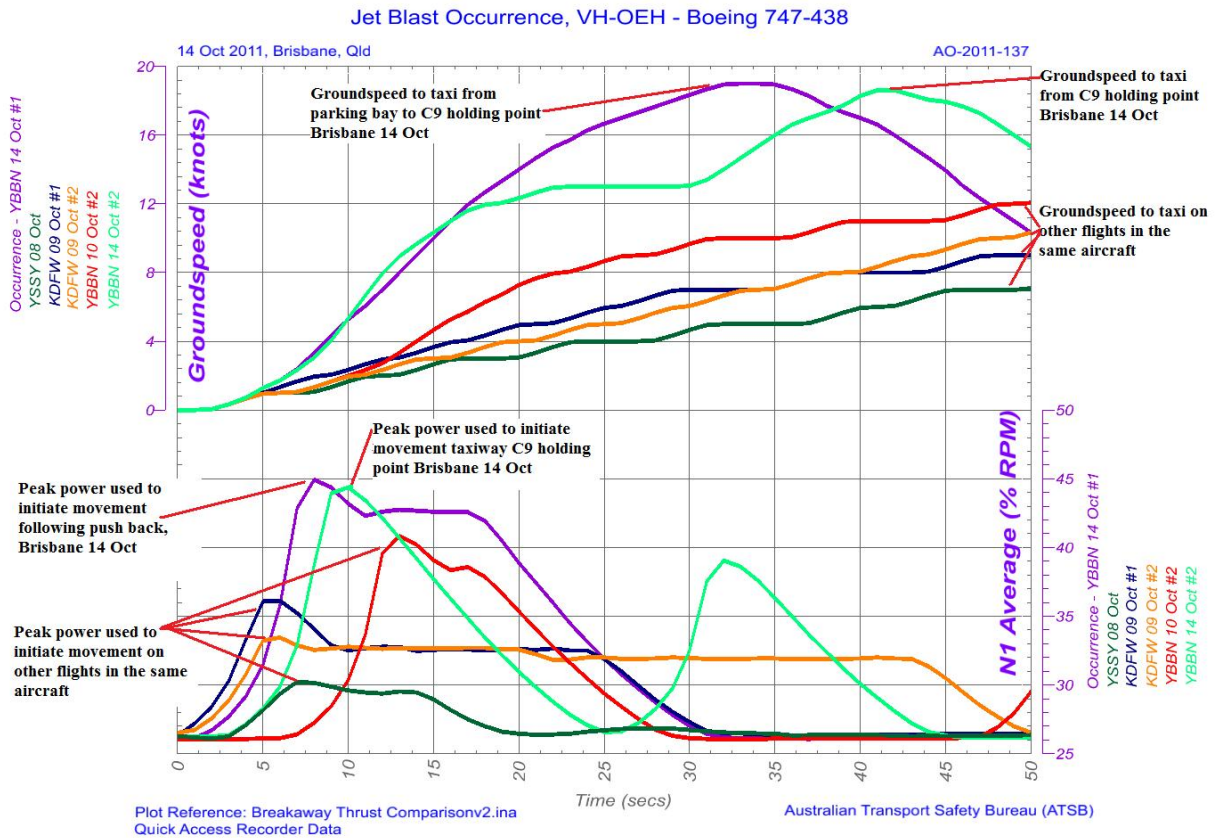
Figure 3 - Breakaway Thrust Comparison VH-OEH

Data from OEH's flight data recorder was reviewed by the ATSB, to determine the breakaway thrust used during the taxi. The average engine low pressure compressor speed (N1), and aircraft ground speed, were compared to data from four previous flights. Figure 3, shows a graphical representation of the values obtained with the purple and light green traces representing this occurrence:

On this occasion OEM was relatively lightly loaded, with a takeoff weight of 234,417 kg compared to a maximum takeoff weight of 412,769 kg. That takeoff weight was the lightest compared to the other flights depicted in figure 3.

There was a 26 cm increase in height from the taxiway C9 holding point to the centreline of taxiway Bravo intersection. Data on the slope of the surface on the other flights depicted in Figure 3 was not available.

On review there was no clear evidence that passengers, crew or ground handling staff were being adversely affected by the blast. Furthermore the operator's internal investigation into the occurrence determined that the maximum recorded N1 thrust used during the taxi and turn was only 27%. The flight crew operating manual stated that a

maximum N1 used for taxi in the A320 was 40%. The event, however, reaffirms the importance of appropriate power settings during ground manoeuvring.

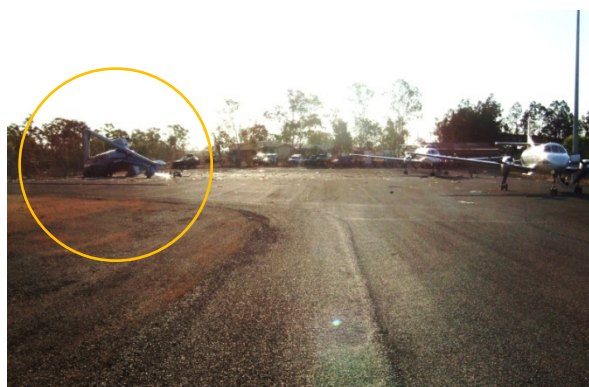
Figure 5: View of Port Keats Airport apron from taxiway after accident (Helicopter circled)

Almost immediately there was a 'tick tick' sound then loud crunching sounds. The main rotor blades had struck the light pole (Figure 3) and started to break apart with debris flung about. The helicopter was rapidly propelled towards the light pole, toppling over onto its left side while vibrating vigorously and shedding blade debris in all directions.

The light pole bent where the main rotor blades had struck it. The upper section fell onto the helicopter with electrical wiring exposed, but unpowered. The left side of the cockpit was pushed inwards from contact with the light pole. The helicopter's tail section was also damaged.
