Australian Government
Australian Transport Safety Bureau

Aviation Short Investigation Bulletin

Issue 12

ATSB Transport Safety Report
Aviation Short Investigations
AB-2012-105
Final

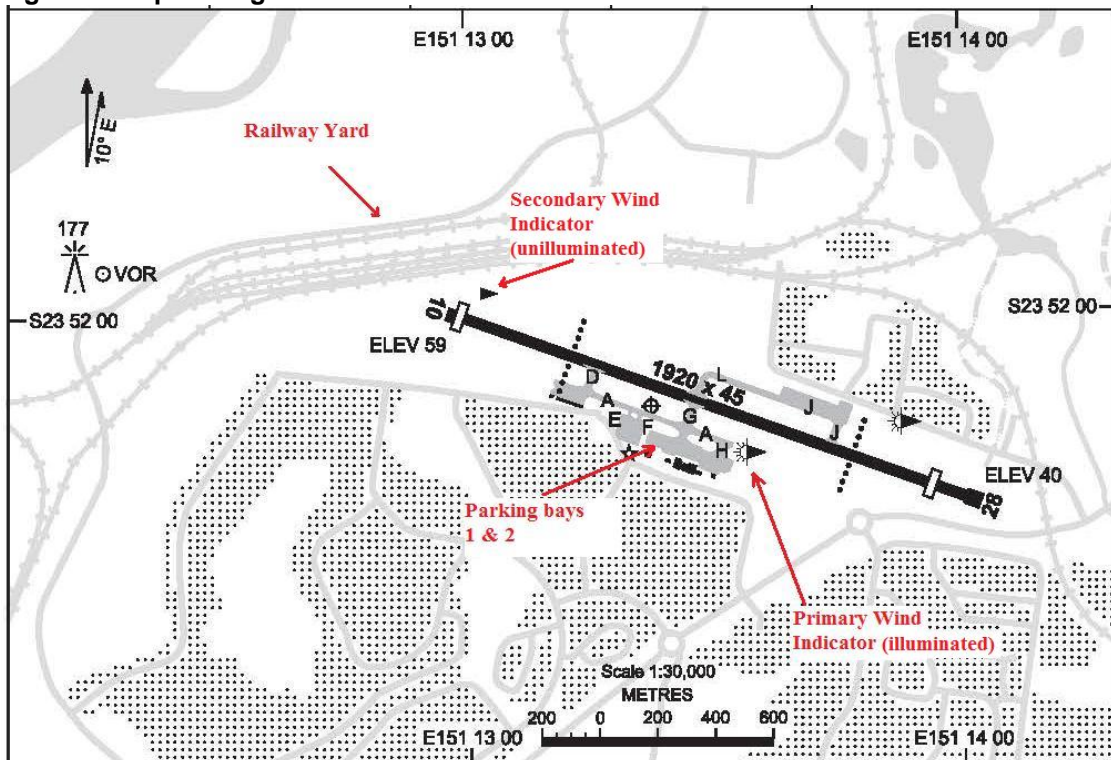
Figure 1: Airport diagram

The primary wind indicator (windsock) was located adjacent to the eastern most corner of the apron (Figure 1). It was behind all aircraft parked on bays 1 to 4. The windsock was situated in low ground relative to the apron. From parking bays 1 and 2, the windsock was partially obscured by a lighting control cabinet (Figure 2). The windsock lights were grouped at the top of the pole.

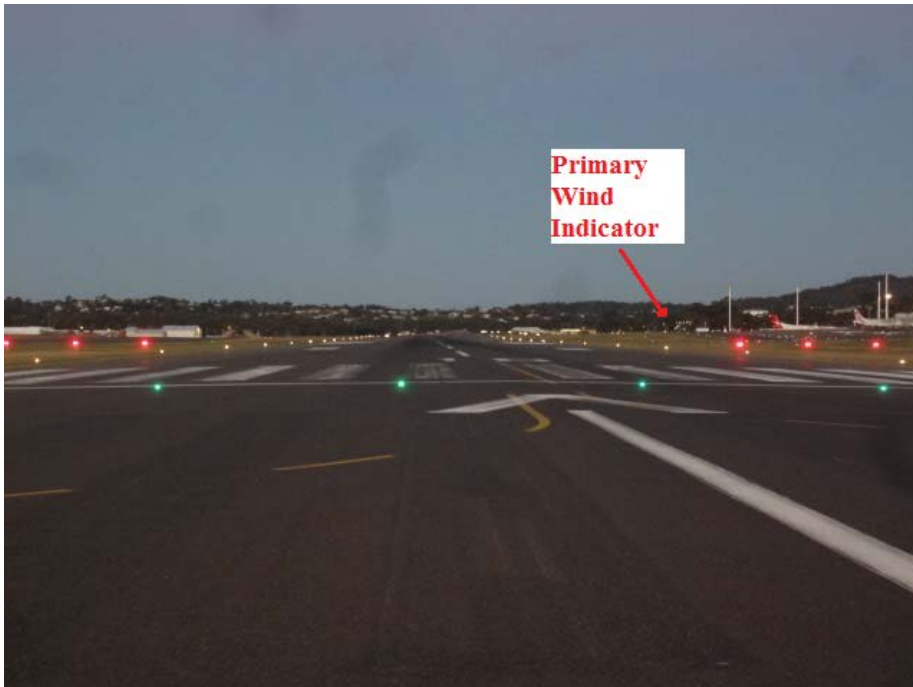
Figure 3: Gladstone runway 10 threshold – lights on

All crew also noted that on line up for runway 10, the illuminated primary windsock is over half way down the runway and behind the terminal flood lighting. There was higher ground containing bright lighting behind the windsock. The combination of these things obscured any flashing warning (Figure 3). All crew stated that they would be more likely to look to the closer unlit windsock

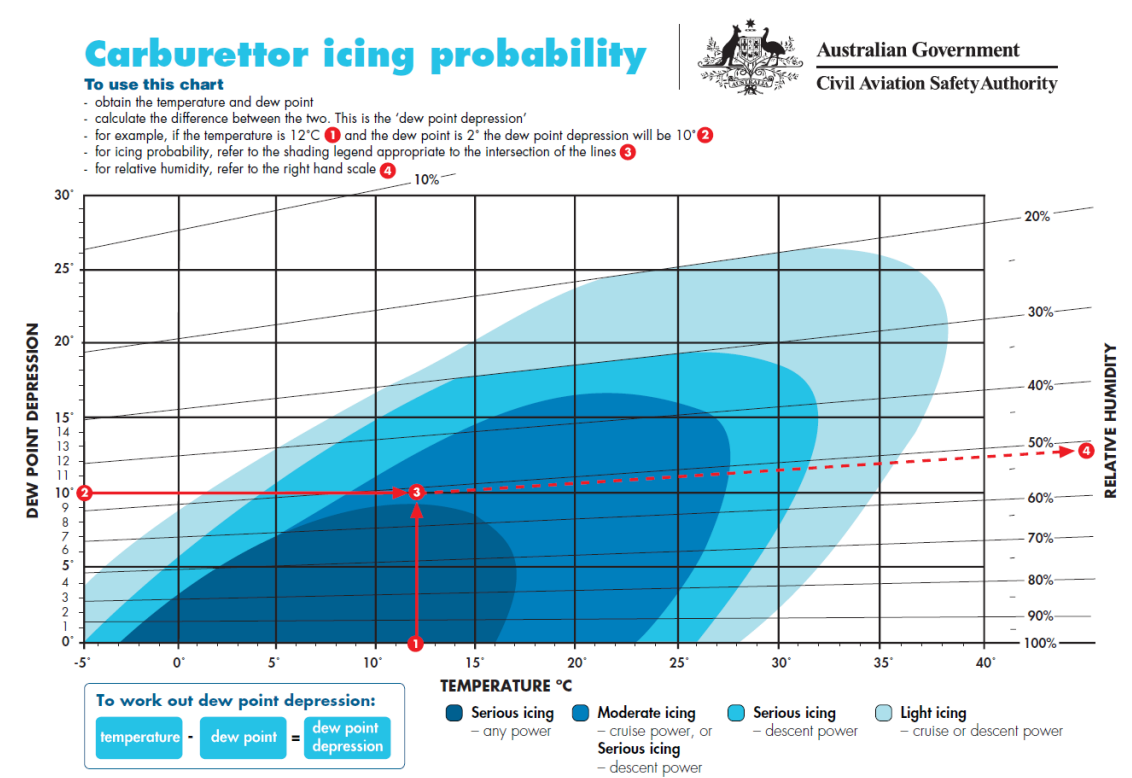
Figure 2: Carburettor icing probability chart

A definitive reason for the reported loss of engine power could not be determined. However, a review of the carburettor icing probability chart reveals that the temperature/dew point spread, put the accident flight in the ‘serious icing – descent power’ operating realm (Figure 2).
