Aviation Short Investigation Bulletin

Issue 13

ATSB Transport Safety Report
Aviation Short Investigations
AB-2012-141
Final

Publication date 27 November 2012

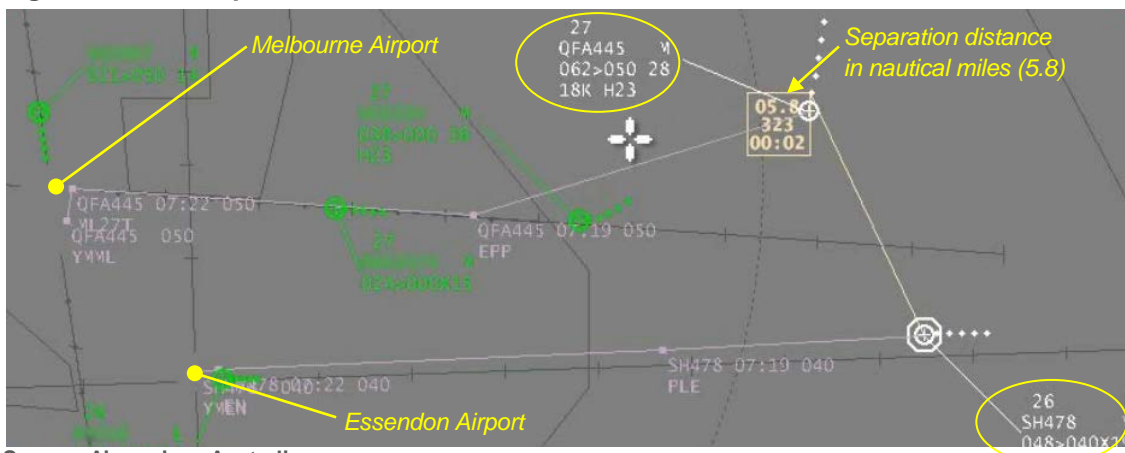
Figure 2: Relative positions of TJS and MYI at 1717:55

At 1717:44, the approach controller (controller) instructed TJS to turn right to a heading of 230°. At 1717:55, the controller instructed TJS to ‘...descend to three thousand you’re cleared ILS² runway 27 approach’. At that time, MYI was inbound to Essendon Airport and located about 6 NM to the south-south-east of TJS (Figure 1).

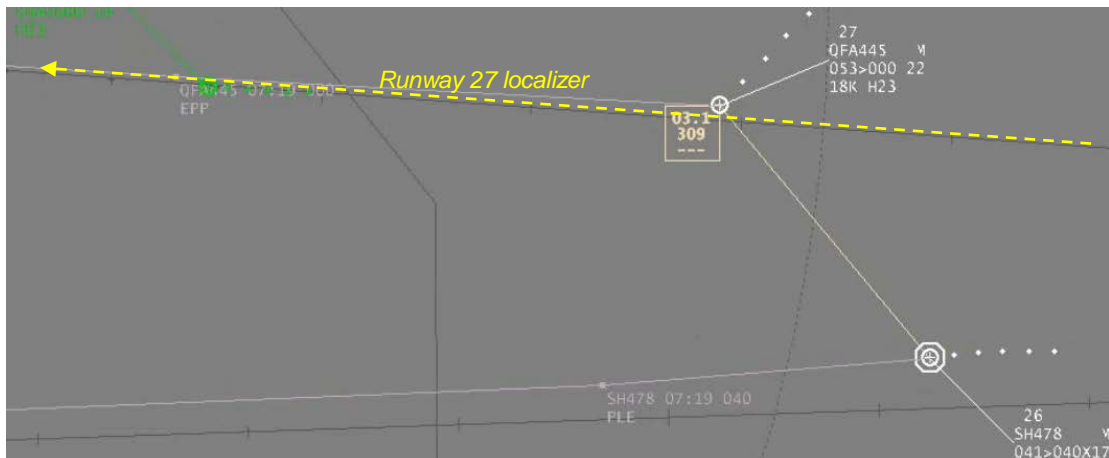
Figure 3: Relative positions of TJS and MYI at 1718:45

Both TJS and MYI were subsequently issued further speed reductions and at 1718:45, TJS was approaching the runway 27 localizer (Figure 2). The separation between the two aircraft at this time was 3.1 NM horizontal and 1,200 ft vertical. However, instead of intercepting the runway 27 localizer, TJS continued through the localizer and, at 1718:53, the controller asked TJS if they were turning right to intercept final. The separation between the two aircraft at that time had reduced to 2.9 NM horizontal and 1,100 ft vertical. In an attempt to maintain the required

separation of 3NM horizontal or 1,000 ft vertical, the controller then reiterated that he needed TJS to turn right and issued MYI with a traffic alert and an instruction to turn left heading 180°.

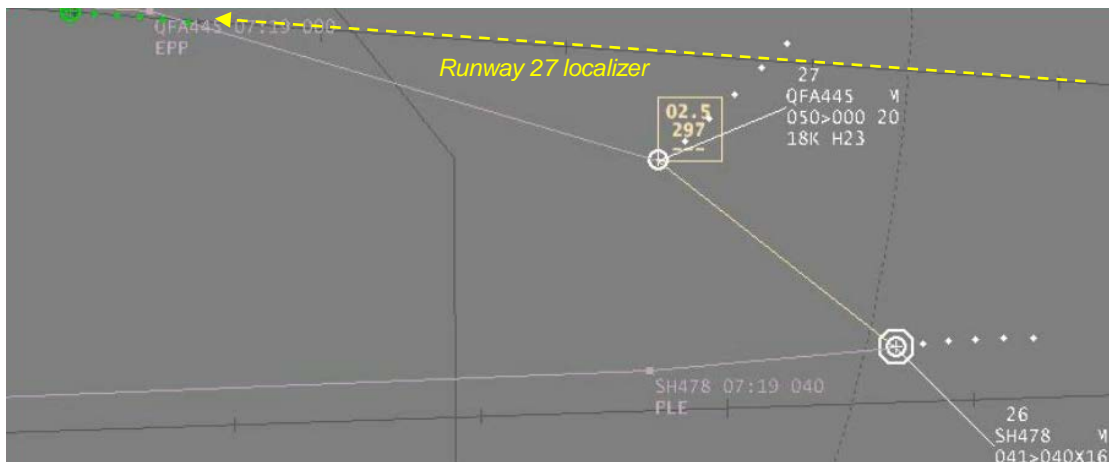
Figure 4: Relative positions of TJS and MYI at 1719:10

At 1719:10, the controller issued TJS with a traffic alert for MYI and instructed TJS to turn right to a heading of 300° to intercept final from the left. TJS was now located about 1 NM to the south of the runway 27 localizer. Separation with MYI had reduced to 2.5 NM horizontal and 900 ft vertical (Figure 3).

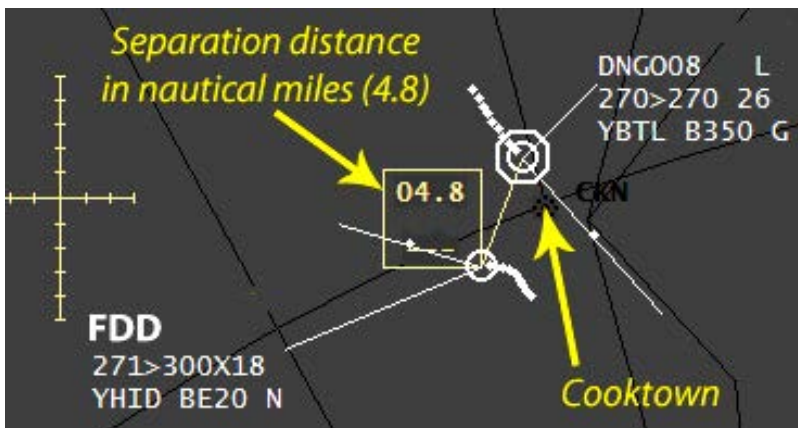
Figure 7: Proximity of the aircraft at 1235:27

At 1235:25, a breakdown of separation occurred as the distance between the aircraft reduced to 4.9 NM (9.1 km) with both aircraft at FL270. The distance reduced further to 4.8 NM (8.9 km) with FDD 100 ft above DINGO 008 (Figure 2), before increasing three seconds later to the required radar separation standard of 5 NM (9.2 km) horizontally or 1,000 ft vertically.

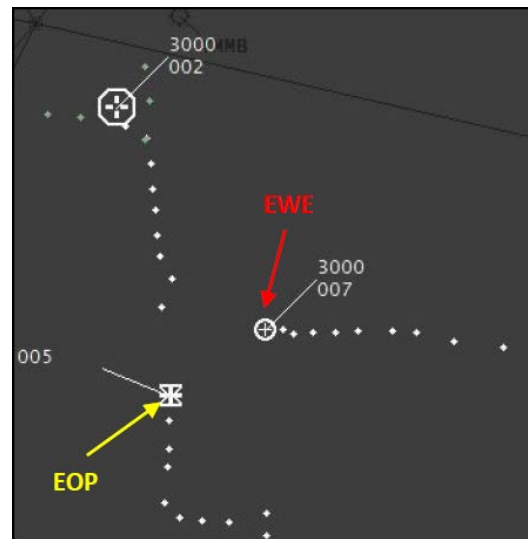
Figure 10: Aircraft positions at 1629

A subsequent review of Airservices Australia surveillance data showed that, at about 1629, EOP and EWE were on converging tracks (Figure 2). Shortly after, the instructor and student of EWE again looked for traffic. With no traffic sighted, they commenced the turn onto final. The turn was conducted lower and later than normal. At about the same time, EOP received an ATC clearance to land.

The pilot of EOP reported that several seconds later he observed EWE pass overhead from his right, about 10-20 metres in front of his aircraft (Figure 3). In response, he reduced engine power and raised the nose of the aircraft slightly to slow the aircraft and increase separation. The pilot then advised ATC that EWE had ‘cut in front’ of his aircraft. Air traffic control immediately instructed EWE to conduct a go-around. The student of EWE commenced a go-around and EOP landed without further incident.
