Analysis of accidents involving VH-registered
non-factory-built aeroplanes 1988–2010

Part 2

ATSB Transport Safety Report
Aviation Research Investigation
AR-2007-043(2)
Final – 26 March 2013

Aviation Research Report
AR-2007-043(2)
FINAL

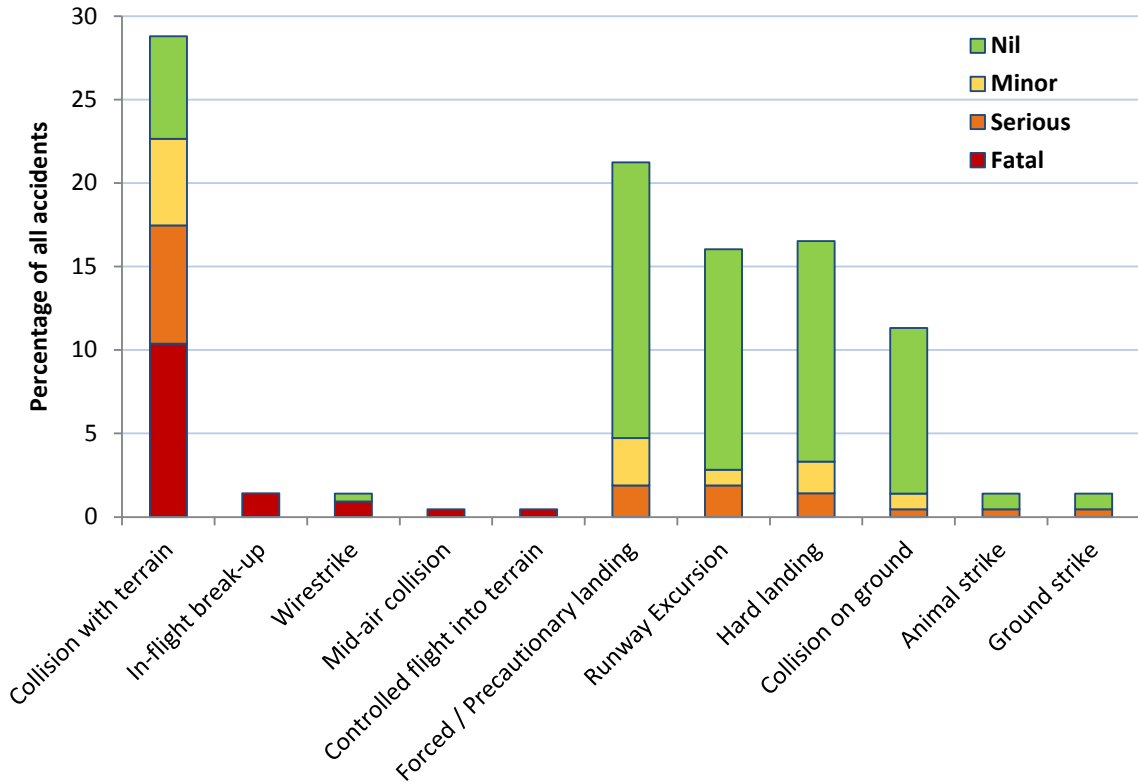
Figure 36: Amateur-built aircraft accidents with serious or fatal injuries

Figure 36 shows all accident events with serious or fatal injuries for amateur-built aircraft. Of particular note is collision with terrain, with the largest number of fatal accidents. However, the proportion of fatal accidents following a collision with terrain is only slightly higher for amateur-built compared with factory-built aircraft, as shown below in Figure 37.

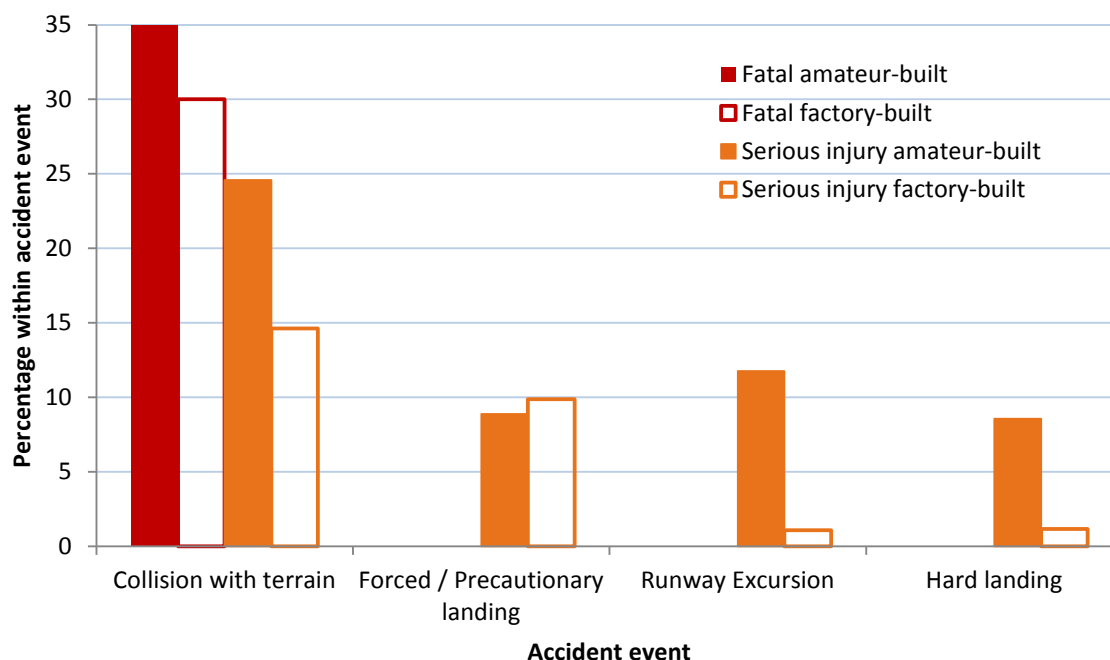
Figure 37: Proportion of serious and fatal injuries within four most common accident events

Serious injury accidents were relatively higher in amateur-built aircraft as a proportion of all accidents compared with factory-built aircraft accidents, as shown in Figure 16 on page 31. This difference is largely accounted for by the higher proportions of serious injury accidents in collision with terrain, runway excursions and hard landings as indicated in Figure 37 below.
