# Aviation Short Investigation Bulletin

Issue 16

AB-2013-028

Final – 21 March 2013

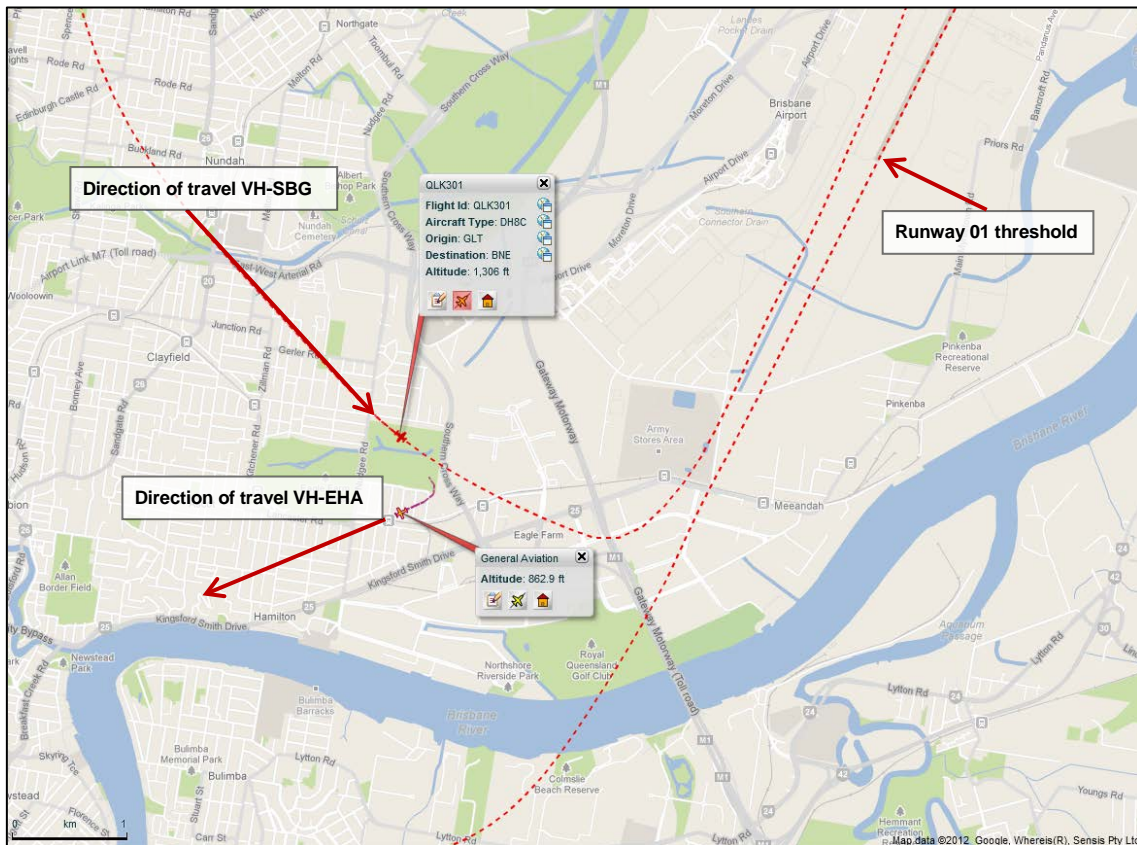
**Figure 1: Aircraft flight paths**

About 50 seconds later, the controller advised the pilot of EHA that SBG was approaching from the north-west and that aircraft was required to be visually identified. The helicopter pilot confirmed sighting SBG and was subsequently issued a clearance to depart Doomben and track direct for the Brisbane central business district (CBD) at an altitude not above 1,000 ft, with a condition to maintain visual separation with SBG.

The flight crew of SBG conducted a left circuit and landed on runway 01 without further incident.

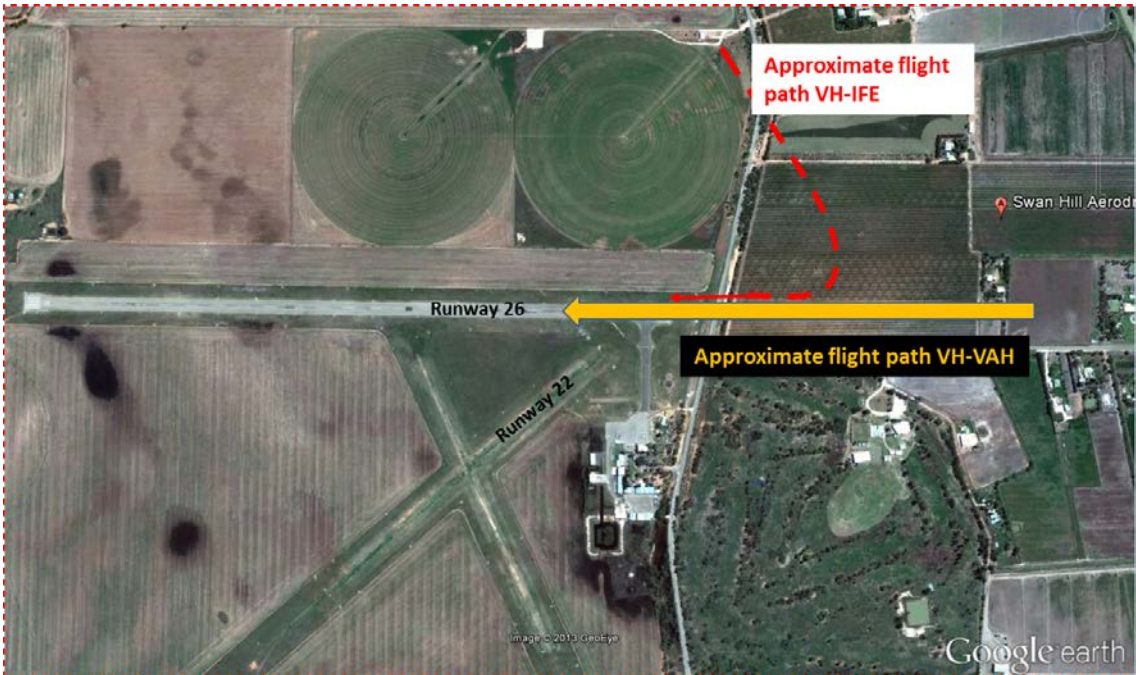
**Figure 3: Approximate flight path of both aircraft at Swan Hill Aerodrome**

The pilot of IFE continued a right descending oval approach (Figure 3) and landed short, on the grass to the right of the sealed section of runway 26. The aircraft then turned right and taxied back to the threshold, remaining close to the runway gable markers. At this point, the pilot of IFE then saw the lights of VAH on short final for runway 26. He manoeuvred to keep IFE as close to the northern gable markers as possible.

The pilot believed the aircraft was landing on runway 22 and would be clear of VAH, as he had observed IFE arriving from the north-west, then commence a curved approach. However, he was unable to establish communication with IFE to confirm this expectation. He was surprised when IFE continued the turn and landed on the grass on the right side of runway 26. At this stage, he felt it was safer to continue the approach and land further down the runway.

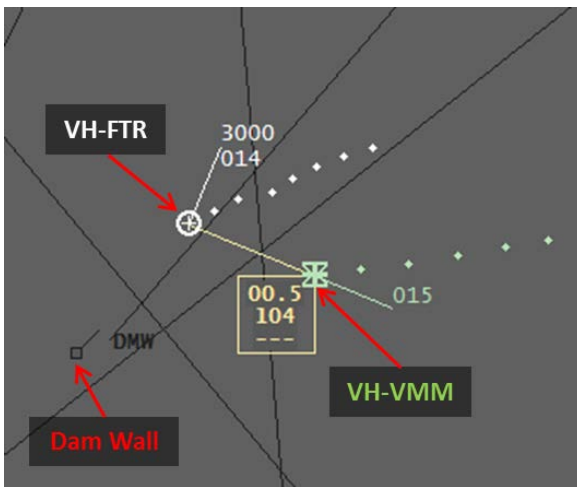
Figure 4: Aircraft positions at 1633:31

Time	VH-FTR	VH-VMM	Separation
1633:18	FTR was maintaining 1,500 ft.	<p>The pilot broadcast his inbound call to Parafield Tower, maintaining 1,500 ft, and received instructions to join downwind for runway 03 Right (R). He was advised of traffic in his 1 o'clock position at the same level. The pilot responded 'copy traffic'. Parafield Tower also advised that the aircraft's transponder had not yet been changed to the appropriate code (Figure 3).</p> <p>The pilot reported initially tracking for the base leg of the runway 21 Left circuit, but soon after, changed heading to track downwind for runway 03R.</p>	Lateral separation was 0.7 NM; vertical separation was 0 ft.
1633:31	As the instructor could not sight the traffic behind, he advised the student to descend to 1,400 ft.	VMM was maintaining 1,500 ft.	Lateral separation reduced to 0.5 NM (Figure 4); vertical separation was 100 ft.
1633:51	FTR was maintaining 1,400 ft.	VMM was observed descending through 1,400 ft.	Lateral separation reduced to 0.2 NM; vertical separation was 0 ft.

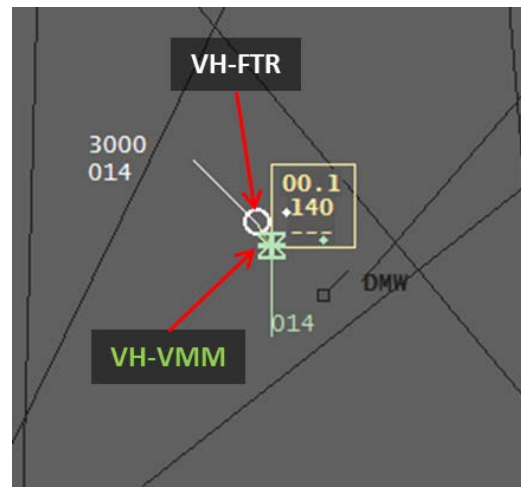
Figure 5: Aircraft positions at 1634:04

1633:56	The instructor advised Parafield Tower that FTR was the traffic passed on to VMM [1633:18].	VMM was observed maintaining 1,300 ft.	Lateral separation reduced to 0.1 NM; vertical separation was 100 ft.
1634:04	<p>Parafield Tower provided FTR with circuit joining instructions. FTR was maintaining 1,400 ft.</p> <p>The instructor and student observed VMM pass overhead.</p>	VMM was observed climbing through 1,400 ft.	Vertical separation was less than 50 ft (Figure 5).
1634:18	The instructor advised Parafield Tower of the incident.

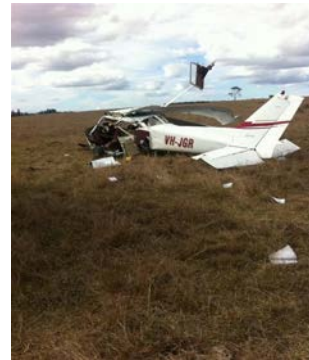
VH-JGR

The pilot was the only person on board and suffered severe injuries as a result of the accident and at about 1500, he was airlifted to hospital.

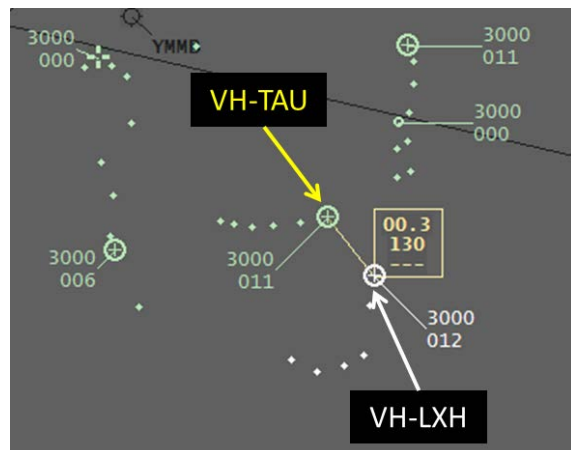
Figure 2: LXH on downwind

LXH made a broadcast advising that they had turned onto downwind. Separation between LXH and TAU reduced to 0.3 NM laterally and 100 feet vertically (Figure 2).

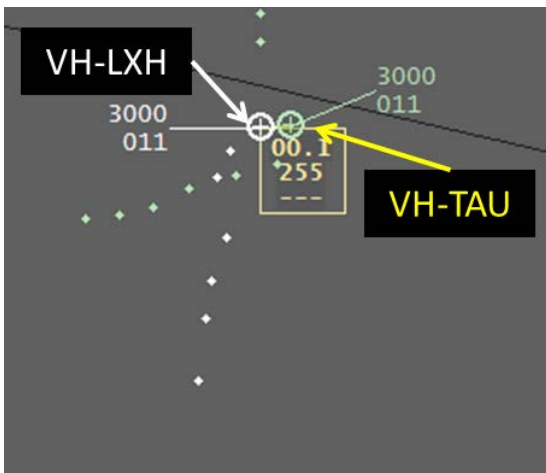
**Figure 3: TAU passes underneath LXH**

Soon after, TAU commenced the turn onto downwind. The instructor of LXH continued to monitor the location of TAU and at 1529, observed TAU pass 100 feet below (Figure 3). TAU then advised ATC that they had turned onto downwind, however, the end of the broadcast was partially over-transmitted. At that time, separation had reduced 0.1 NM laterally, with both aircraft at 1,100 feet. Air traffic control then advised another aircraft, VH-TAX (TAX)<sup>3</sup> to follow the ‘Cherokee’ on mid-downwind. The pilot of TAX acknowledged the call.

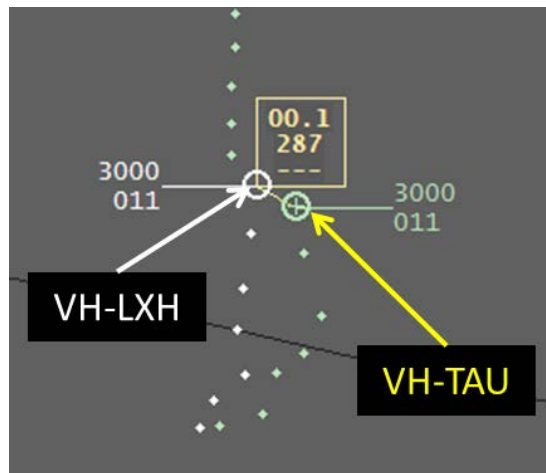
**Figure 4: TAU sighted LXH**

About 30 seconds later, the instructor of TAU observed LXH to the left and incorrectly advised ATC that they had traffic in their ‘3 o’clock’<sup>4</sup> position and asked if they were to be following that aircraft (Figure 4). LXH then advised ATC that TAU had cut them off. ATC confirmed that TAU was to follow LXH and that they should widen their circuit to ensure separation.

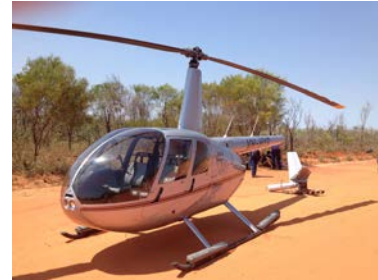
VH-HYR

The pilot planned on performing a power recovery<sup>7</sup> and terminated the autorotation at about 10 feet above the ground with 0 knots groundspeed,<sup>8</sup> at the same time winding on throttle to increase the engine RPM, however the engine did not respond. The low rotor RPM light and horn activated and the pilot increased the collective lever in attempt to utilise the remaining rotor RPM to cushion the landing. However, the helicopter landed heavily and the main rotor severed the tail boom. All occupants exited the helicopter without injury.
