Collision between train BC151 and an excavator

near Maitland, NSW | 20 December 2011

ATSB Transport Safety Report

RO-2011-018

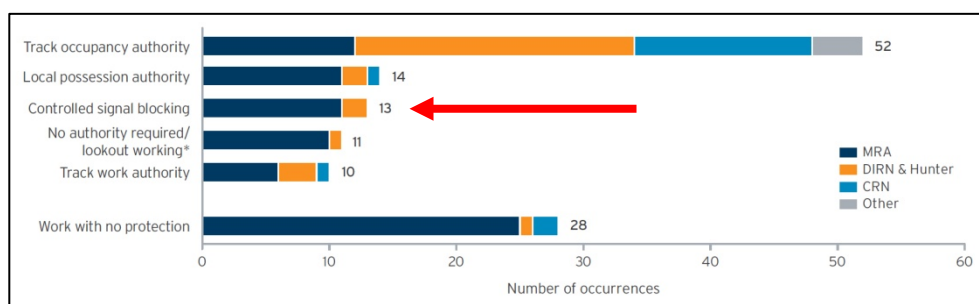
Figure 10: Extract from ITSR 2010-11 report, worksite protection

Of interest is the high number of serious failures in the systems to manage the safety of on-track workers (worksite protection) which are classified as a precursor rail safety occurrence. The report breaks down the data into the five methods of worksite protection (Figure 10).

Based on the ITSR data for 2010-11, CSB irregularities contributed to 10.2 per cent of the total worksite protection irregularities. The most prominent failure of CSB working was at Kogarah¹⁹, NSW, which occurred on 13 April 2010, resulting in a rail worker being struck and fatally injured by a train.

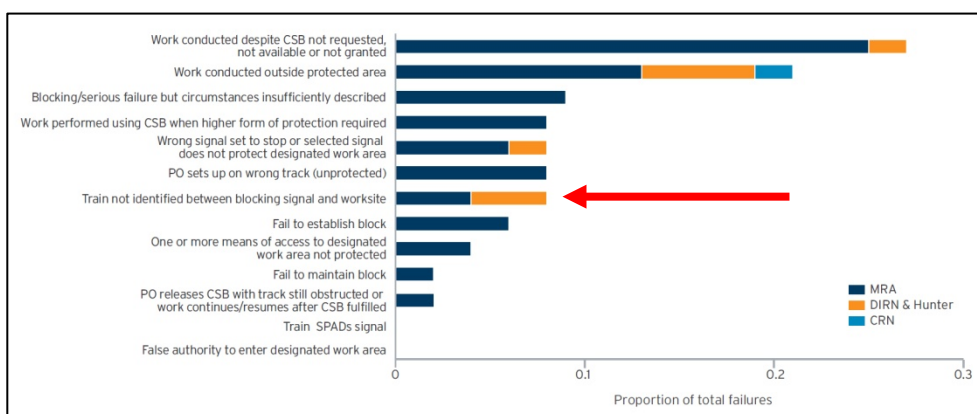
Figure 11: Extract from ITSR report, CSB failure types

Comparing this finding with the ITSR report data (Figure 11), this type of failure within CSB working represents a less significant proportion of total failure types (about 8 per cent of total CSB irregularities). However, when considering the imminent approach of a train towards an unprotected worksite, the consequences of this type of failure are far more serious. Similarly with TOA working, a ‘train incorrectly believed or not confirmed to be beyond a work location’ represents a less significant proportion of total failure types. However, as with a CSB this type of failure is far more serious, as highlighted in the ATSB report RO-2010-004 into a collision between a track mounted excavator and the XPT WT27 near Newbridge, NSW, on 5 May 2010 where a track worker was also fatally injured.
