Australian Government
Australian Transport Safety Bureau

Aviation Short Investigation Bulletin

Issue 17

AB-2013-050

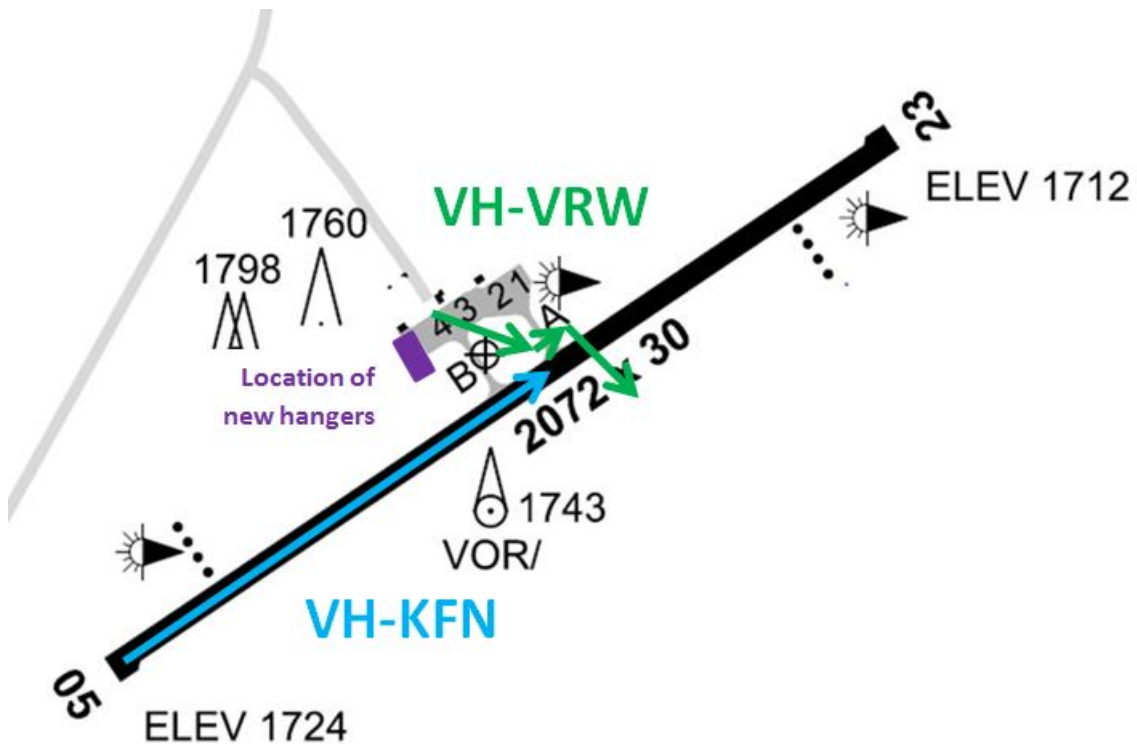
Figure 1: Track of VH-KFN (blue) and VH-VRW (green)

Radio transmissions at Newman are recorded for administrative purposes. A review of the recording for a period immediately before and after the incident showed that both KFN and VRW made all necessary radio transmissions prior to entering the runway. However, transmissions by KFN once on the runway were not recorded, though those made by VRW in the vicinity of the runway were. Recorded transmissions by VRW after the incident were clearly part of a conversation with KFN, though KFN's transmissions were not recorded.

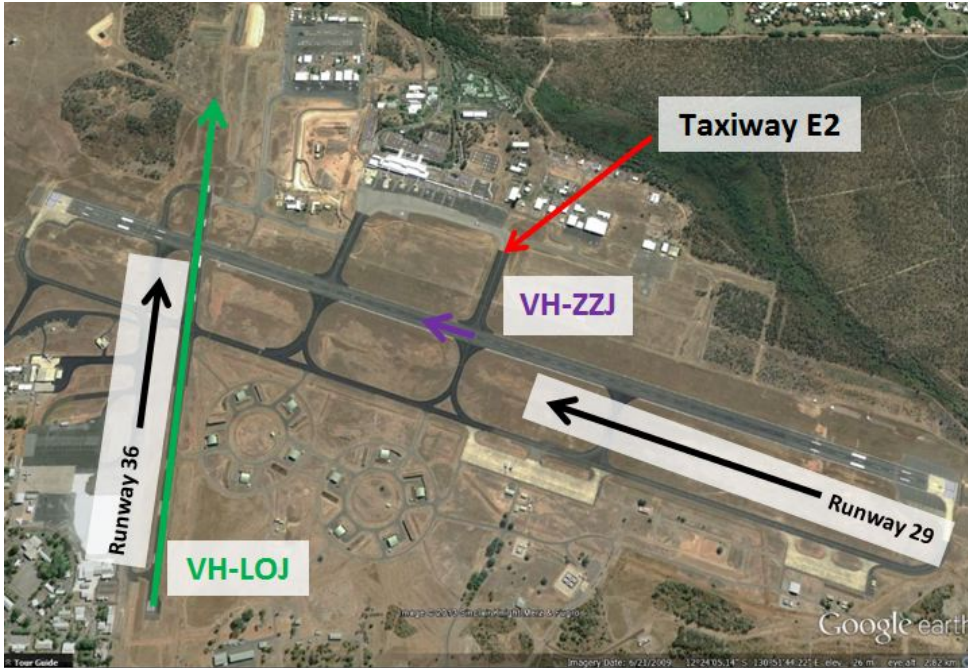
Figure 1: Track of VH-LOJ (green) and position of VH-ZZJ (purple)

Air traffic services at Darwin are provided by the Department of Defence (Defence). The Defence investigation found that an unsafe takeoff clearance had been issued to LOJ, resulting in a runway separation breakdown. Further, the ADC failed to monitor both ZZJ and LOJ during the takeoff, a critical phase of operation. The actions of the pilot of ZZJ, by delaying the takeoff, reduced the potential severity of the incident.

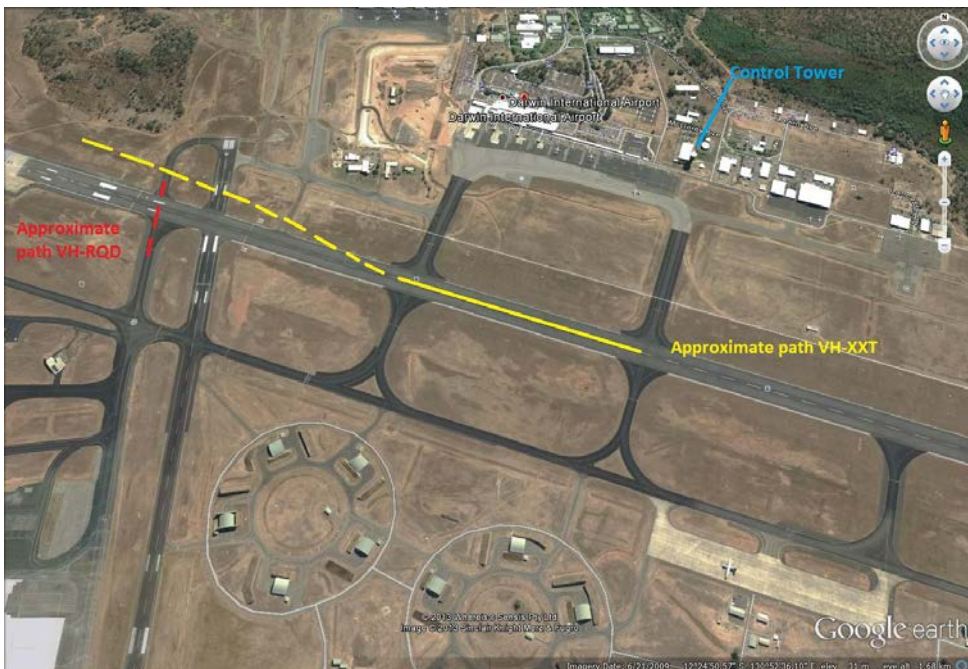
Figure 2: Approximate path VH-XXT and VH-RQD

It was estimated both visually and by radar that XXT then overflew RQD crossing the runway by between 150 ft and 500 ft (Figure 2).

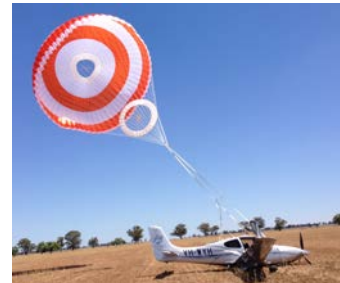
WYH at the accident site

At about 1359, WYH overflew Gilgandra and continued on towards Dubbo, at which point the oil pressure gauge indicated about 12 psi. The approximate flight time remaining to Dubbo was 11 minutes. At 1401, the engine failed and the pilot could hear something rattling around in the engine cowling. The pilot turned the aircraft towards Gilgandra aerodrome and broadcast a mayday call, indicating that the engine had failed and he intended to land at Gilgandra aerodrome. The pilot then shut down the engine. It became evident that a landing at Gilgandra aerodrome was not achievable and he looked for a suitable landing point away from roads, trees and possible power lines. The pilot broadcast a call on the Melbourne Centre frequency advising that they

The pilot indicated that there was no sign of an external oil leak from the engine and there was no oil on the windscreen (Figure 2).

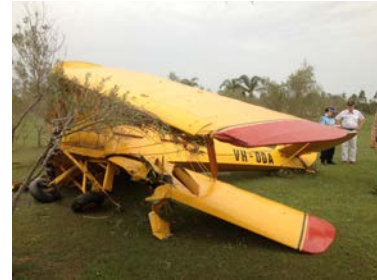
Aircraft damage

The positive aspects of wearing full restraint harnesses, evacuating the aircraft quickly and extinguishing the fire ensured neither pilot experienced further injuries.

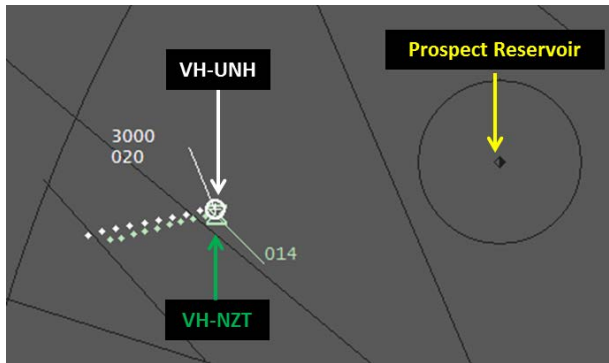
Figure 2: Aircraft positions at 1550:47

Both UNH and NZT continued tracking for Prospect and when at 4-5 NM, the instructor of NZT changed radio frequency to Bankstown Tower. Shortly after, at 3.5 NM (1550:47 Eastern Daylight-saving Time²), UNH was observed on the Airservices Australia surveillance data descending overhead NZT with 600 ft recorded vertical separation, which was actually 500 ft, accounting for

NZT’s transponder discrepancy (Figure 2). The pilot of NZT reported maintaining 1,500 ft while UNH continued to descend.

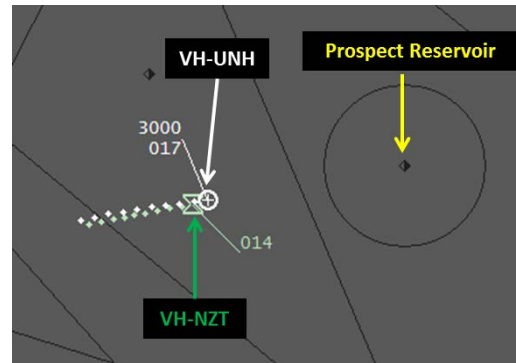
Figure 3: Aircraft positions at 1551:19

At 1551:19, the surveillance data showed that there was 0.2 NM lateral and 300 ft vertical separation (200 ft actual) between UNH and NZT (Figure 3). After that time, for undetermined reasons, the altitude readout for NZT on the Airservices Australia surveillance data was temporarily corrupted and not recorded.

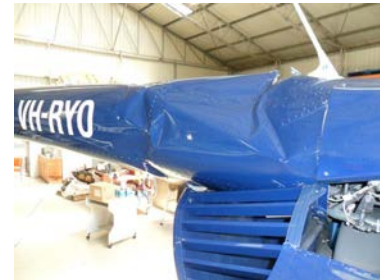
Helicopter damage

A witness reported hearing the rotor RPM behaving erratically and observing the helicopter pitching and rolling. The tail boom contacted the ground several times and the helicopter then rotated around the tail and came to rest on its right side.
