# Collision involving a motor vehicle and train 4460S

10 km south of Port Germein, South Australia | 19 March 2012

## ATSB Transport Safety Report

RO-2012-003

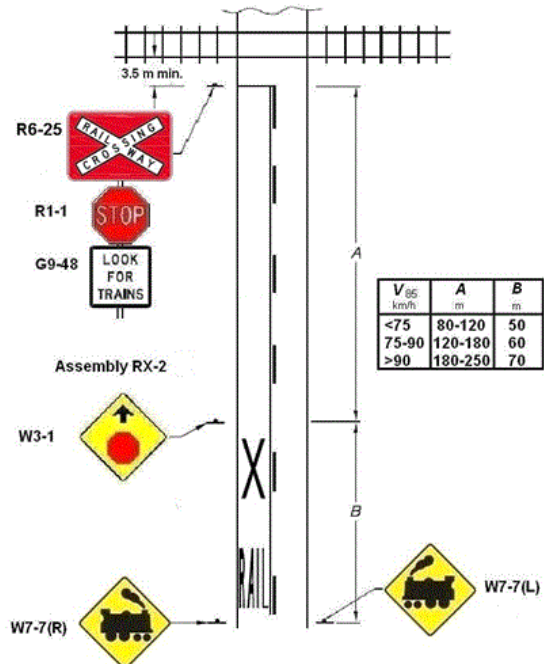
**Figure 6 Signage prescribed in AS1742.7 with W7-7(L) being optional**

An examination of the signage on the western approach to the crossing (Figure 5), the direction of the motor vehicle travel, revealed that the signage was generally in compliance with the requirements of the AS1742.7-2007 (Figure 6).

There were some minor non-conformances, but these were unlikely to have been factors that contributed to the collision:
