Australian Government
Australian Transport Safety Bureau

Aviation Short Investigation Bulletin

Issue 18

AB-2013-070

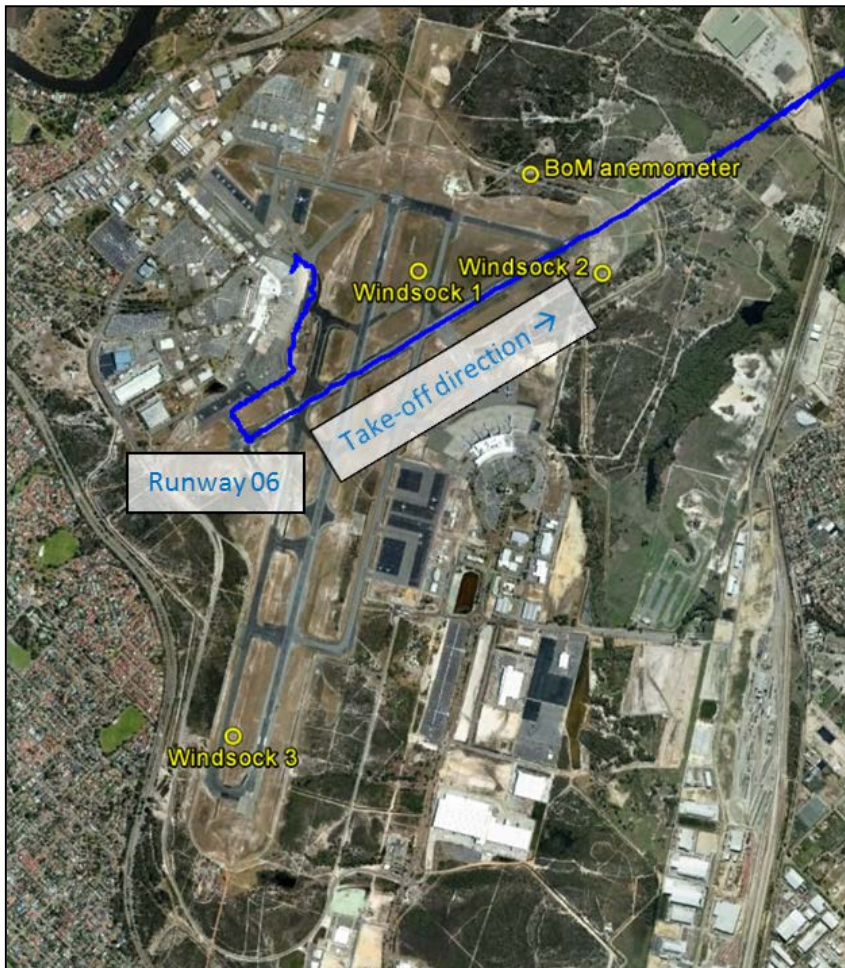
Figure 1: Take-off path and windsock locations

There were three windsocks at Perth Airport (Figure 1); however, there was no windsock near the threshold of runway 06. Before takeoff, the captain observed that windsock 1 was indicating a headwind component. The first officer also confirmed that windsock 2 was showing a headwind component. Any headwind component was acceptable for takeoff as the performance figures had assumed nil wind.

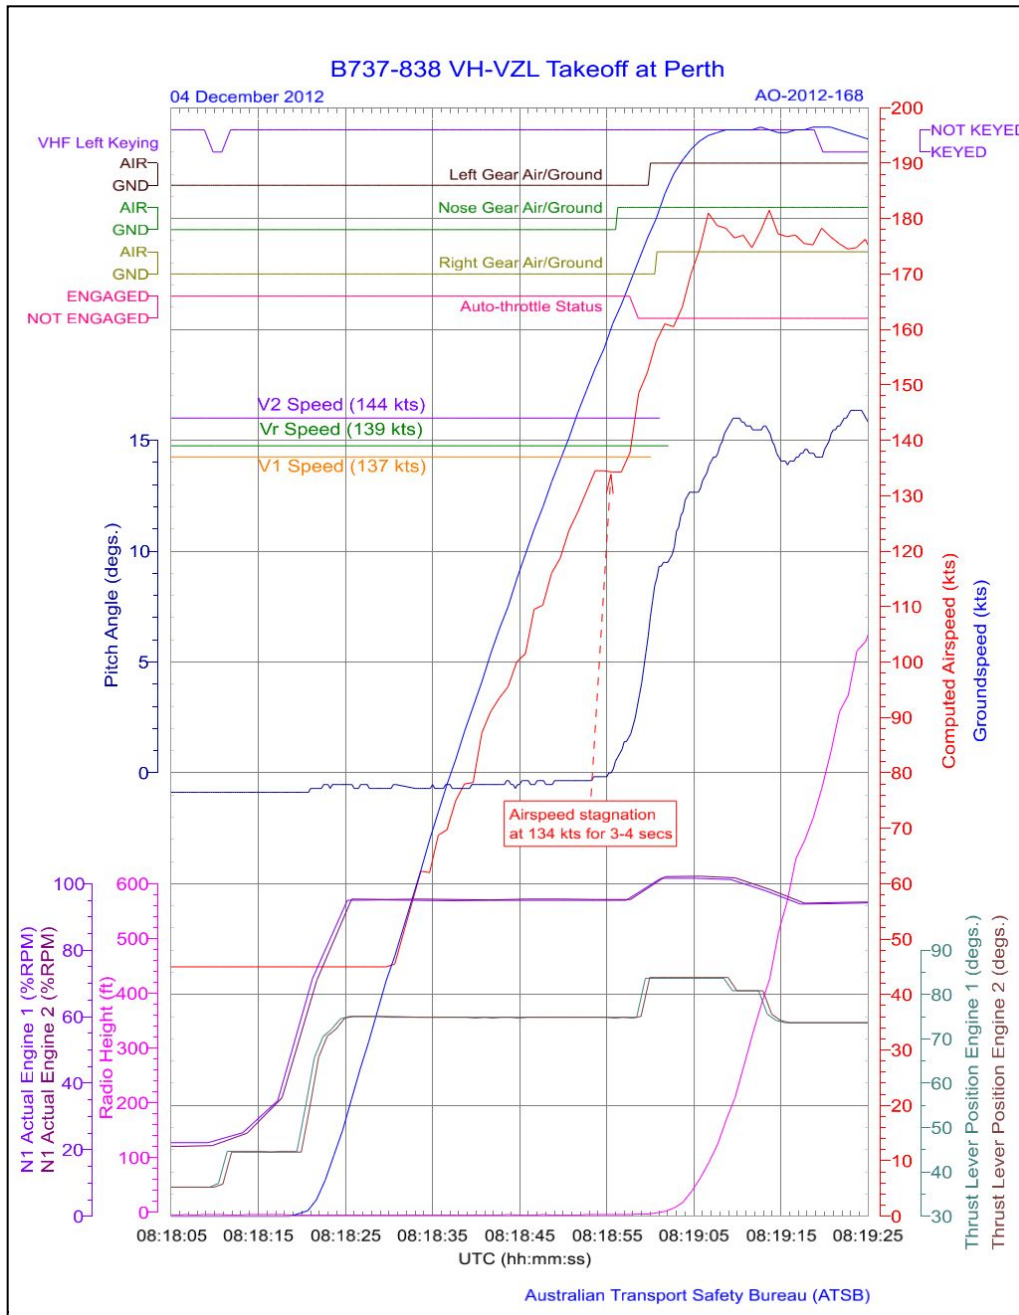
Figure 2: QAR data

Quick access recorder (QAR) data was obtained from the operator and analysed by the ATSB (Figure 2). The data showed that the airspeed stagnated¹⁴ at 134 kt for 3-4 seconds just below the V₁ speed of 137 kt, the auto-throttle was disconnected and maximum thrust was set.

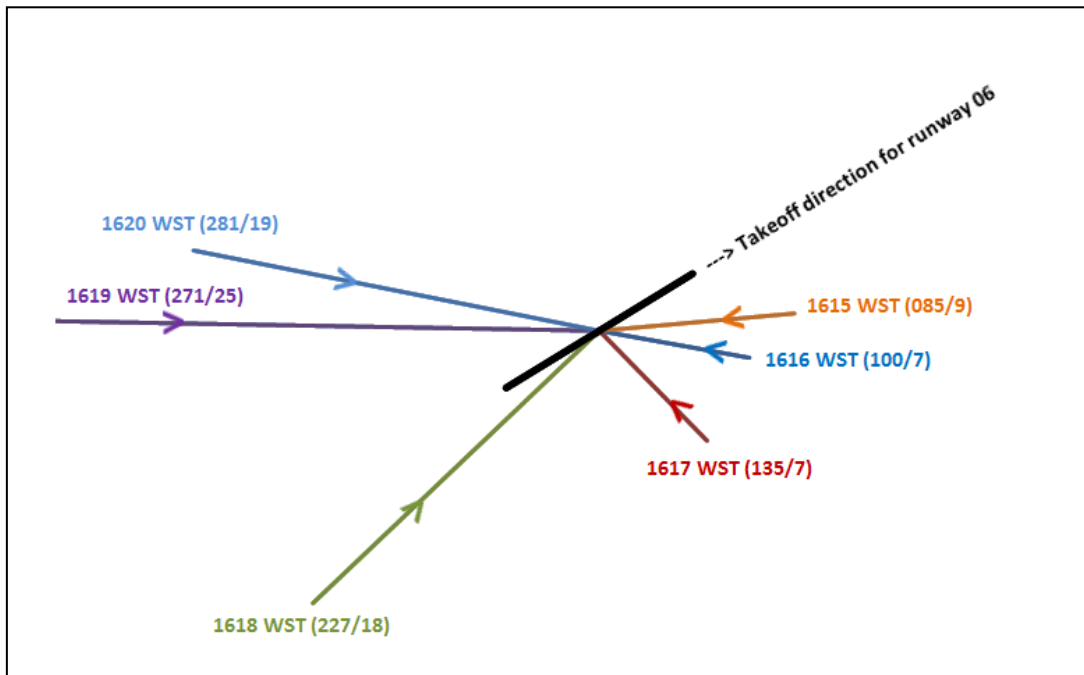
Figure 3: BoM anemometer data – maximum wind gusts

The Bureau of Meteorology (BoM) provided one minute wind readings from their airport anemometer. The anemometer was located near the northern end of runway 06 (Figure 1). The maximum wind gusts during the one minute periods around the time of takeoff are shown to scale in Figure 3. The wind direction value is averaged over a one minute period. Wind values are given in wind direction/wind speed format in units of °T/kt.

The anemometer experienced a significant wind change at 1618 that would have resulted in tailwind conditions at least near the northern part of runway 06.

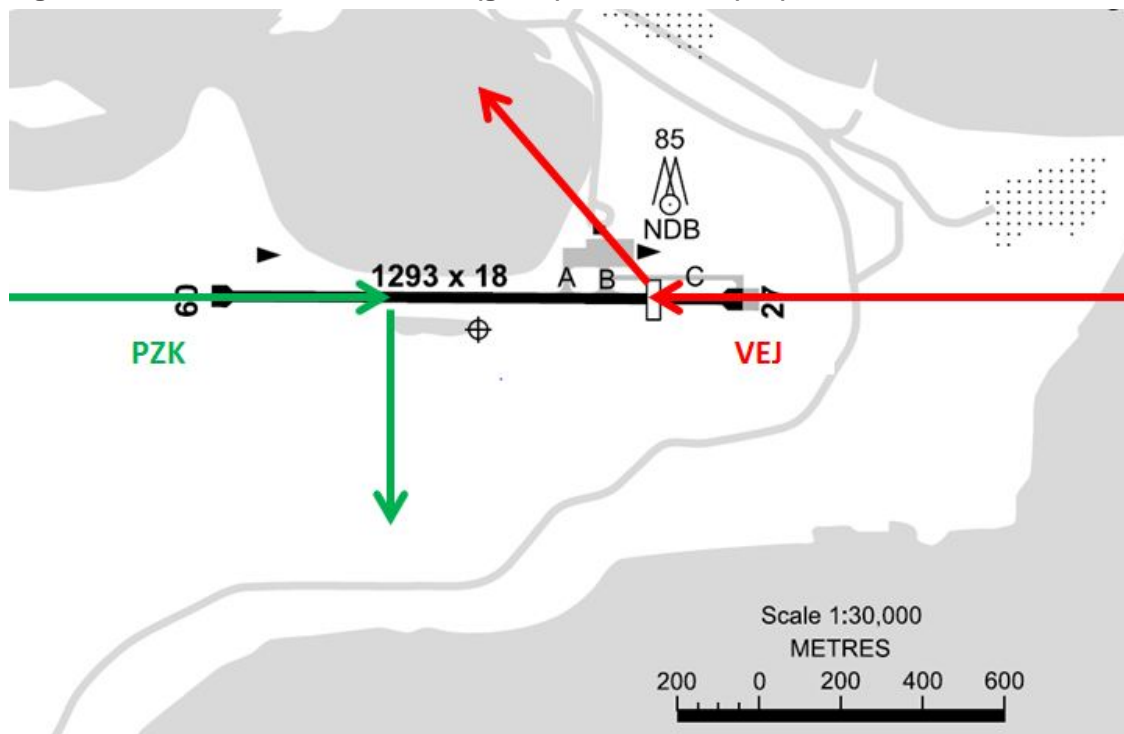
Figure 1: Estimated track of VH-PZK (green) and VH-VEJ (red)

At 1221 Western Standard Time³, as PZK approached the threshold for runway 09 at about 200 ft above mean sea level, the pilot observed an aircraft about 650 m ahead on the reciprocal heading at the same level. As the pilot of PZK initiated a sharp right turn, he observed the other aircraft also turn right (Figure 1). The other aircraft was later identified as VEJ. The lateral distance between the aircraft reduced to 0.2 NM.

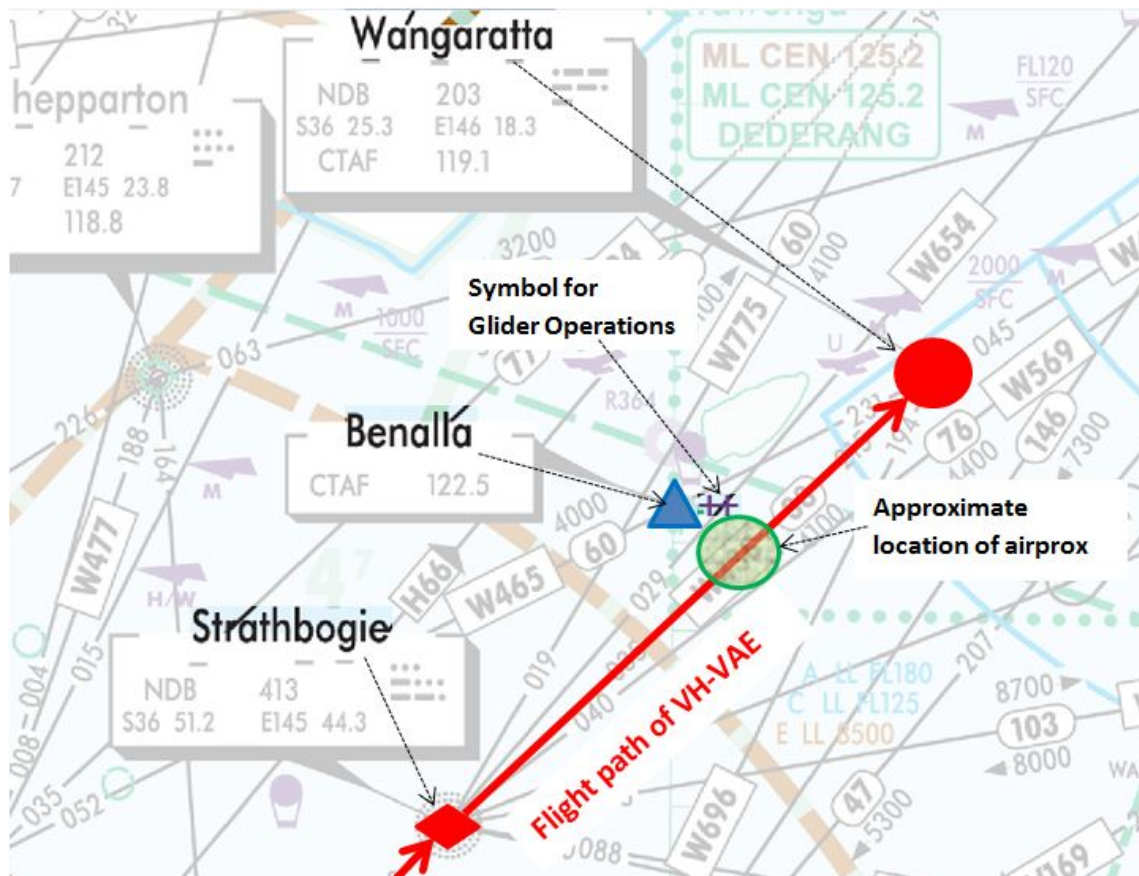
Figure 1: Map showing VAE's track (red) and the Gliding Operations symbol at Benalla

The presence of a glider in an area into which a medium-sized aircraft may be descending at more than 200 knots is a clear case when "un-alerted" see and avoid is not sufficient and needs to be supplemented by use of radio.

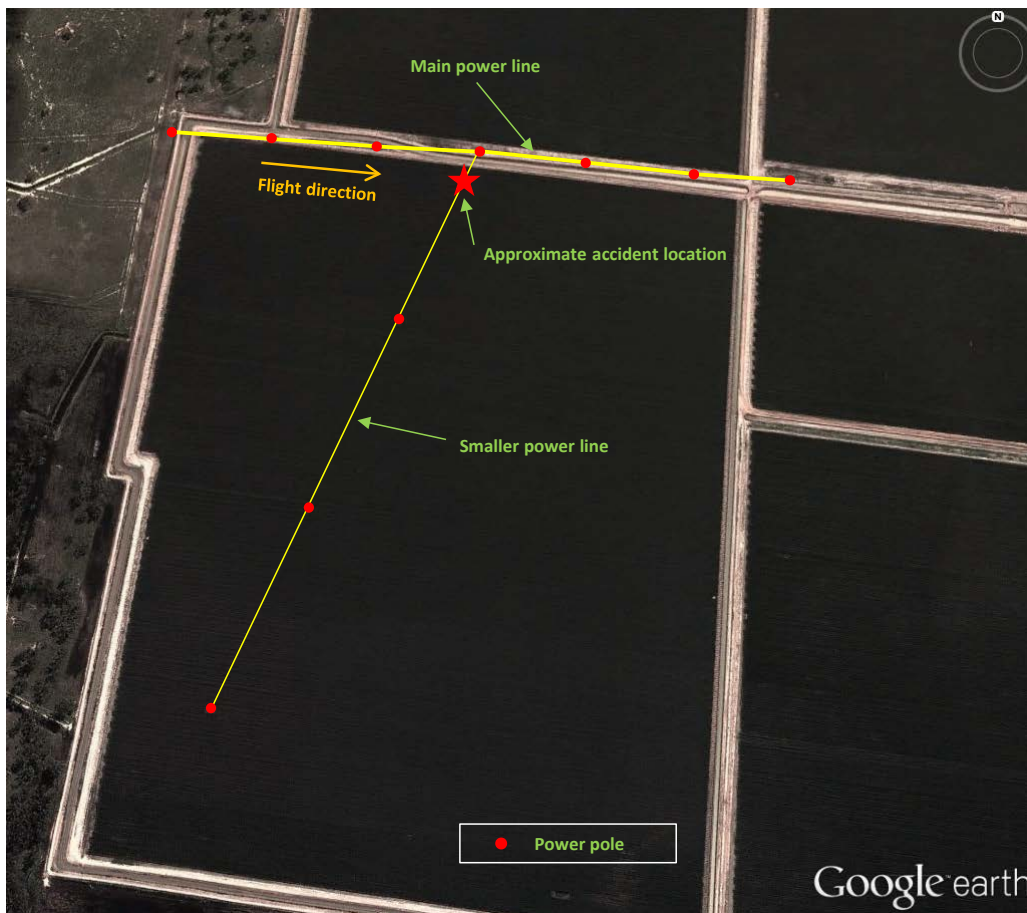
Figure 1: Representation of field being sprayed

The pilot was carrying out the final spray run (clean-up run), to use the last of the spray product on the edge of the field, before returning to the loading airstrip that was located about 1 km away. The pilot was flying from west to east, parallel to the main power line (Figure 1), which was located beside the field, outside of the area being sprayed. Another smaller power line with three wires ran diagonally across the field from the main power line and went for about 1 km across the field to a farm yard. When the pilot had run out of product, he pulled up to gain altitude before returning to the loading airstrip, when he struck the smaller power line that ran diagonally across the field. Two of the wires were cut by the aircraft's wire protection system and the third wrapped around the propeller hub, arresting the aircraft and pulling it around in a half circle, where it came to rest on the ground (Figure 2). The aircraft sustained serious damage, while the pilot was uninjured.

For this reason, the Aerial Agricultural Association of Australia recommends that an additional hazard check should be performed from a safe height prior to every change of direction or 'clean up run'. The extra safety check for wires is important, as the obstructions may appear new or different from the new direction of flight.

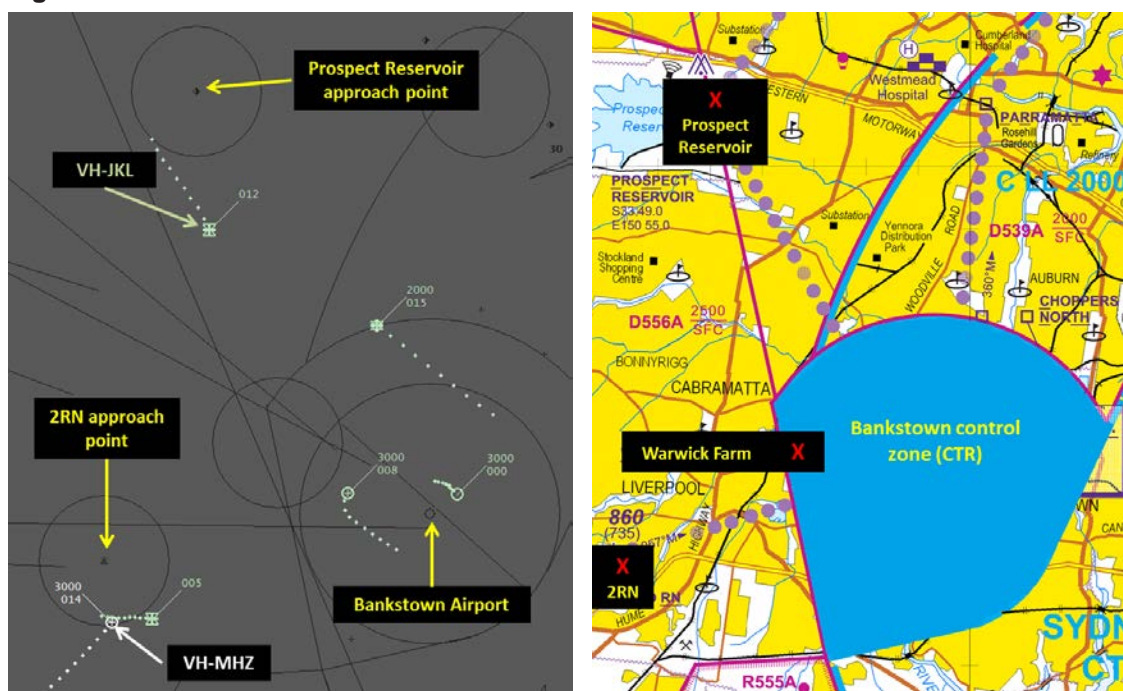
Figure 1: VH-MHZ and VH-JKL inbound to Bankstown

At the same time, the pilot of a Piper PA-44 aircraft, registered VH-MHZ (MHZ), was conducting a ferry flight from Wedderburn (NSW) to Bankstown. At about 1026, when at the '2RN' VFR approach point, the pilot attempted to broadcast an inbound call to Bankstown Tower; however, the pilot reported that the call was over-transmitted. Shortly after, a second inbound call was broadcast, which the pilot reported was again over-transmitted.

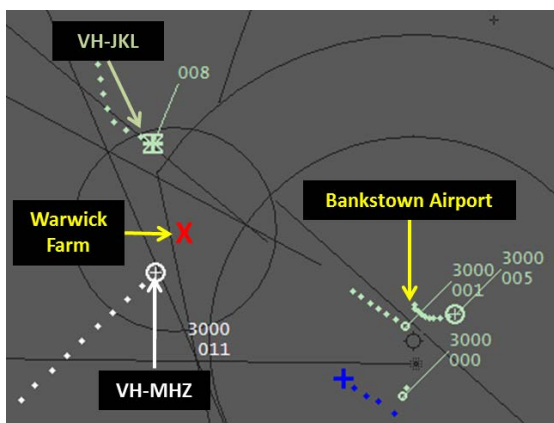
Figure 2: Aircraft positions at 1028

At about 1028, ATC advised the pilot of JKL of an unidentified aircraft to the south, about 0.5 NM away. The pilot replied to ATC that he would descend and monitor the aircraft. The pilot reported descending 50-100 ft and conducting a slight right turn. As MHZ passed overhead JKL, vertical separation reduced to 200 ft and then increased to 400 ft as JKL descended (Figure 3). The pilot of MHZ did not sight JKL as it was obscured by the nose of the aircraft.

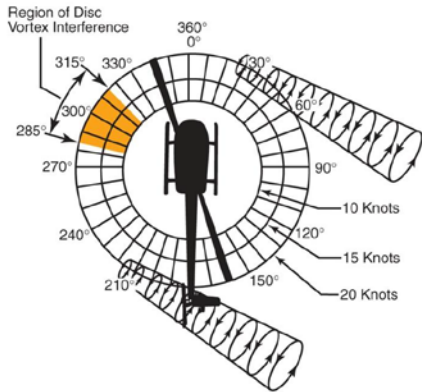
Figure 2: Main rotor disc vortex interference

- wind from the left front of the helicopter at between 285° to 315° relative to the nose of the helicopter (Figure 2).
- left crosswind between 210° and 330° relative to the nose of the helicopter (Figure 3).
- tailwind from 120° to 240° relative to the nose of the helicopter (Figure 4)
