# Aviation Short Investigation Bulletin

Issue 19

AB-2013-079

Final – 29 May 2013

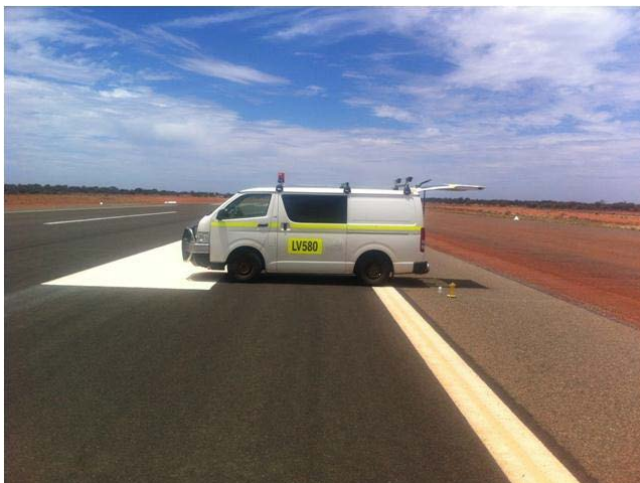
**Figure 1: Vehicle location on runway**

At about 1045 Western Standard Time,<sup>1</sup> the aerodrome reporting officer (ARO), who was a qualified electrician, arrived at Leinster aerodrome to continue a works order that required the levelling of the runway lights. The ARO went to the terminal office to retrieve a hand held radio and then drove onto the taxiway. Before entering the runway, he made a broadcast on the Leinster common traffic advisory frequency (CTAF) using the hand held radio, indicating he was entering runway 10/28. The ARO reported that he received the voice identification of 'Leinster aerodrome' from the aerodrome frequency response unit (AFRU).<sup>2</sup> He proceeded to the end of runway 28 and commenced work. As the temperature was above 40°C, the ARO positioned the vehicle on the edge of the runway to provide some shade from the sun while he worked on the runway light (Figure 1).

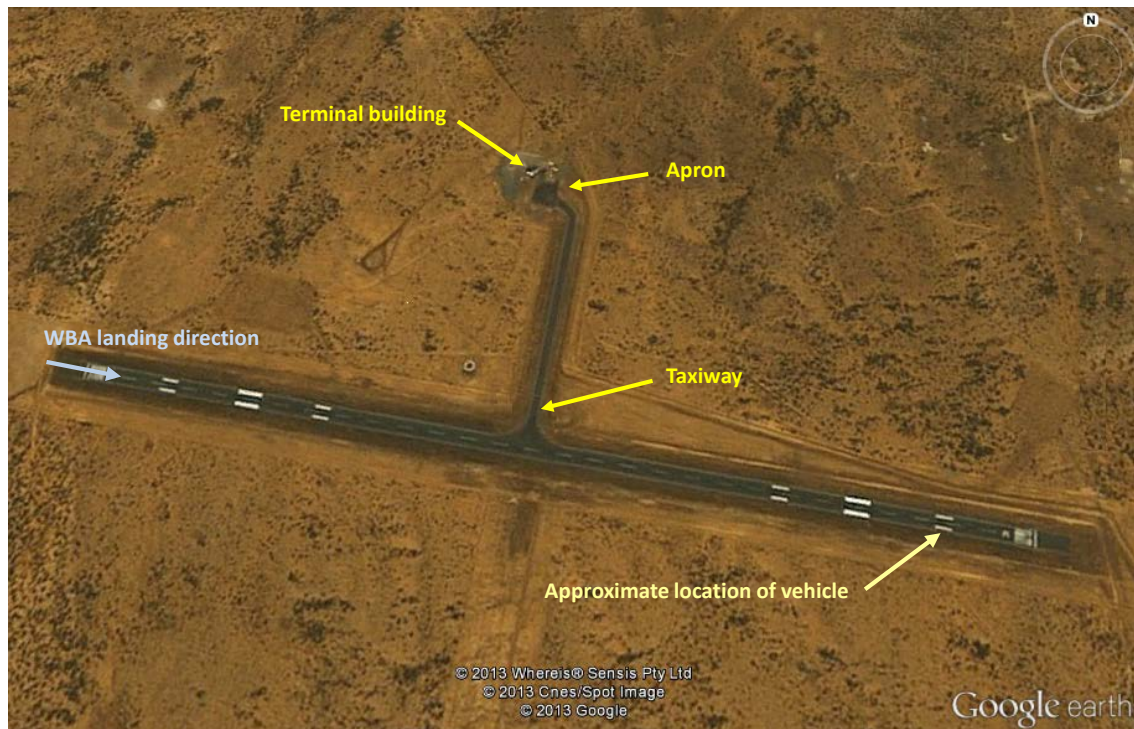
**Figure 2: Location of vehicle on the runway**

The crew of WBA taxied past the vehicle and used the turning node at the end of the runway to turn around. The aircraft was then taxied back along the runway to the taxiway that led to the terminal (Figure 2). The crew made a broadcast on the CTAF again to contact the vehicle driver, but did not receive a response. The ARO reported that he heard the radio transmission, but it was unintelligible. The crew continued to the terminal and after shutting down, they made another broadcast on the CTAF, with no response received.

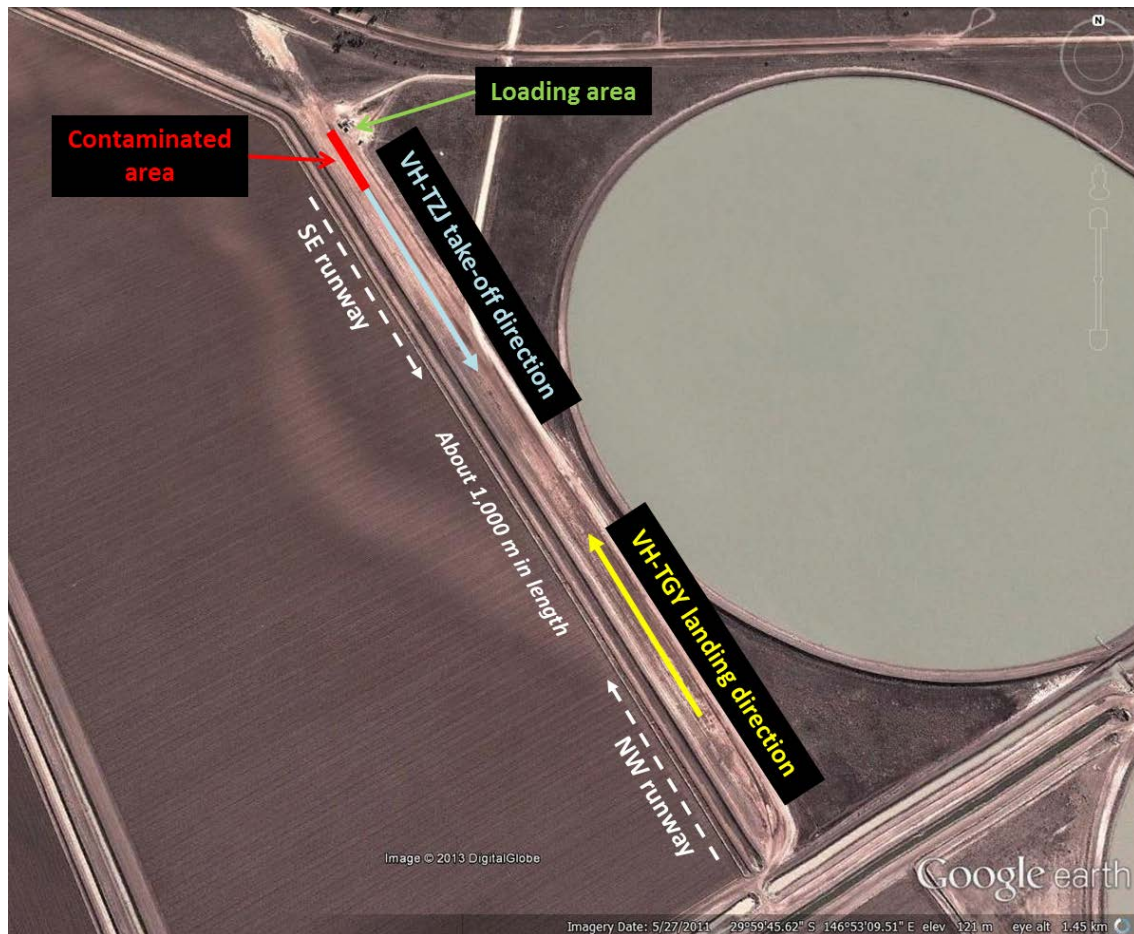
Figure 1: Rumleigh airstrip

The takeoff was continued and the aircraft returned to the airstrip, landing on the north-west runway. During the landing roll, the pilot manoeuvred TZJ to the left of the contaminated area, with the aircraft's left wheel on dry ground and the right wheel on the contaminated area. The pilot shut down the aircraft and confirmed that the cockpit switches were appropriately selected for spraying operations. After exiting, the pilot examined the fire-bombing door, with no irregularities found. As a precaution, the mixers partially loaded the hopper with water to test the door. As the door remained closed, the hopper was re-loaded with the water/chemical.

TZJ then departed off the south-east runway, through the contaminated area. The pilot reported that, while mud was observed spraying up from the aircraft's wheels, directional control was maintained. After takeoff, the pilot attempted to contact TGY again on the UHF, but without success. The pilot of TZJ commenced his spraying flight.

When approaching the runway end at a reasonably slow speed, but faster than his normal taxi speed, the pilot of TGY suddenly observed mud spraying up from the aircraft's wheels. The aircraft then commenced sliding and turning to the left. When the left wheel contacted dry ground, the aircraft swung further left and tipped forward, resulting in the propeller contacting the ground. The aircraft then tipped backwards and the tail wheel assembly detached. TGY came to rest at 90° to the runway direction. The pilot of TGY exited and spoke to the mixers, who advised that the fire-bombing door in TZJ had malfunctioned and released the 2,700 L load, contaminating the runway. TGY sustained minor damage (Figure 2).

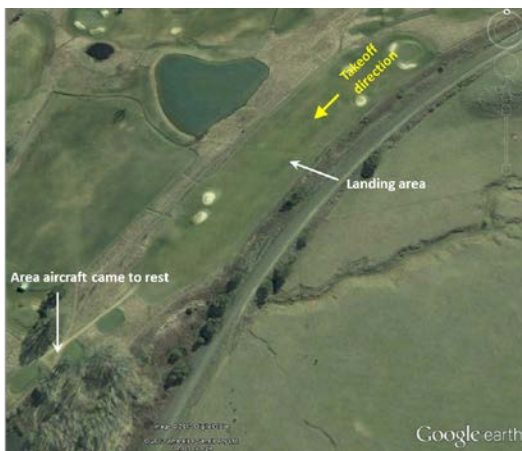
Figure 1: Landing area

The pilot reported that the aircraft accelerated as normal, however during the take-off run he realised the aircraft would not clear the trees at the end of the landing area and elected to reject the take-off. The pilot reduced the power to idle and applied the brakes, however the remaining distance was insufficient and the left wing impacted a tree, the aircraft turned over and came to rest inverted. The pilot was uninjured and the aircraft sustained substantial damage (Figure 2).

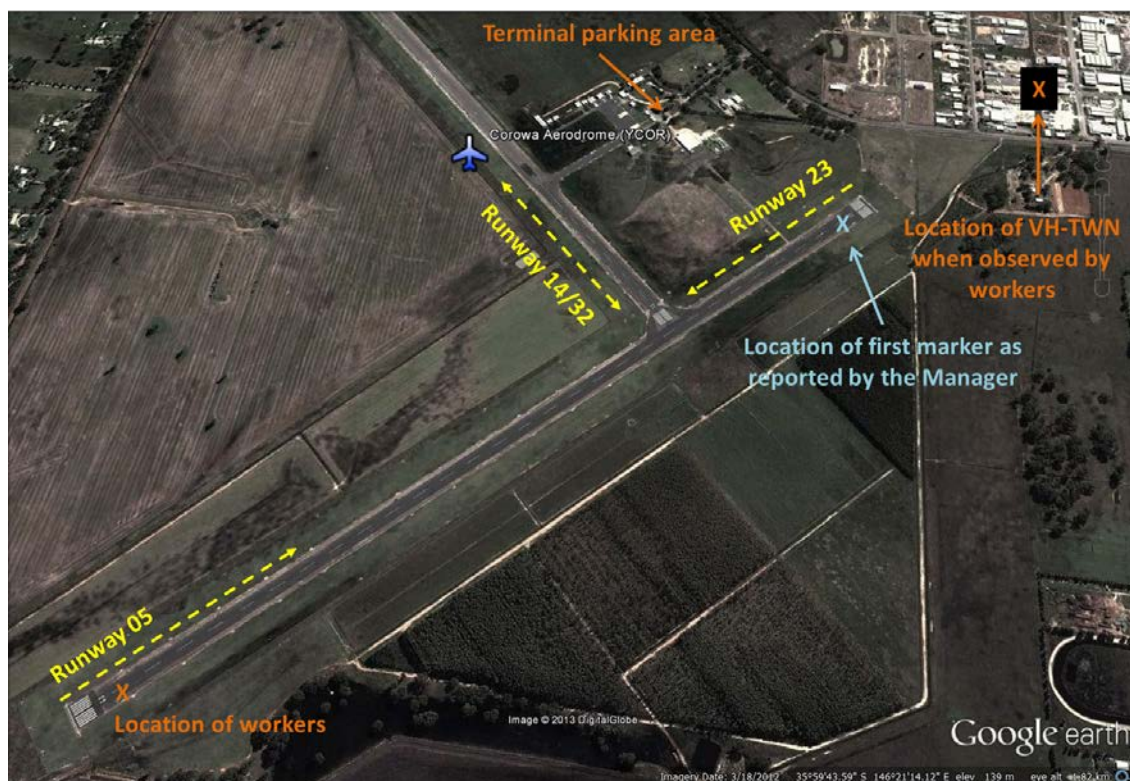
**Figure 1: Position of VH-TWN and aerodrome workers**

The workers were monitoring the CTAF on a hand held radio, but no broadcasts from TWN were reportedly heard.

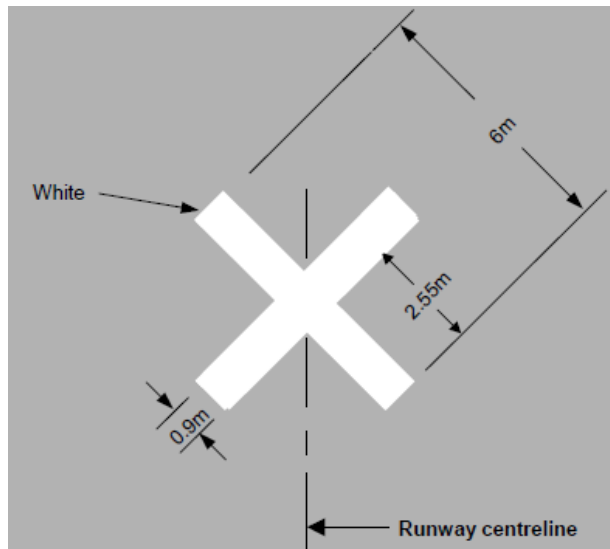
**Figure 2: A ‘smaller’ unserviceability marking**

According to MOS 139, the unserviceability marker used on runway 05/23 was considered a 'smaller' marking (Figure 2). These types of markings are to be displayed at each end of the unserviceability and in the intermediate area at intervals of no more than 200 m. The Aerodrome Manager reported that there was 10-11 unserviceability markers placed on the runway, with the first marker placed near the runway 23 number. Consequently, the spacing between each unserviceability marker was per the requirements of MOS 139.

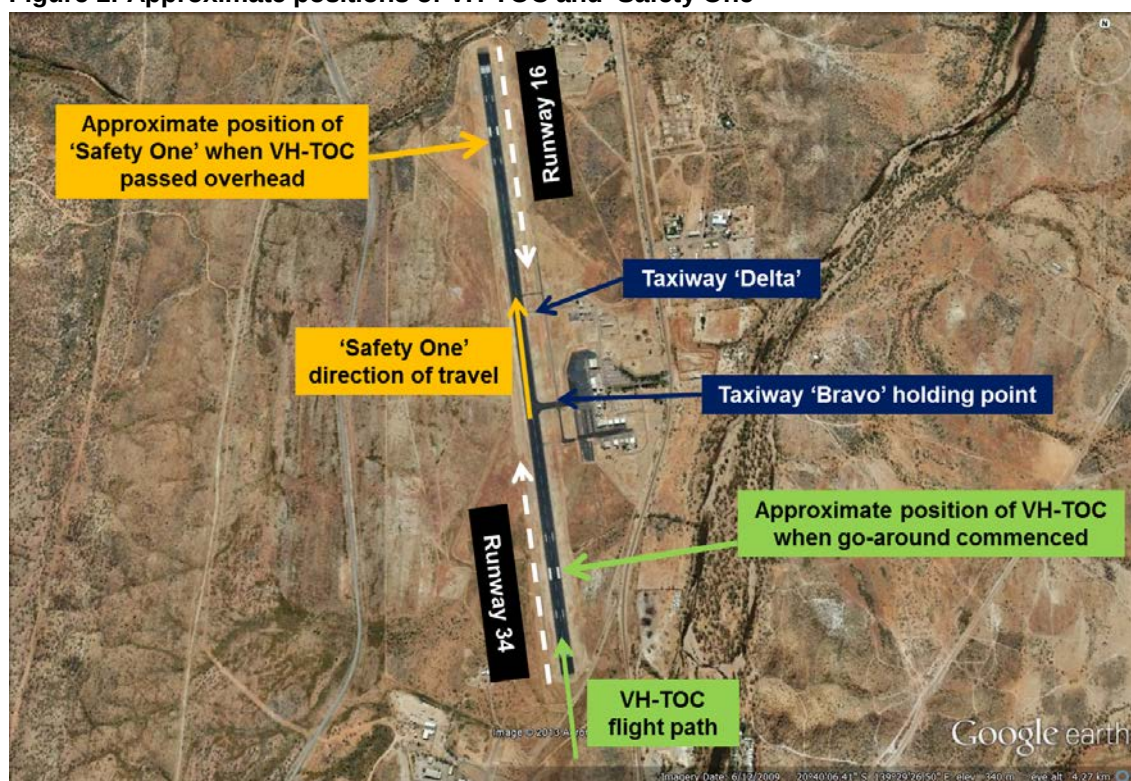
**Figure 1: Approximate positions of VH-TOC and 'Safety One'**

At about 1200 Eastern Standard Time,<sup>4</sup> the Mount Isa airport safety officer (ASO) was preparing to conduct a runway and lighting inspection in vehicle 'Safety One' in preparation for the arrival of a scheduled passenger flight at 1340. The ASO turned on the vehicle's radio and the primary and secondary lighting, which included a rotating flashing light mounted on the roof. The ASO then activated the pilot activated lighting (PAL)<sup>5</sup> and aerodrome frequency response unit (AFRU)<sup>6</sup> systems, and received a response from the AFRU indicating the correct radio frequency had been selected.
