Stevedore fatality on board the general cargo ship *Weaver Arrow*

at Newcastle, New South Wales | 23 September 2012

ATSB Transport Safety Report
Marine Occurrence Investigation
296-MO-2012-010
Final – 4 June 2013

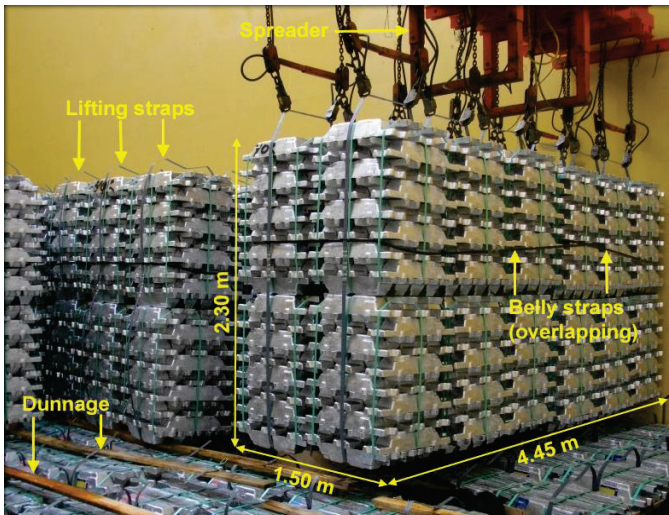
Figure 4: Ingot lifts stowed in cargo hold

Cargo loading continued throughout the night of 22-23 September. Ingots were stowed in the cargo holds in three athwartships rows of 15 lifts each (Figure 3). Once a full tier of ingots had been stowed, the stevedores arranged timber planks (dunnage) before stowing the next tier (Figure 4). To prevent the cargo from shifting during the sea passage, the spaces between rows were filled with inflatable rubber bags (airbags) by the ship's crew.
