# Aviation Short Investigation Bulletin

Issue 21

**ATSB Transport Safety Report**  
Aviation Short Investigations  
AB-2013-117  
Final – 7 August 2013

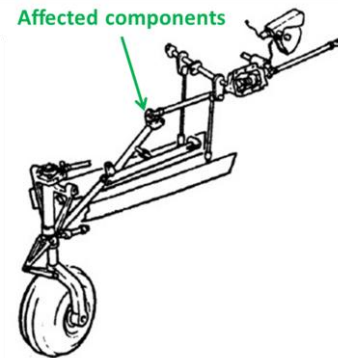
As the aircraft's main landing gear touched down, the copilot selected the fuel and mixture controls to off, while the PIC concurrently reduced the throttle settings to idle and turned the electrical system off. The aircraft's nose then lowered and slid along the runway. The aircraft came to a stop and the crew exited. As a precaution, the aircraft was covered with fire retardant foam, but no fire resulted. A video of the landing can be viewed at:
