Flight control system event involving Cessna 210N, VH-JHF

48 km West of Bourke Airport, New South Wales | 12 September 2011

ATSB Transport Safety Report
Aviation Occurrence Investigation
AO-2011-115
Final – 16 August 2013

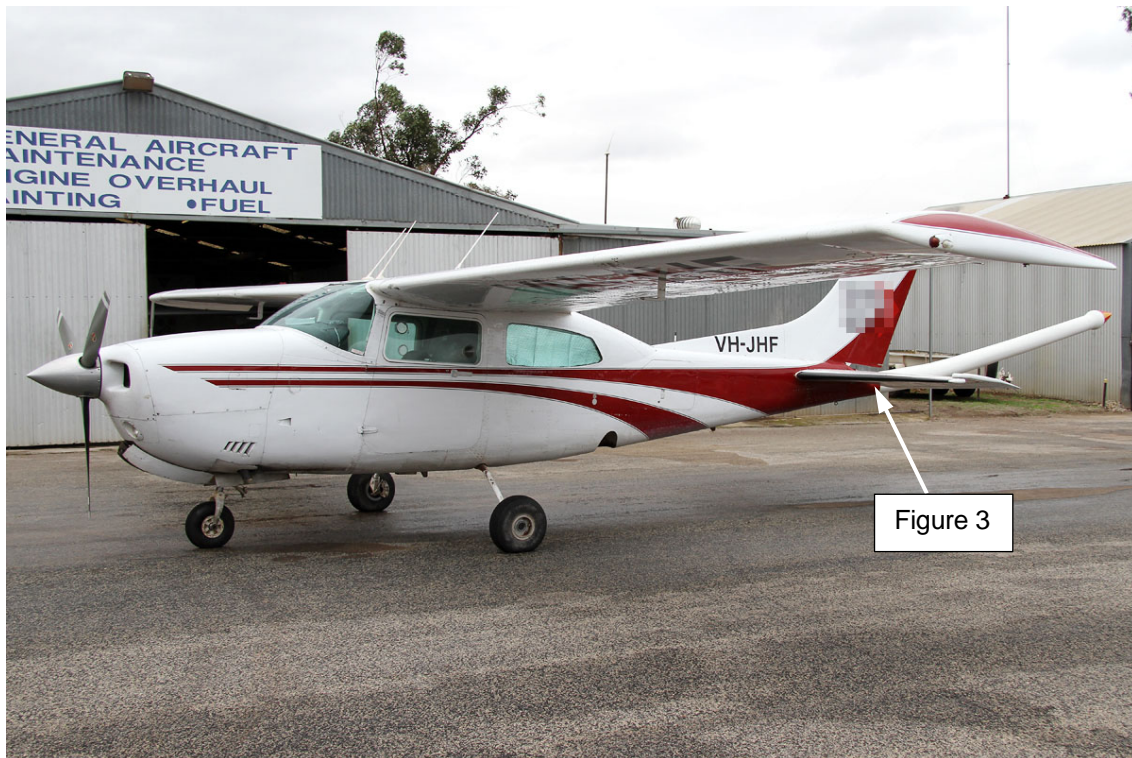
Figure 1: VH-JHF

On 12 September 2011 at about 1000 EST¹, the pilot of a Cessna 210N registered VH-JHF (Figure 1) was conducting low-level aerial survey operations near Bourke Aerodrome, New South Wales. While manoeuvring at an altitude of approximately 260 feet, the aircraft pitched down in response to a turbulence event, requiring the pilot to make an immediate corrective pitch-up control input. After this event, the pilot reported that the elevator felt partially jammed and that it was very difficult to make elevator inputs and difficult to maintain altitude.
