Derailment of train 7SP3

Roto, New South Wales | 4 March 2012

ATSB Transport Safety Report
Rail Occurrence Investigation
RO-2012-002
Final – 30 August 2013

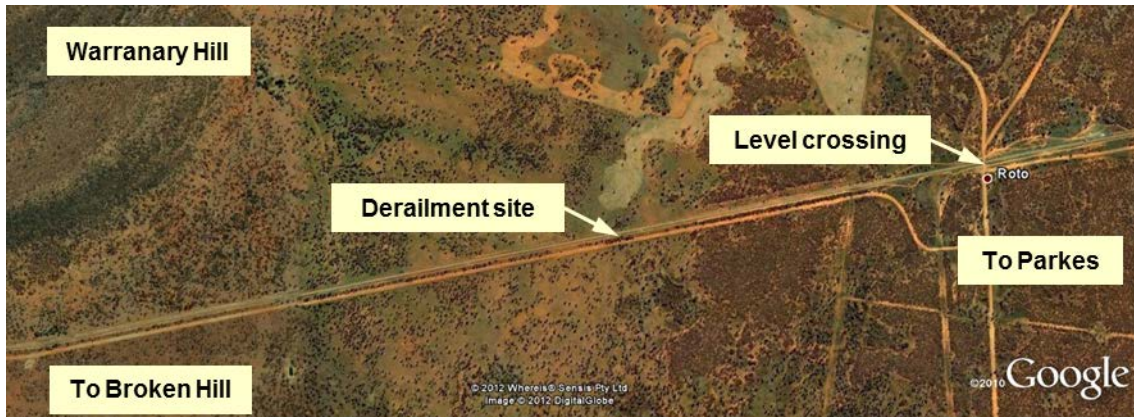
Figure 2: Derailment site west of Roto

As train 7SP3 approached Roto light rain had begun to fall; the intensity increased as the train passed through Roto. At about 0711, train 7SP3 traversed the level crossing located to the west of Roto (Figure 2). The train was travelling at approximately 93 km/h when the mentor driver observed 'white water' flowing over the track ahead and instructed the trainee driver to apply the train brake. The trainee driver made a normal operating mode brake application of around 70-kpa.
