**Australian Transport Safety Bureau**

AVIATION SAFETY INVESTIGATION REPORT

200302820

**Model R22 Mariner**

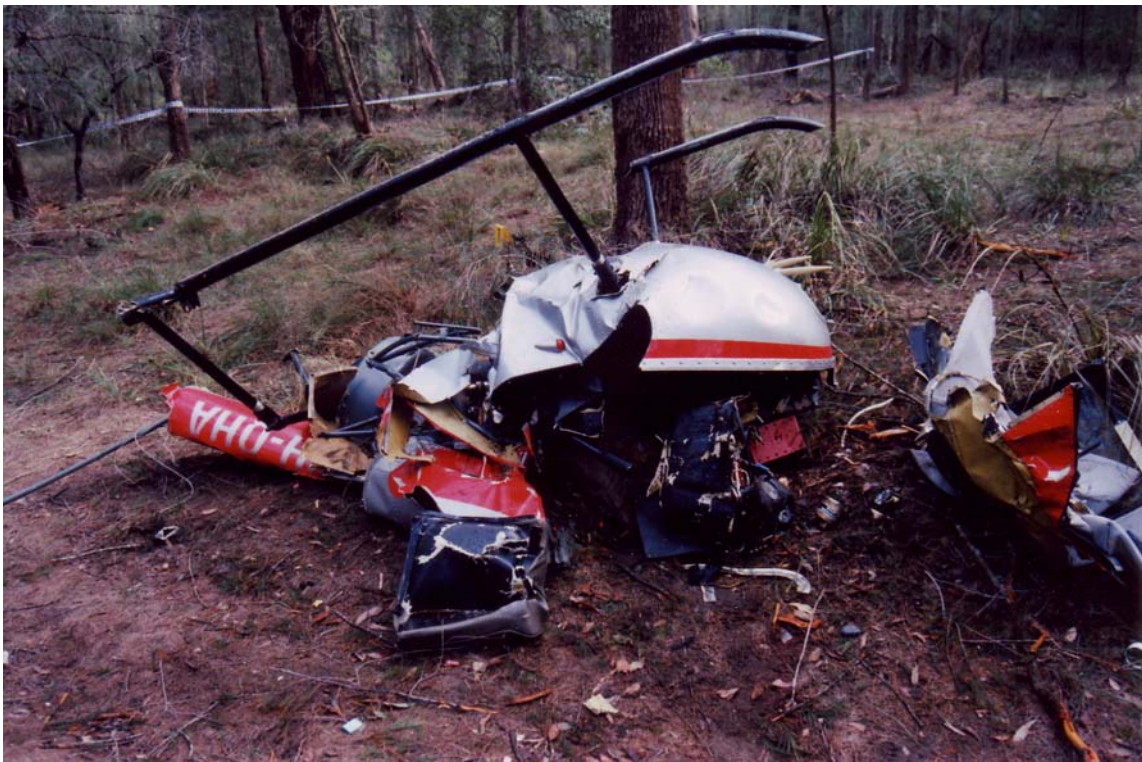
**Figure 1: Accident site**

The helicopter descended and impacted the ground in an inverted attitude. Both occupants were fatally injured (see Figure 1).

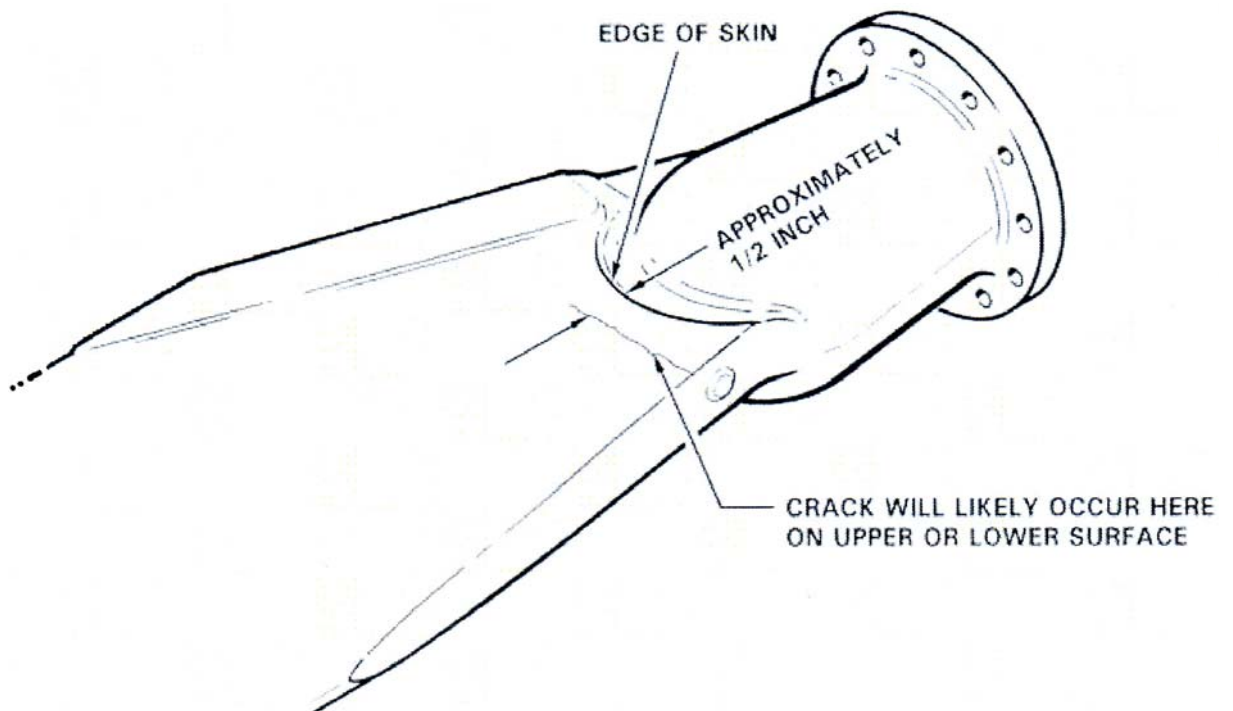
**Figure 3: Diagram included in Service Letter 53**

BACKGROUND: A main rotor blade fatigue failure could occur if the helicopter is repeatedly flown above its approved gross weight limit or operated above its approved manifold pressure limits. The first indication of a fatigue crack in progress may be a rotor that will not stay balanced after being adjusted. Another indication may be the appearance of a very fine hairline crack appearing in the areas shown in the figure below.

1. Visually examine both the upper and lower surface of each blade in the areas shown with a 10x magnifying glass.
2. If any indication of a crack is found, immediately ground the aircraft and return the suspect blade to the RHC factory for examination.

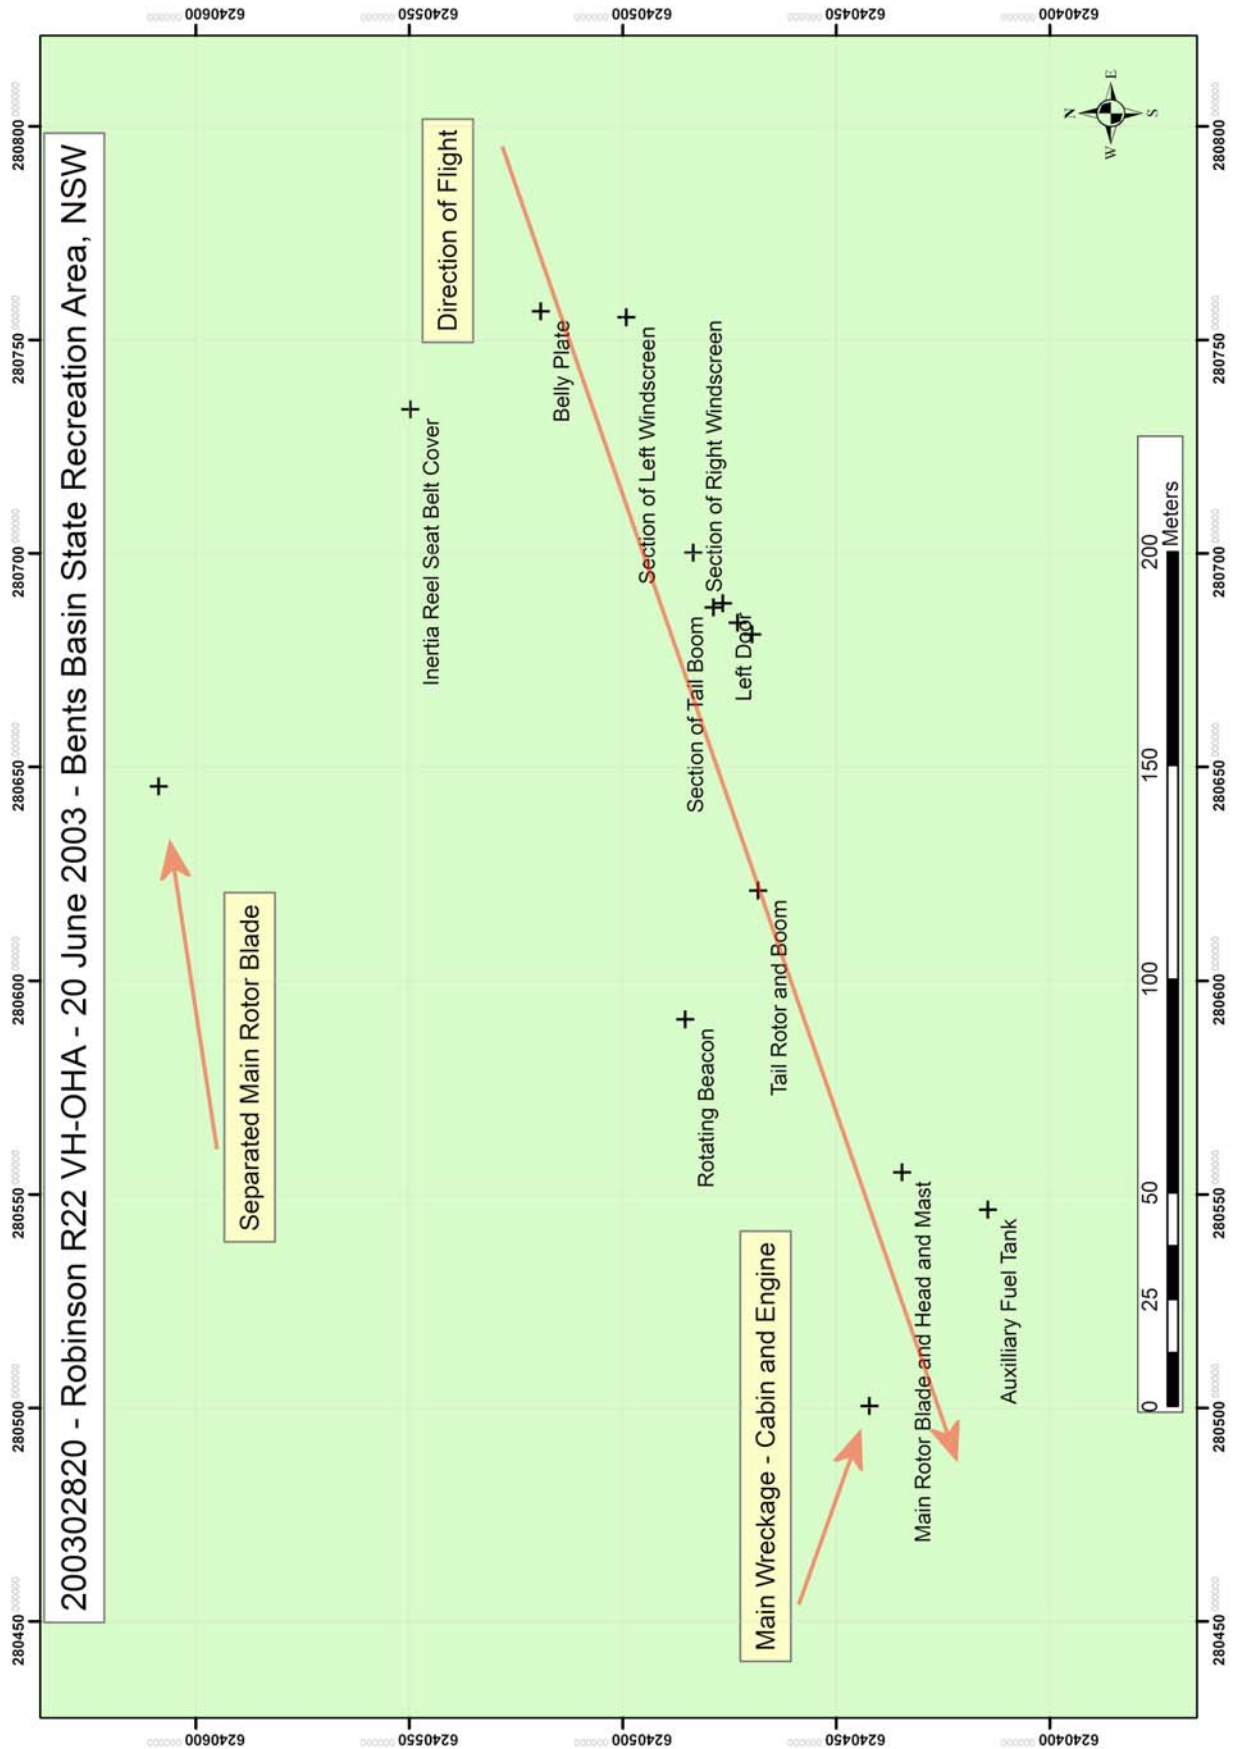
**Figure 4: Wreckage Map and Component Location**

The length of the complete wreckage trail was approximately 700 m, with the cabin and engine located in the most westerly section. The wreckage trail commenced with light paper items from the cockpit. The separated main rotor blade (blue blade) was located approximately 135 m north of the approximate wreckage trail centreline. The other main rotor blade (red blade), which remained attached to the main rotor head, was located approximately 55 m to the east of the main cabin and engine (see Figure 4). All of the components of the helicopter were identified and located within the wreckage trail.

Examination of the helicopter and engine at the accident site revealed no evidence to indicate that they were not capable of normal operation prior to the failure of the 'blue' main rotor blade.

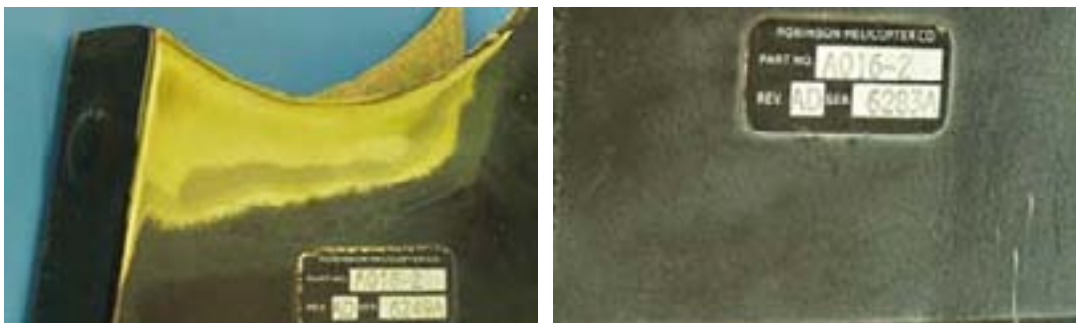
**Figure 3: Blade identification decals on the main rotor blades from VH-OHA**

Main rotor blades are identified by a part number and a serial number. These numbers are recorded on a decal attached to the lower blade surface near the blade root. The fractured blade was identified as p/n A016-2, rev. AD, s/n 6249A, see figure 3. The other main rotor blade fitted to the helicopter at the time of the accident was identified as p/n A016-2, rev. AD, s/n 6283A, see figure 3. The serial numbers of the blades were cross checked with the serial number engraved on a normally enclosed part of the blade structure.

a) fractured blade

b) intact blade

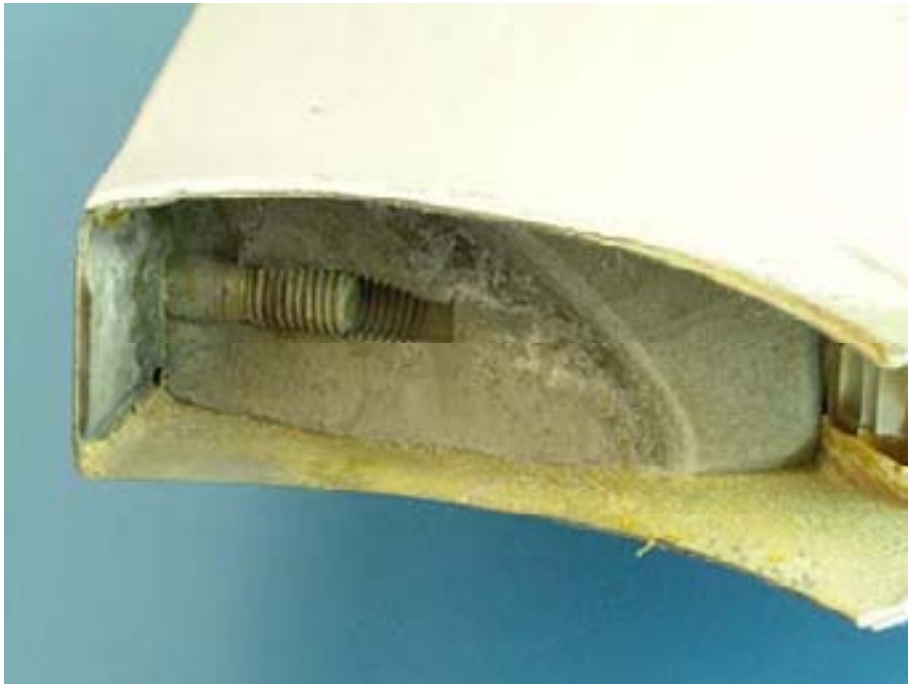
**Figure 5: Detailed views of the blade side of the fracture, as received**

The fracture surface features indicate that fracture occurred as a result of the progressive growth of a crack from the inboard bolthole. The mechanism of crack growth was established to be fatigue, that is, crack initiation and progressive crack extension in response to the development of a number of repeated localised alternating stresses during operation. The features of the fracture are shown in figures 4 and 5.

a) Looking down from the upper surface of the blade

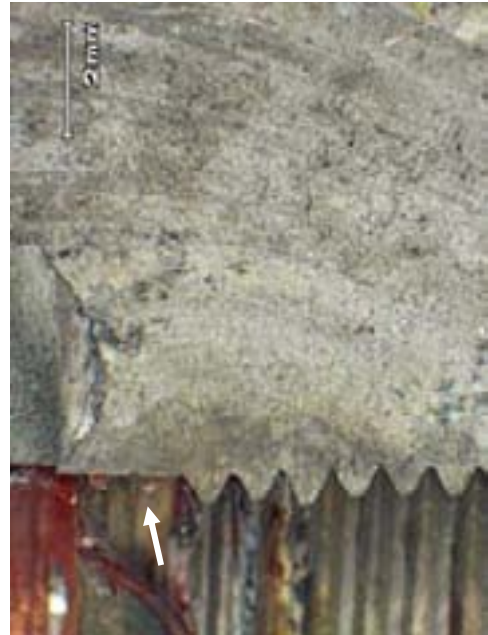
a) Third initiation site, crack growth from this site was influenced by the presence of the crack growing from second initiation site

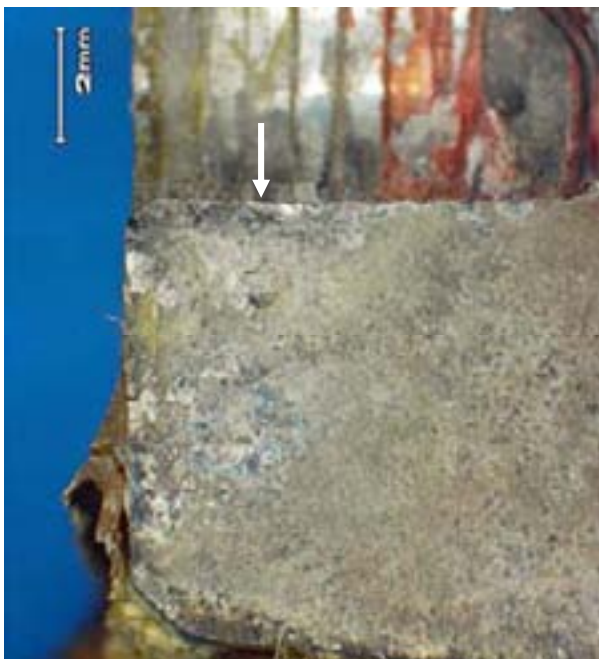
b) Second initiation site

Fatigue crack initiation was associated with localised corrosion. It was not associated with the remnant of the thread.

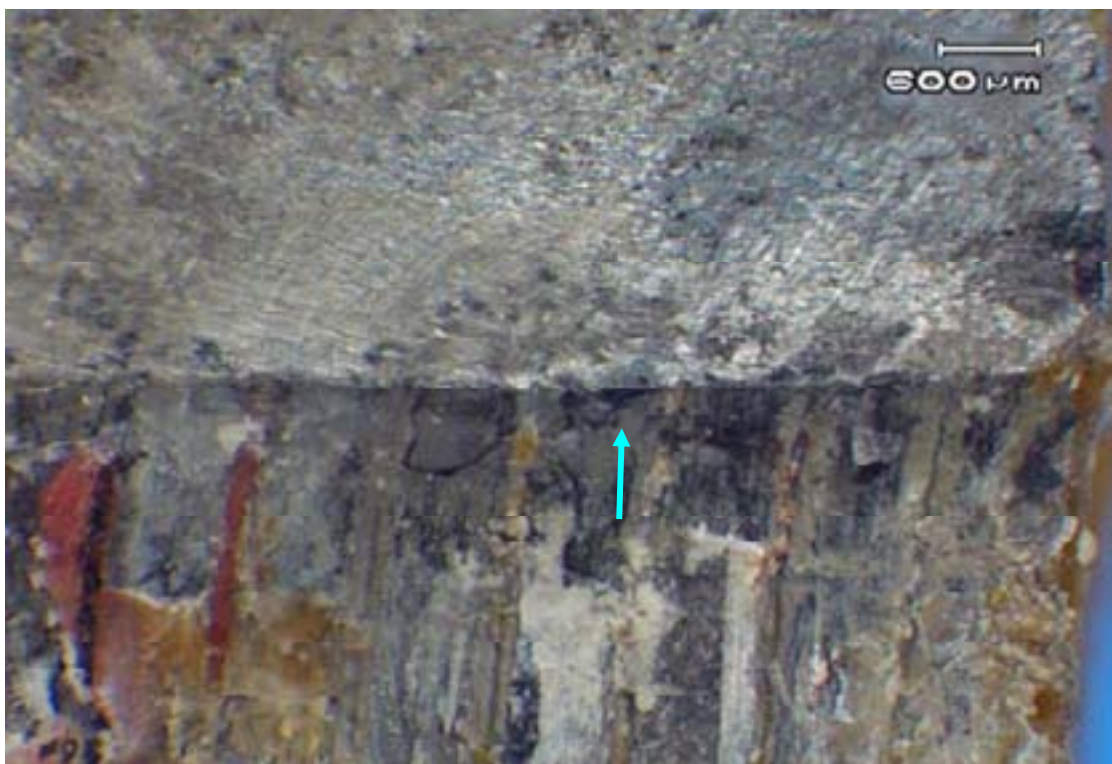
**Figure 9: Extended focus light microscope image of the first initiation site**

It is evident that moisture had penetrated the fatigue crack and reacted with the crack surfaces. Following removal of the bolt it was evident that localised corrosion had occurred in the counterbore, see figures 8 and 9.

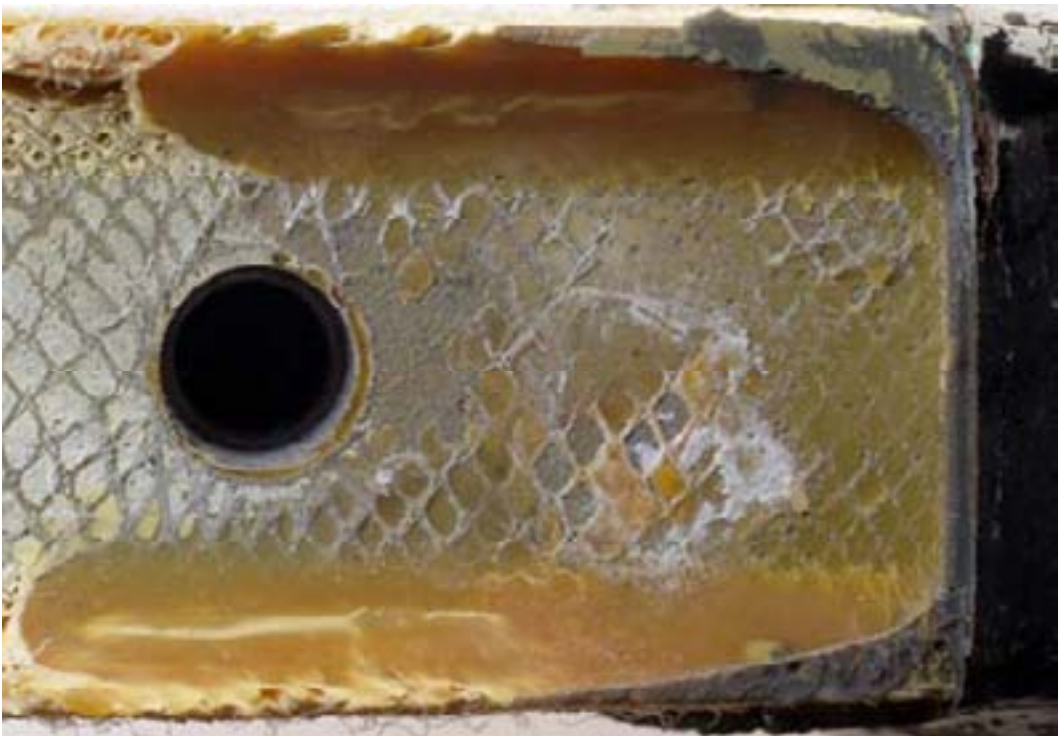
a) Disbonding has extended from the end of the spar to the edge of the inboard bolthole

b) Detailed view of the region between the inboard bolthole and spar end

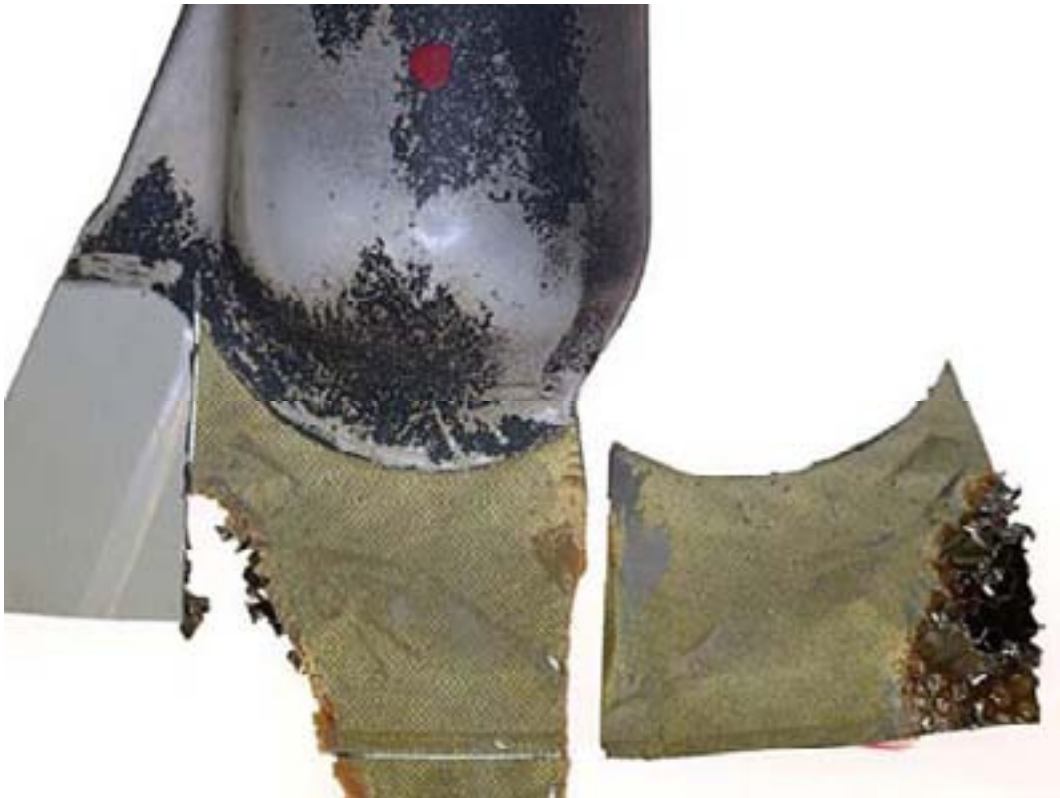
**Figure 15: The nature of the adhesive bond between the upper and lower blade skins, blade s/n 6283A**

b) Only a small region of adhesive disbonding was present, arrowed

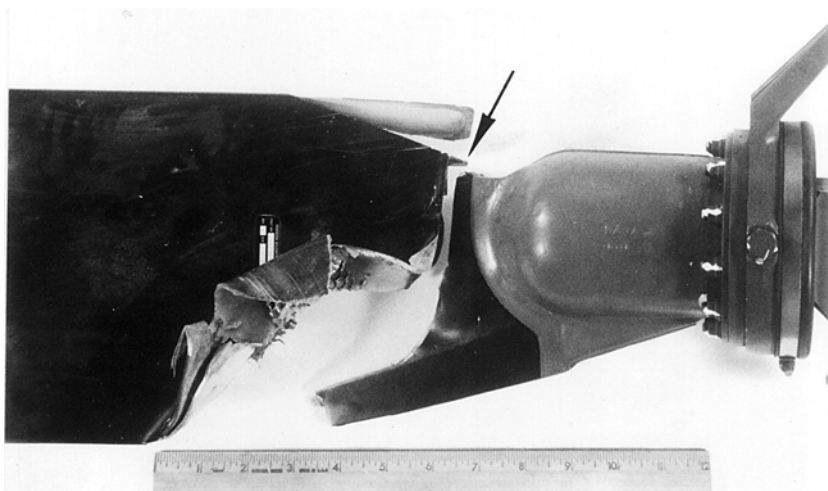
**Figure 21: Photographs from NTSB Metallurgist's Factual Report No. 82-32  
April 7, 1982**

a) Fracture location

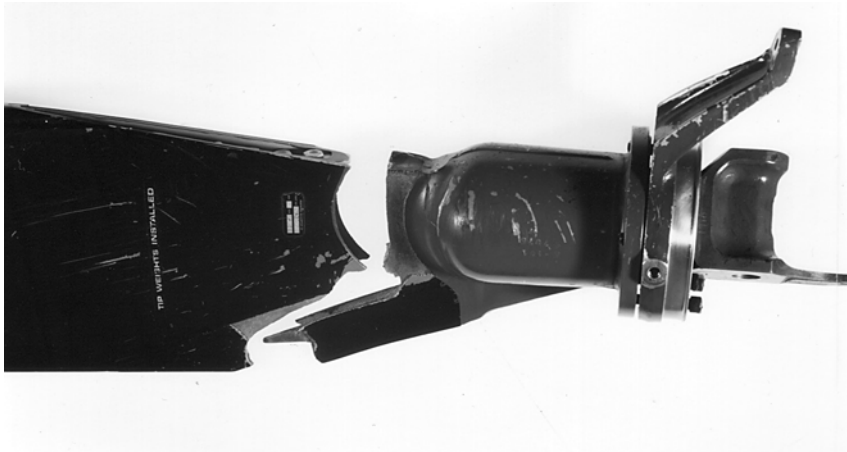
a) Fracture location

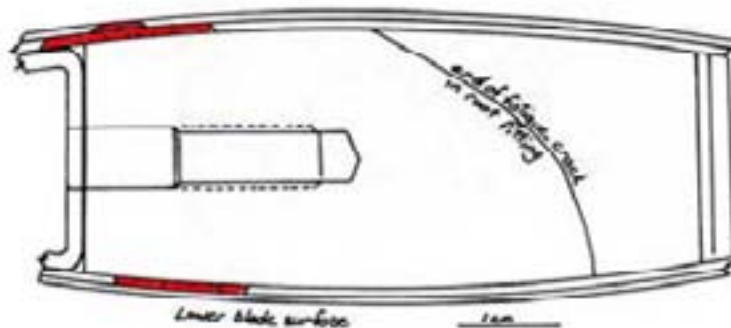
c) The regions coloured red show the extent of fatigue crack growth in the blades skins

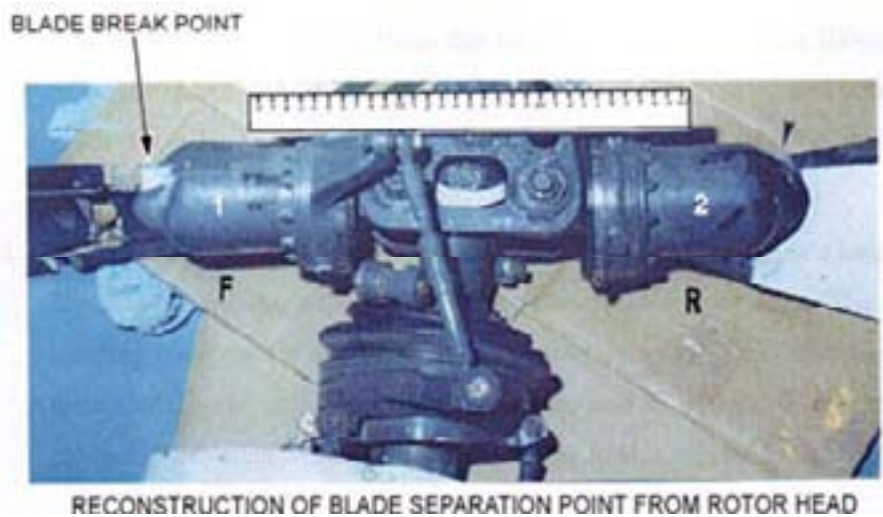
Fracture occurred during forward flight, power line survey.

a) Fracture location

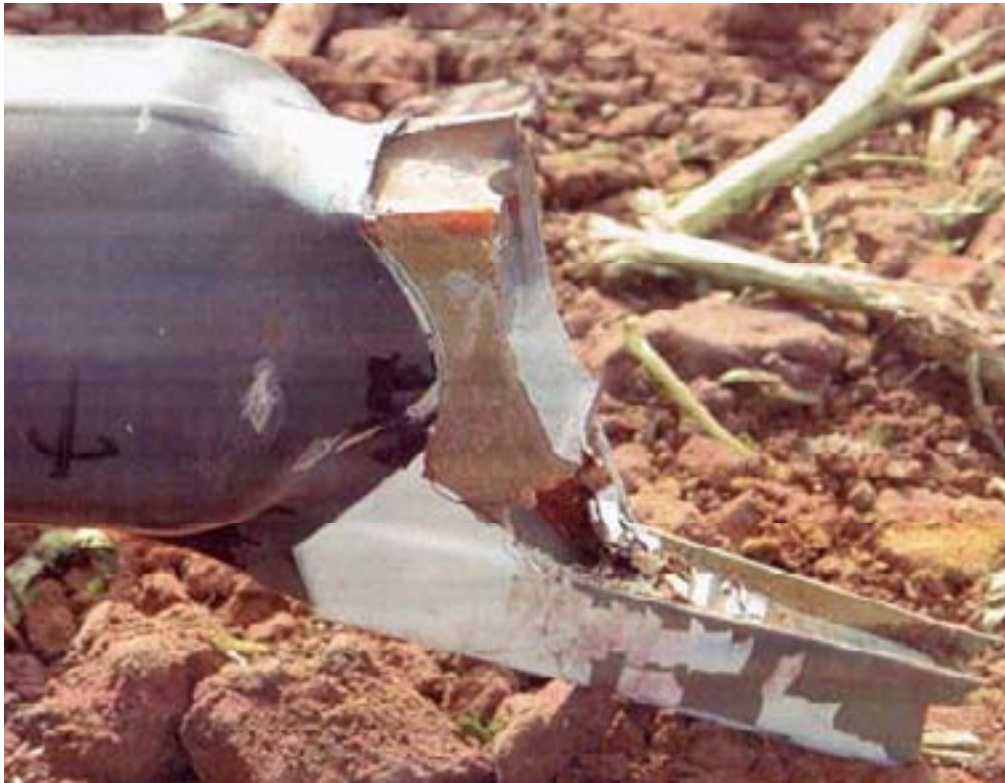
**Figure 25: continued**

c) The root fitting side of the fracture, as recovered

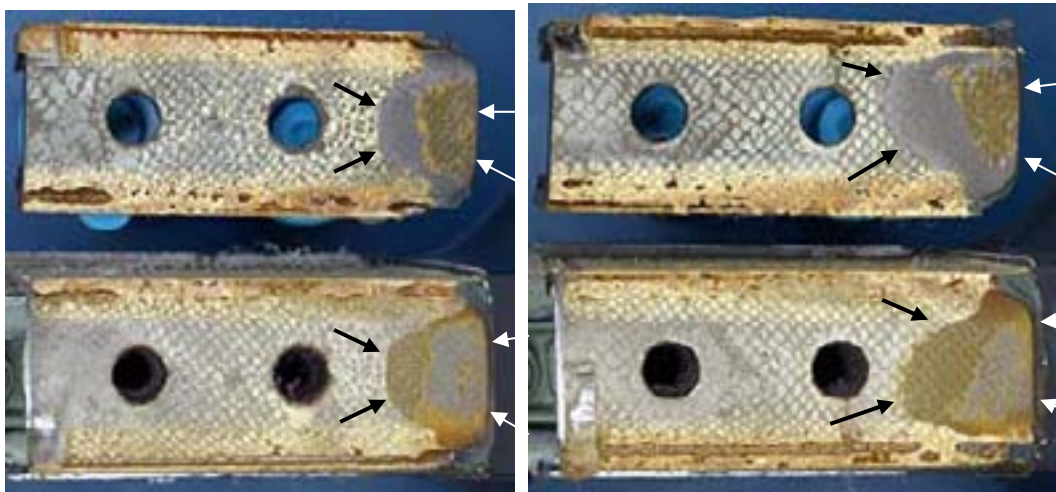
**Figure 31: The extent of disbonding between the root fitting and inboard end of the blade spar – helicopters used in cattle mustering operations**

a) VH-UXF, 12616B

VH-UXF, 12587B

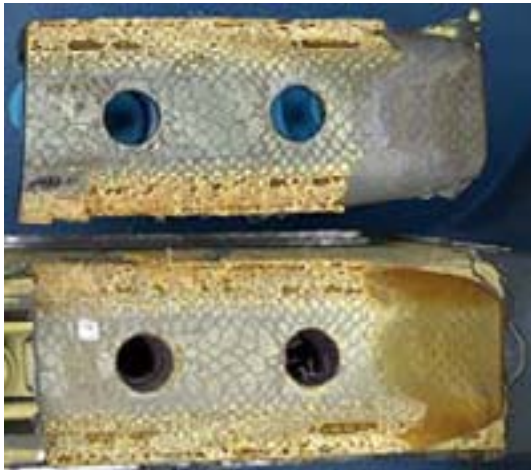
Regions of disbond are characterised by the darker, honey brown colour and regions where the metallic surface of the spar is exposed. Regions where the intact bond was fractured during the strip down process are characterised by a light cream colour and a rougher appearance. The cross-hatched appearance of the adhesive is an effect of the scrim cloth used to create the adhesive film. The regions of adhesive disbond are arrowed.

b) VH-LOT s/n 8411B  
approximately 1700 hours)

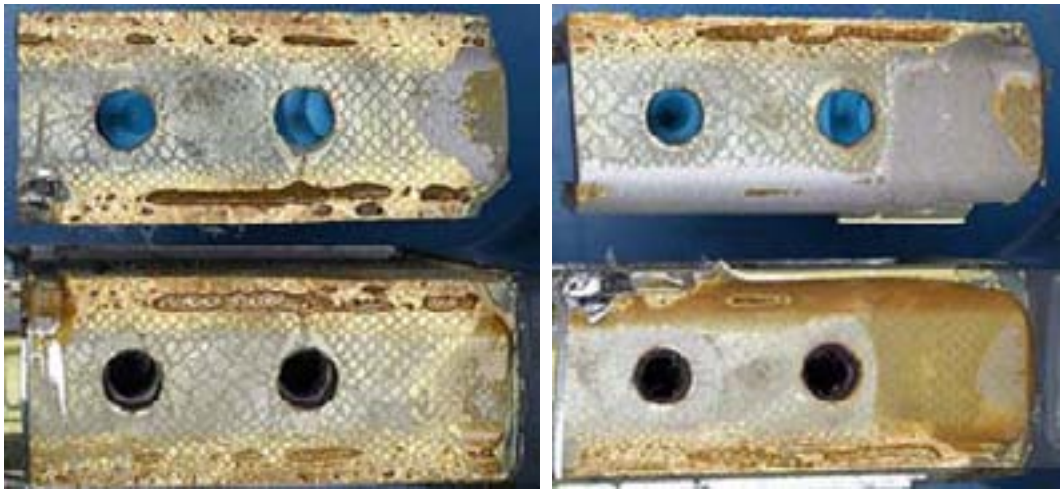
**Figure 32: The extent of disbonding between the root fitting and inboard end of the blade spar – helicopters not used in cattle mustering operations**

VH-HVX s/n74810 1693.4 hours TIS

VH-HCO, s/n 11277B, 203 hours TIS

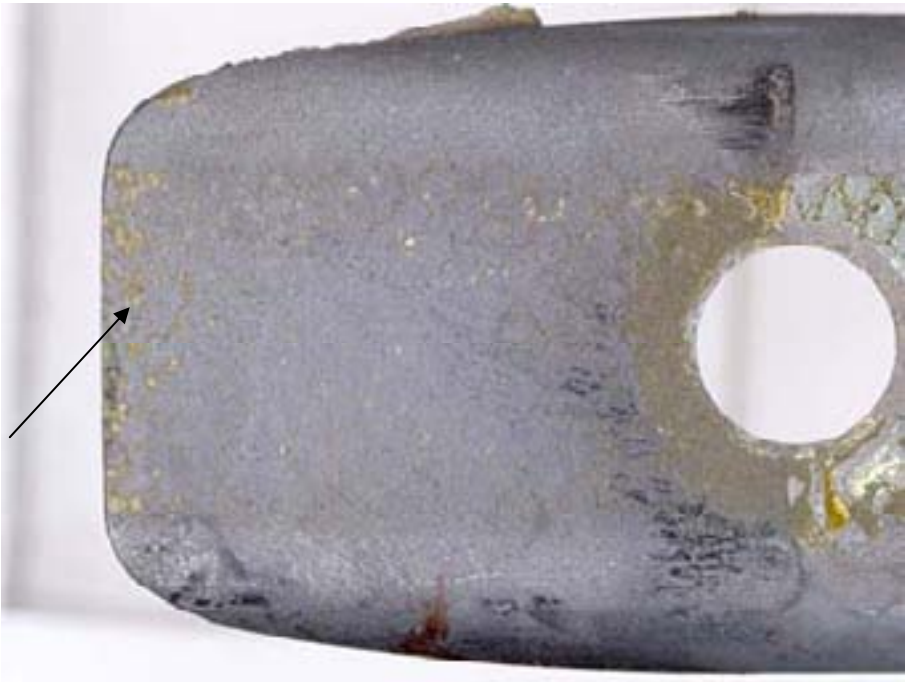
**Figure 36: The distribution of adhesive material bonded to the spar, VH-LDR**

a) VH-LDR fractured blade, adhesive bonded to the spar, at the spar end is arrowed

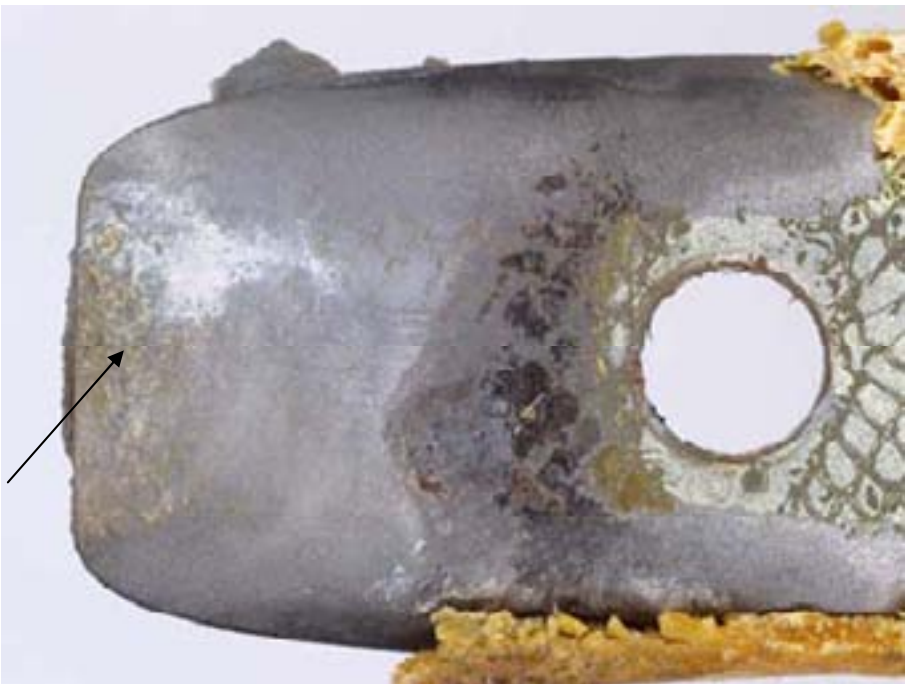
b) VH-LDR intact blade, adhesive bonded to the spar, at the spar end is arrowed

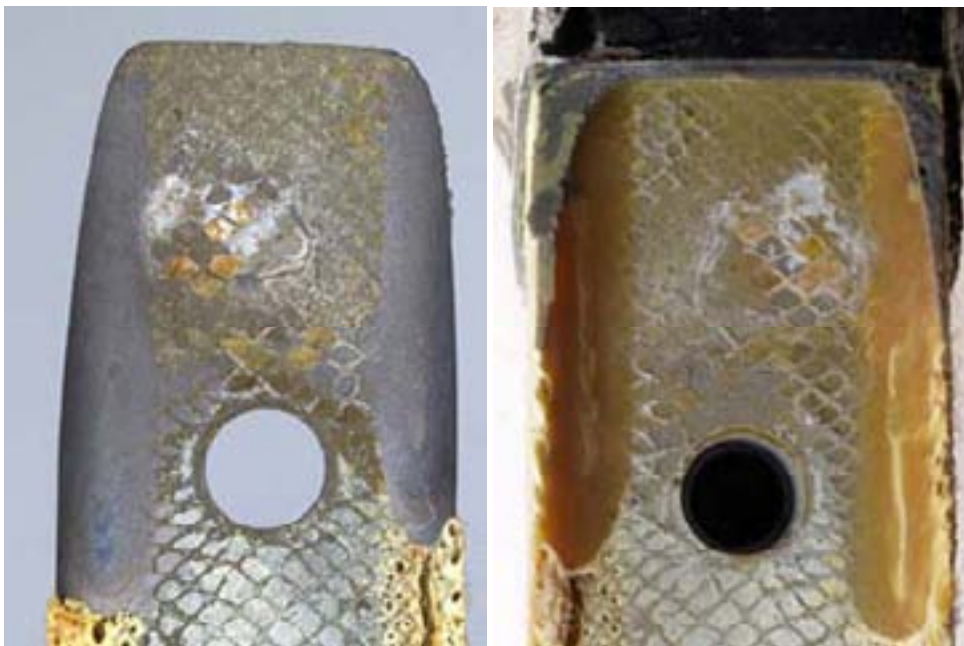
b) VH-OHA intact blade

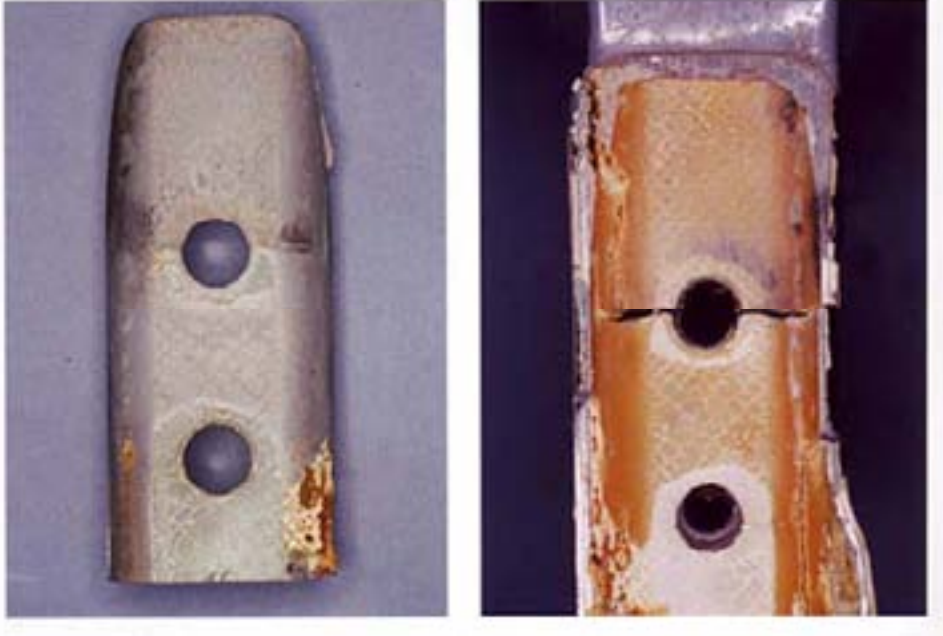
**Figure 42: Extent of spar/fitting disbonding, VH-LDR**

a) VH-LDR fractured blade

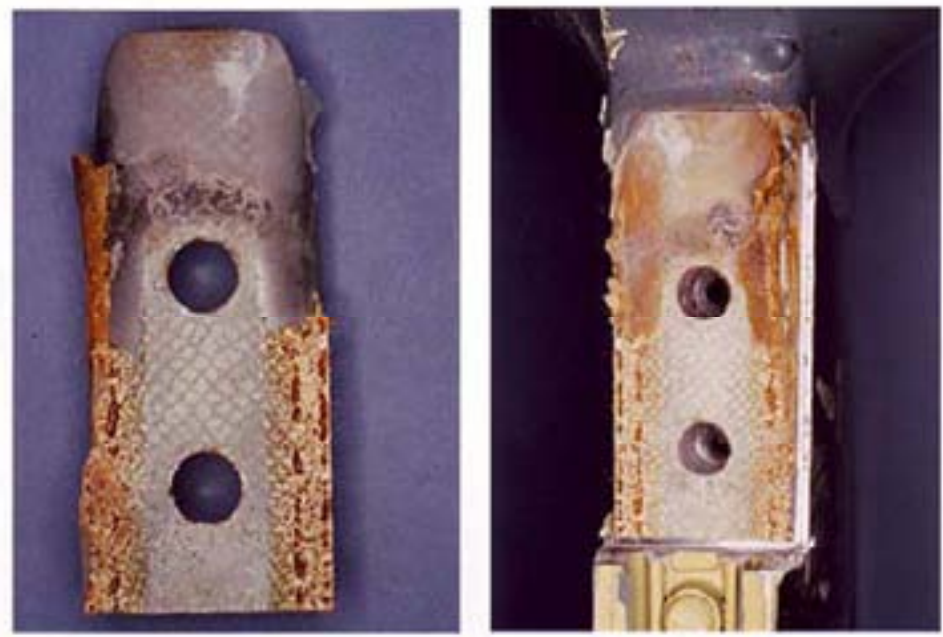
b) VH-LDR intact blade

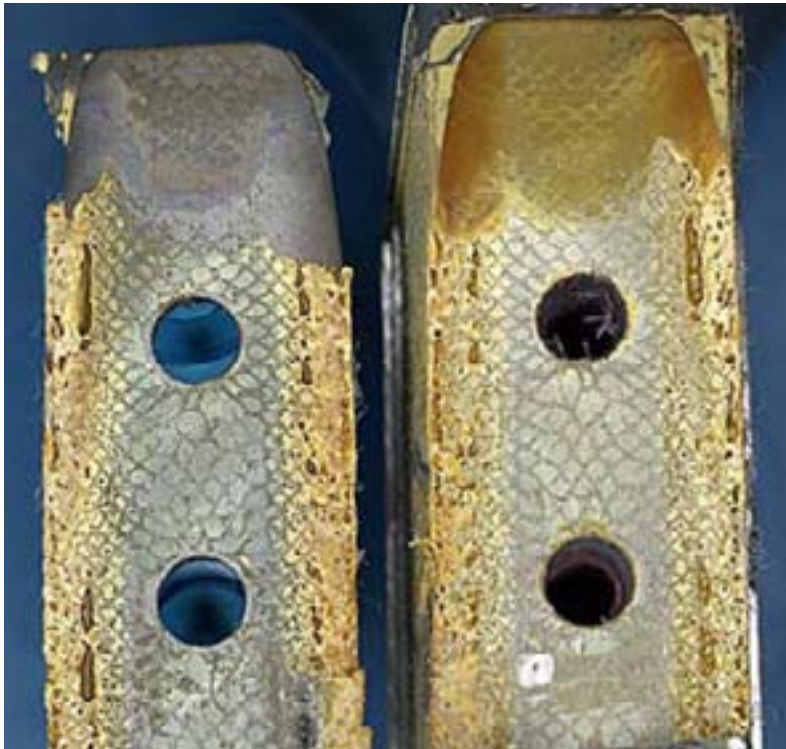
a) VH-LOT, s/n 8411B

The evidence obtained from examinations of blade pairs, that is, the two blades fitted to a helicopter and both of which are subjected to the same operating loads and environment, shows that there is a marked difference in the extent of disbonding. In each case of fatigue cracking and blade fracture, disbonding has extended to the bolthole. While in the case of the blade paired with the fractured blade; disbonding has not extended to the edge of the inboard bolthole. This behaviour is shown in figures 41 and 42, the blade pairs from VH-OHA and VH-LDR. In contrast, blade s/n 8414B from the pair of blades fitted to VH-LOT demonstrates that bonding around the inboard hole can be protected by the installed bolt despite extensive disbonding from the end of the spar and between the two boltholes, see figure 43.

**Figure 43: Extent of spar/fitting disbonding, VH-LOT**

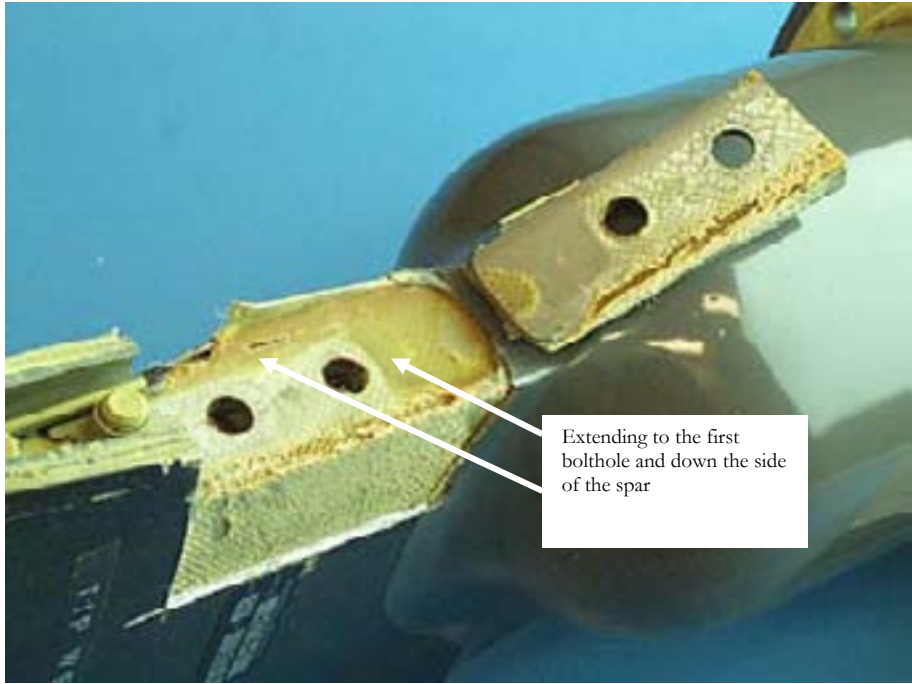
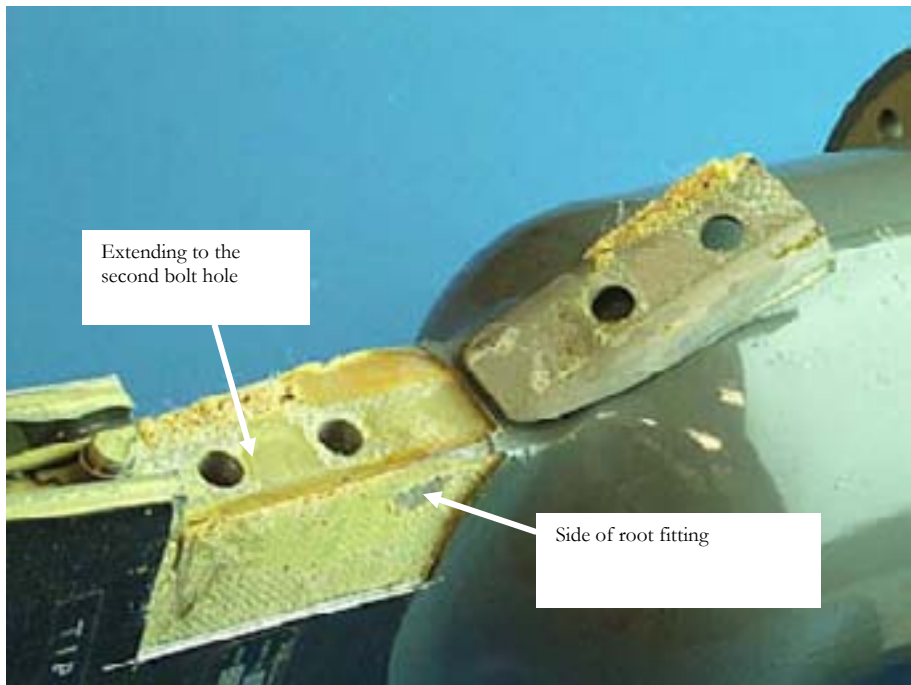
Figure 6. Examples of varying extents of adhesion failure (debonding)
