Derailment of freight train 331

Lowdina, Tasmania | 9 April 2013

ATSB Transport Safety Report
Rail Occurrence Investigation
RO-2013-012
Final – 15 October 2013

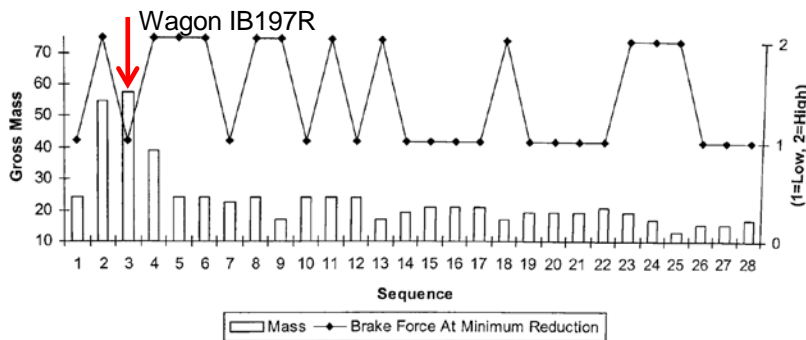
Figure 3: Consist mass distribution graph

The train was marshalled with loaded wagons predominating towards the front of the train and empty wagons towards the rear of the train (Figure 3). The line in Figure 3 represents the brake force for each wagon at minimum brake pipe reduction (brake application).

Based on the available evidence, train handling is not considered to be a contributing factor in this derailment. Furthermore, it is considered that any in-train forces that were the result of braking would have equalised before wagon IB197R travelled over the twist defect and, therefore, did not contribute to the incident.

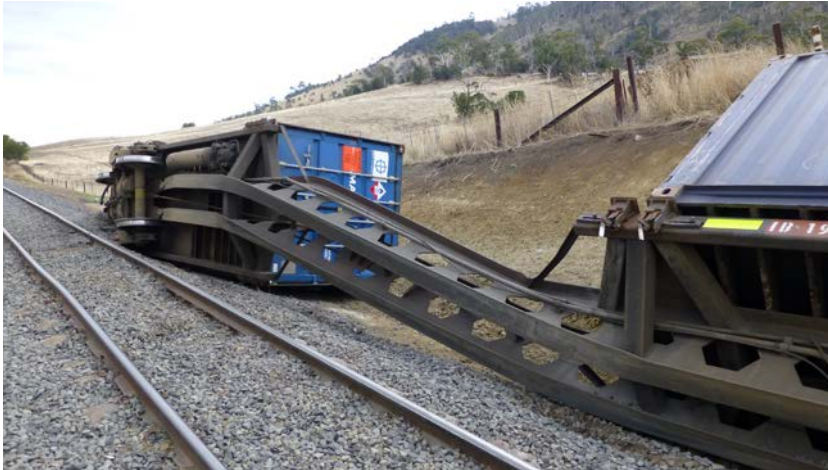
Figure 4: Wagon IB197R

Wagon IB197R was a skeletal beam wagon (Figure 4) capable of carrying the equivalent of three TEU⁶. The wagon was constructed in 1992 in New Zealand and consisted of the skeletal deck, three-piece bogies, gap type side bearers and a single stage braking system. The wagon was limited to carry up to 72 t gross.
