Collision of passenger train T842 with station platform

Cleveland, Queensland | 31 January 2013

ATSB Transport Safety Report

RO-2013-005

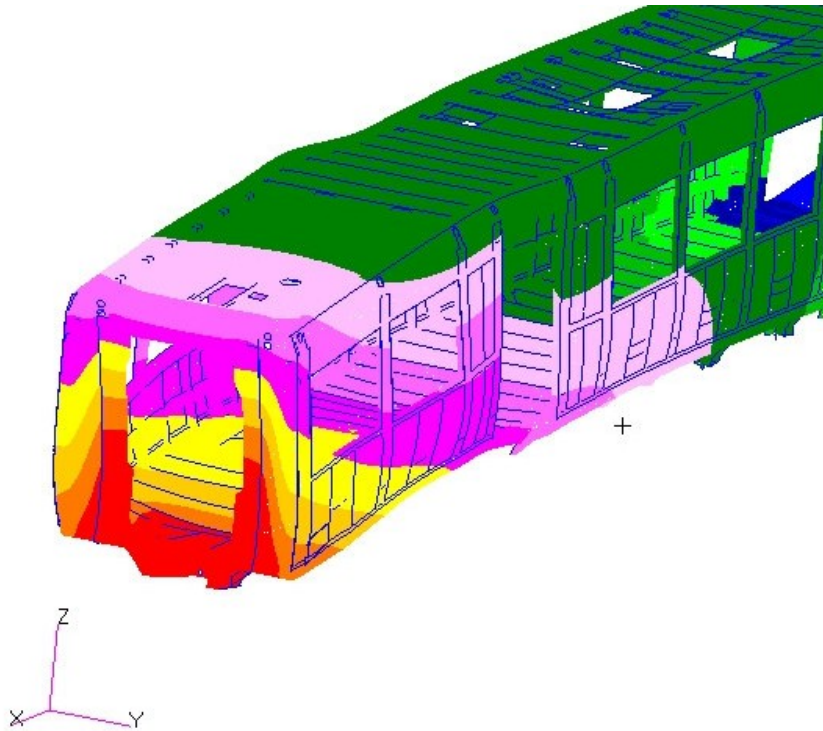
Figure 12: Finite element analysis of IMU160 and SMU260 class showing stress concentration levels of the car body resulting from a frontal collision load of 2600 kN at floor level. (Maximum longitudinal car body deflection = 21.9 mm at end wall)

During the collision at Cleveland, the leading car's coupler impacted the buffer stop which transferred the longitudinal load through the headstock¹⁸ primarily at the floor level of the train. The maximum ultimate loads tested during the FEA modelling were set at 260 MPa where all regions of stress would exceed the critical design threshold. This stress level is the minimum allowable for all car body structural materials under ultimate loads. The following examples of FEA models show the concentrations of stress at collision loads of 2600 kN at the leading portion of the car body (Figure 12), the driver cab frame (Figure 13)and headstock (Figure 14).

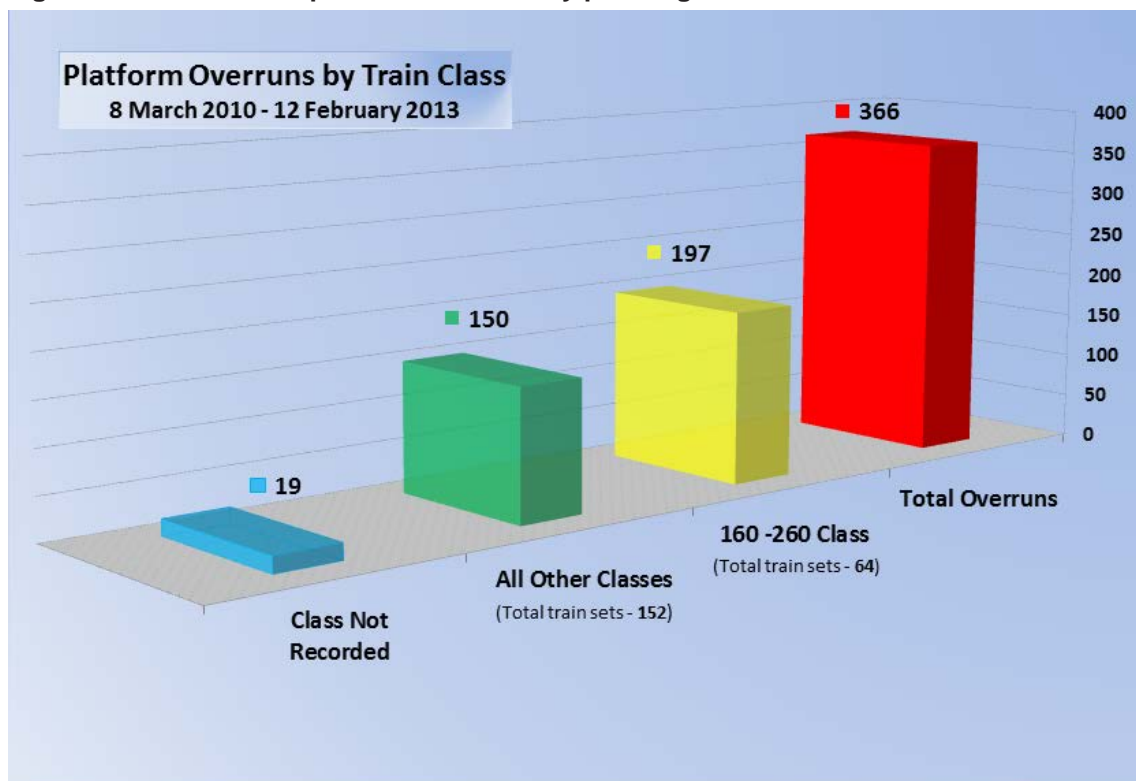
Figure 16: Train station platform overruns by passenger train class

Queensland Rail’s Citytrain Information Reporting System (CIRS) occurrence data for the period 8 March 2010 to 12 February 2013 was reviewed to assess the volume and frequency of trains that had been reported by drivers for overrunning station platforms. The data was filtered to separate IMU160 and SMU260 class trains and this information was compared to all remaining train classes operating on the Citytrain network (Figure 16). A small quantity of data (about 5 per cent) did not contain sufficient information to determine the train class and these trains were shown as ‘Class not recorded’. The data shows that a disproportionately higher number of the IMU160 and SMU260 class trains were involved in overrun occurrences, particularly considering that these trains only comprise 30 per cent of the fleet.

The remaining 70 per cent of the Citytrain fleet, mostly comprising tread braked and a combination of tread and disc braked train sets, were found to be involved in significantly less overruns.

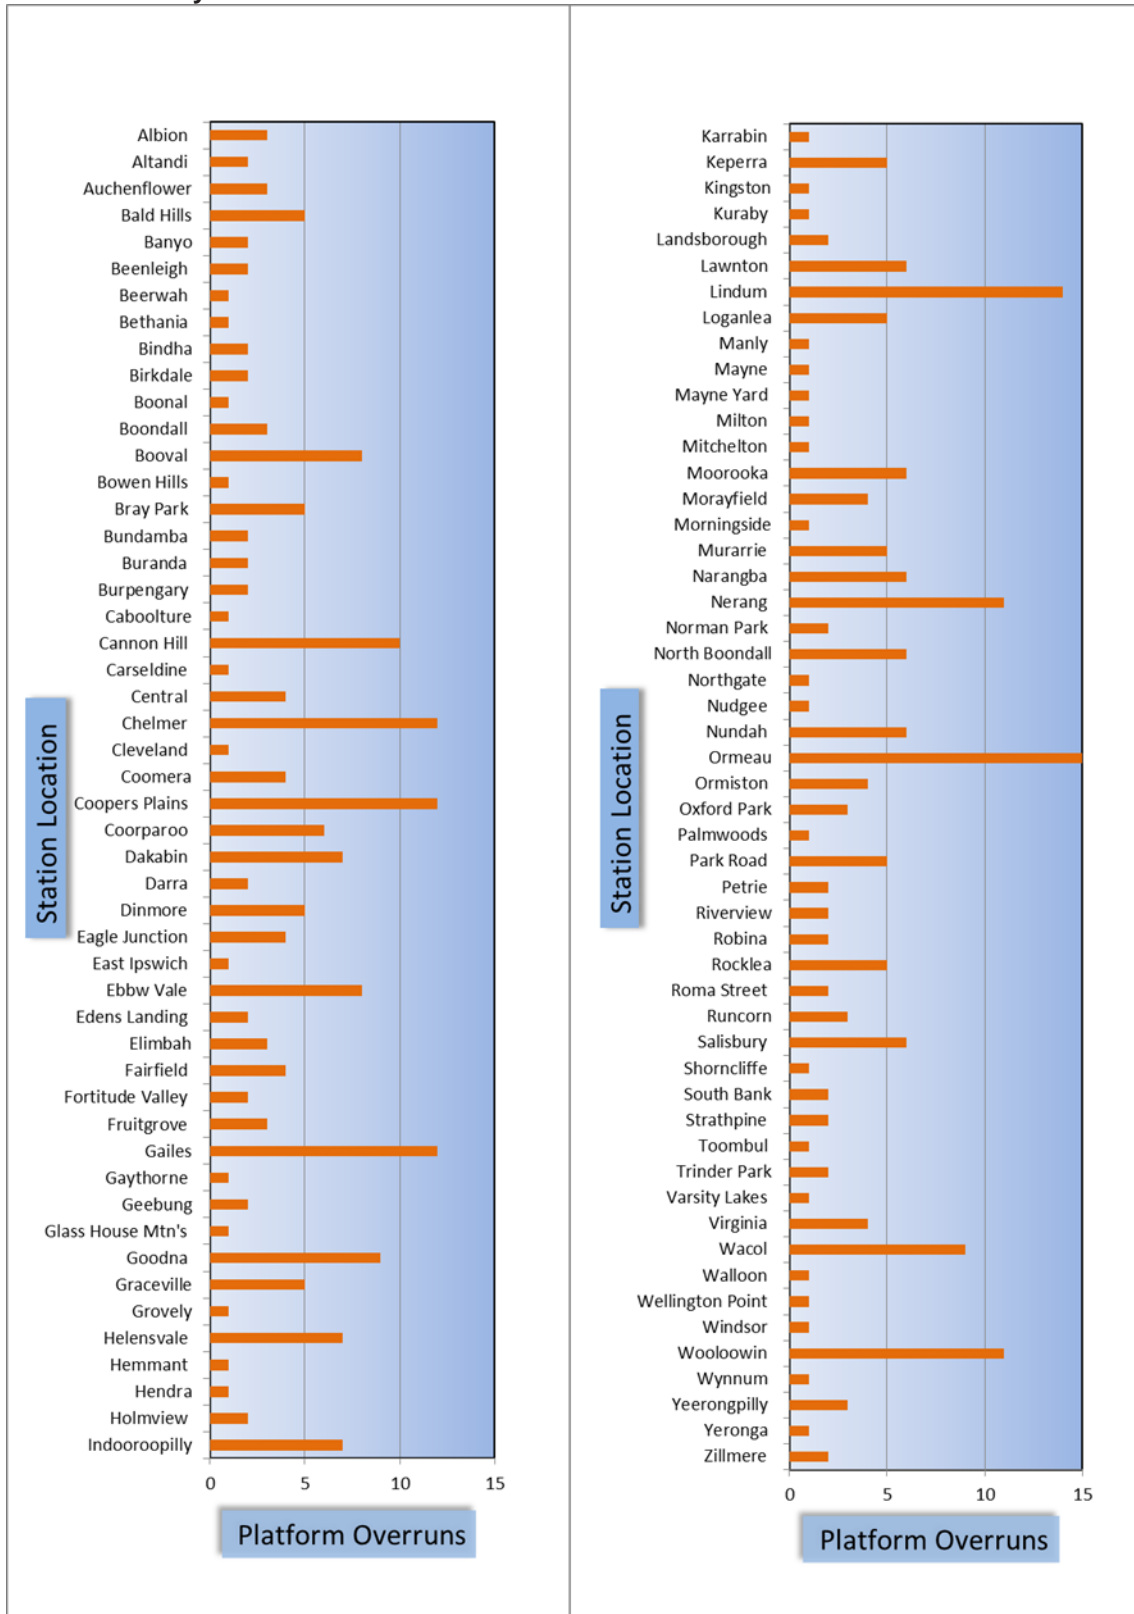
Figure 17: All passenger train overruns at station platforms (alphabetical order) March 2010 to January 2013

Between 8 March 2010 to 1 January 2013, 366 platform overrun reports were recorded throughout the Queensland Rail Citytrain network (Figure 17). These reports included all suburban passenger multiple unit types and 197 of these occurrences involved IMU160 and SMU260 class vehicles fitted with wheel slip-slide control systems.

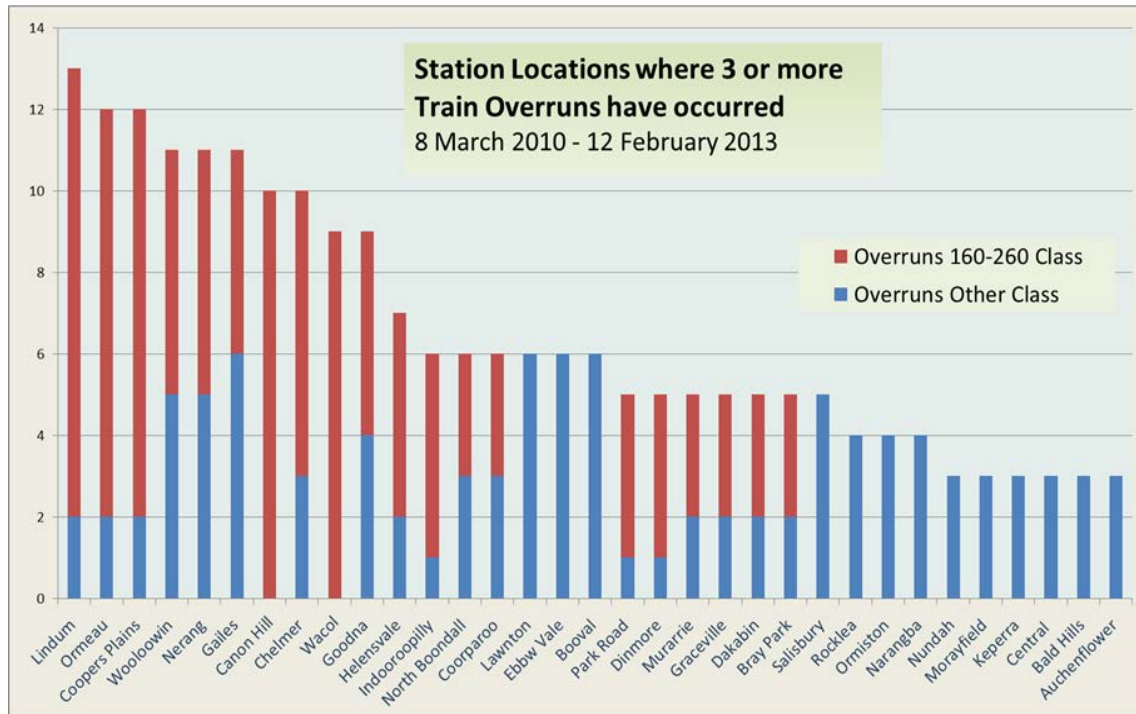
Figure 18: Incidence of passenger train overruns by station location

An assessment of overrun data was made to discover if particular train types had a higher incidence of slide occurrences when stopping at railway stations and whether individual locations showed a higher number of occurrences (Figure 18) for trains that were predominantly fitted with disc or tread brakes. The overrun occurrences involving the IMU160 and SMU260 classes were compared with the other train classes in the Queensland Rail Citytrain fleet for the period 8 March 2010 to 12 February 2013.

The findings exclude station locations where there were less than three train overrun occurrences and trains where the class type was not identified.

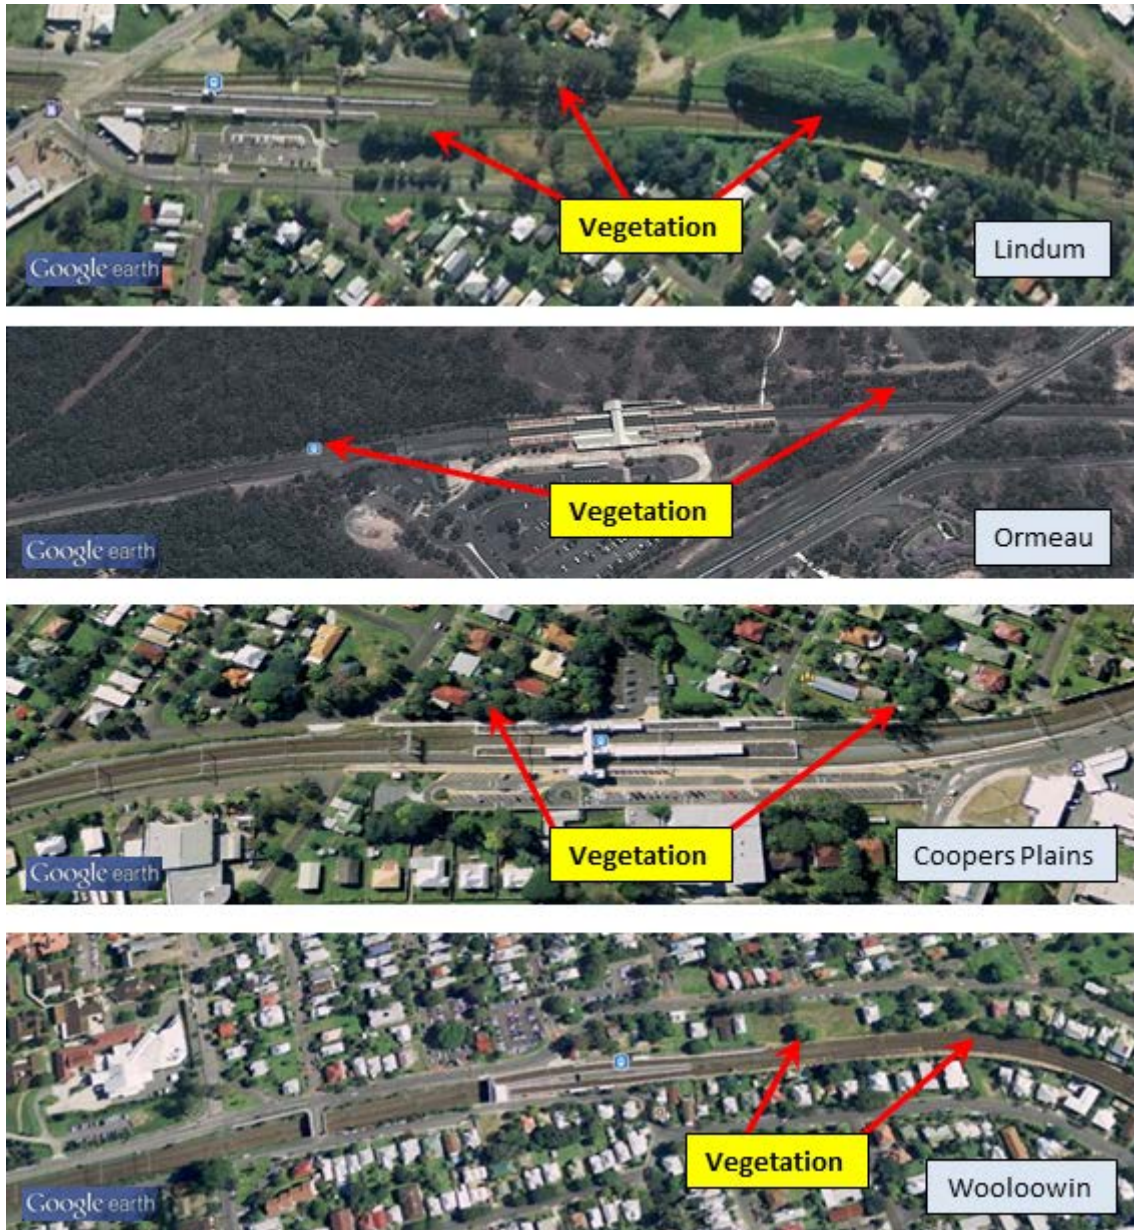
Figure 19: Railway station locations recording a high incidence of train overruns where trackside vegetation on the approaches was identified.

Typically, the top 10 locations where trains had overrun station platforms were found to have vegetation growing next to, or overhanging the railway corridor, and were within the train braking zones on the approach to these stations. Figure 19 shows the topography either side of railway stations recording the greatest number of overruns for the period.

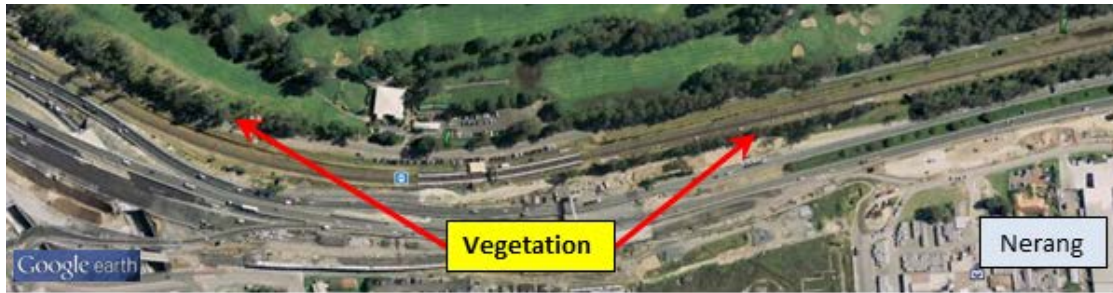
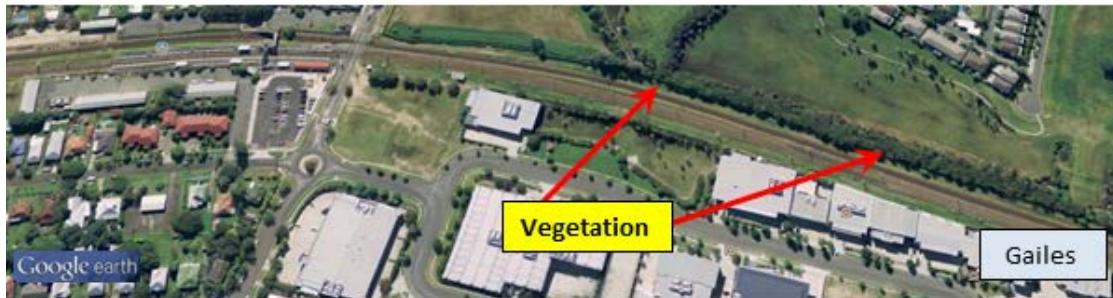
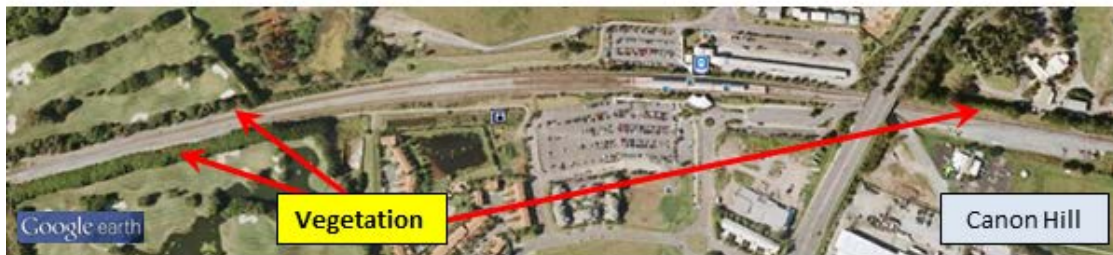
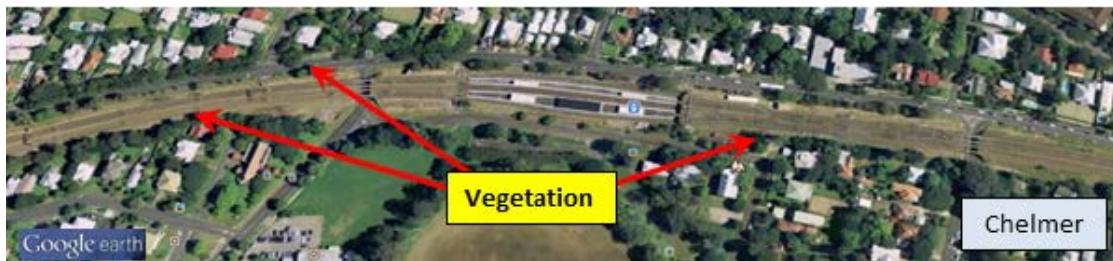
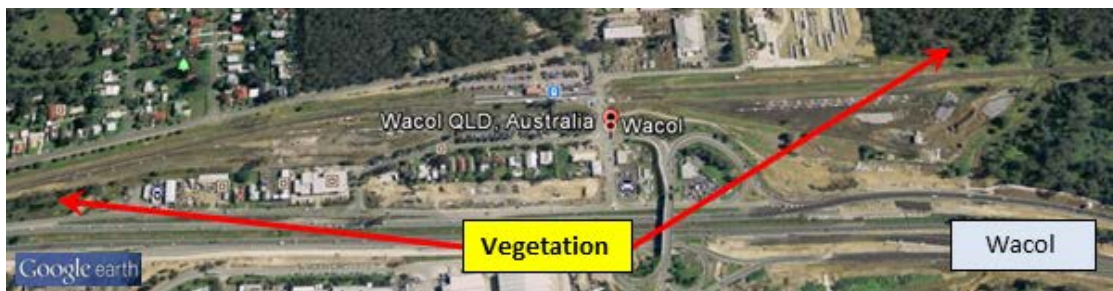
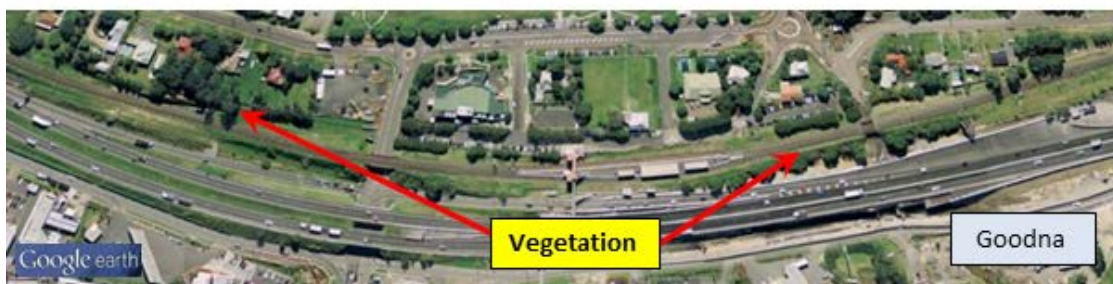
Figure 20: Railway station locations recording a high incidence of train overruns where trackside vegetation on the approaches was identified.

The results showed the IMU160 and SMU260 class trains had higher incidence of station overruns at Lindum, Ormeau, Coopers Plains, Canon Hill and Wacol. Most locations included overruns by the other classes of trains except Canon Hill and Wacol where the IMU160 and SMU260 classes were solely represented. The remaining 23 station locations that recorded a lower number of overrun events with other classes included 13 stations that did not have the IMU160 and SMU260 class represented. Where there were three or more overrun occurrences recorded at these railway stations for this period, 163 involved the IMU160 and SMU260 class and 101 were by the other train classes.

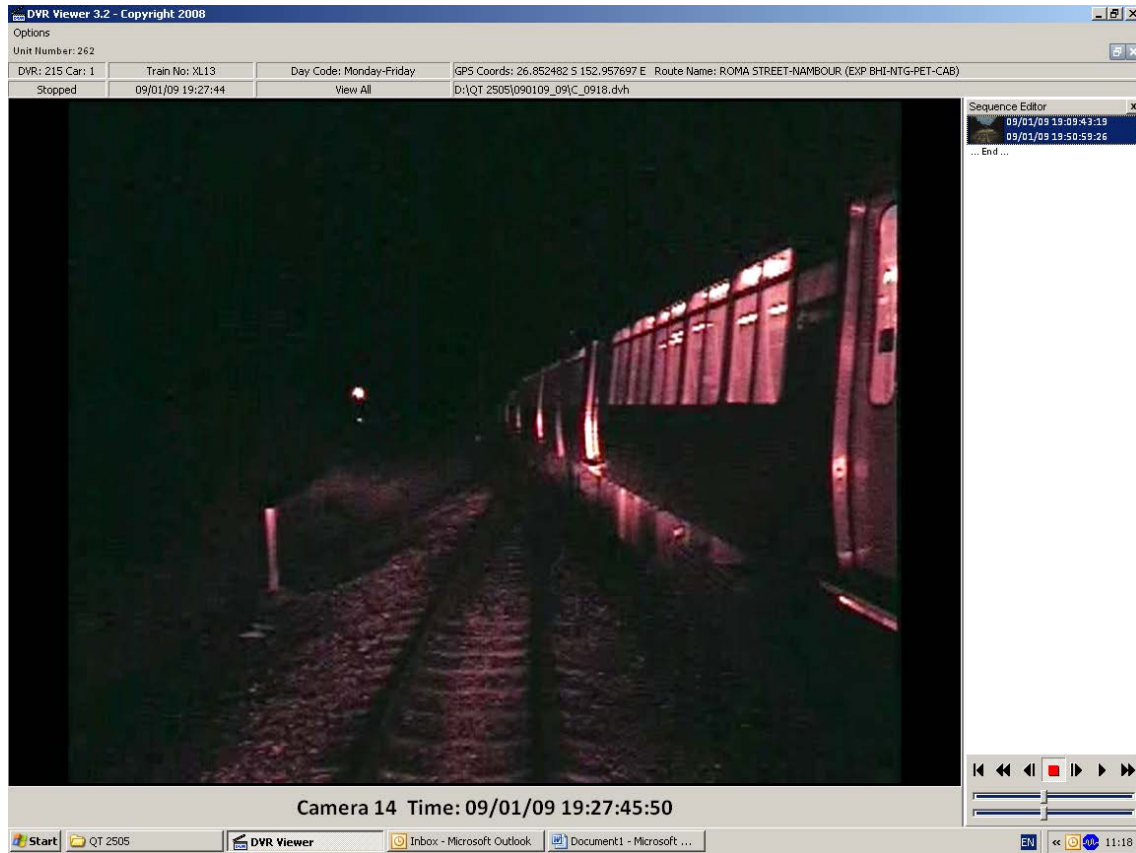
Figure 21: Video image from the leading camera on train 1L13 showing opposing train 1990 on the adjacent track, 30 seconds after both trains stopped.

The Passenger Services and Rolling stock Assets division subsequently extracted train event and brake control unit data and video imagery before carrying out inspections and static tests in the workshop. A series of still images were captured from the leading camera on train 1L13 and analysed. These images provided the sequence of events for train 1L13, as it approached and then passed signal BH23, view of the headlights of opposing and approaching train 1990 and when both trains had come to a stop about 35 m from the point of conflict (Figure 21).

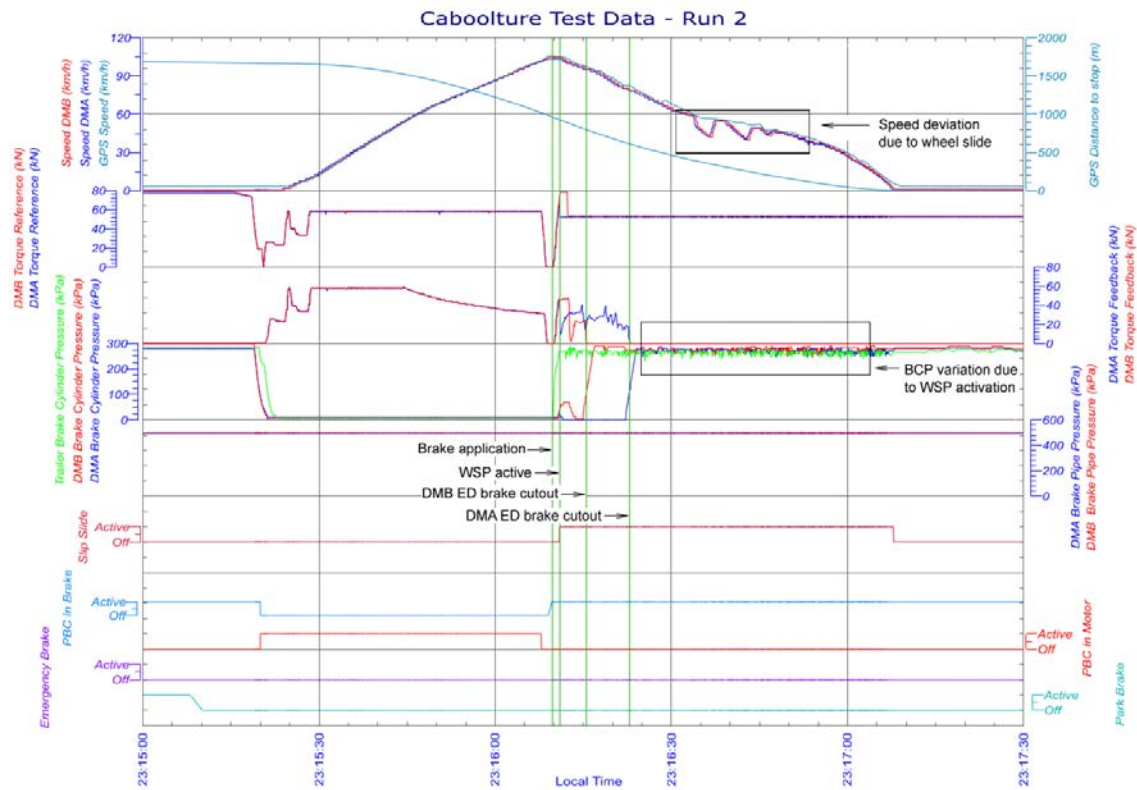
Figure 23: IMU186 brake test 2 - Caboolture - 19 February 2013

T-Car BCP increased as the friction brakes progressively applied. About 1 s after the initial brake application, the slide parameter (WSP) activated and remained in this condition for 56.8 s until the train had slowed to 2 km/h. When assessed with identical nominal speeds used in Test 1, the deceleration rate was calculated to be 0.476 m/s² (Figure 23) again failing to meet the Downer EDI CES01183 specification.
