# Loss of separation involving CASA C212-CC, VH-MQD, operating in the Richmond parachuting area and Boeing 737-7BX, VH VBP

near Richmond Aerodrome, NSW | 5 November 2011

**ATSB Transport Safety Report**  
Aviation Occurrence Investigation  
AO-2011-142  
Final – 16 December 2013

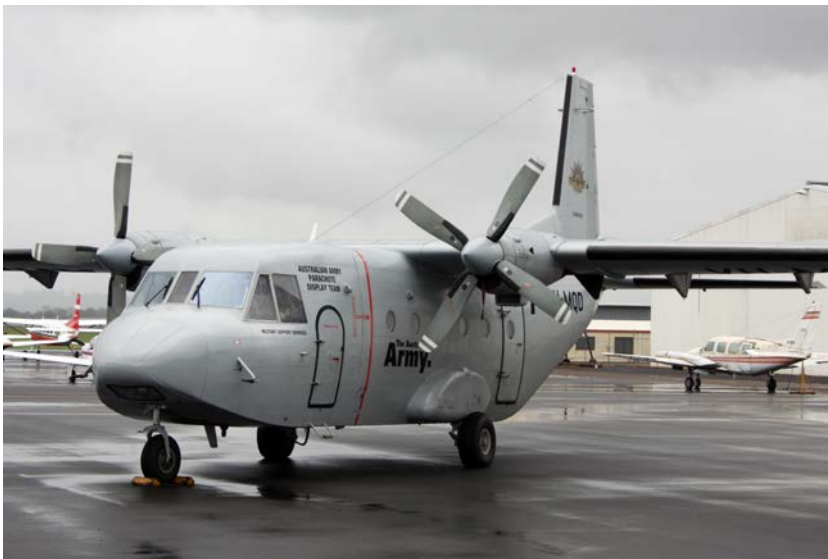
**Figure 1: Aircraft VH-MQD**

- a Construcciones Aeronáuticas S A C212-CC (C212) aircraft, registered VH-MQD (Figure 1), which was conducting parachute operations over the Western Grass Drop Zone at Richmond
- a Boeing Company 737-7BX (737) aircraft, registered VH-VBP, which was being operated on a scheduled passenger flight from Sydney to Cairns, Queensland.

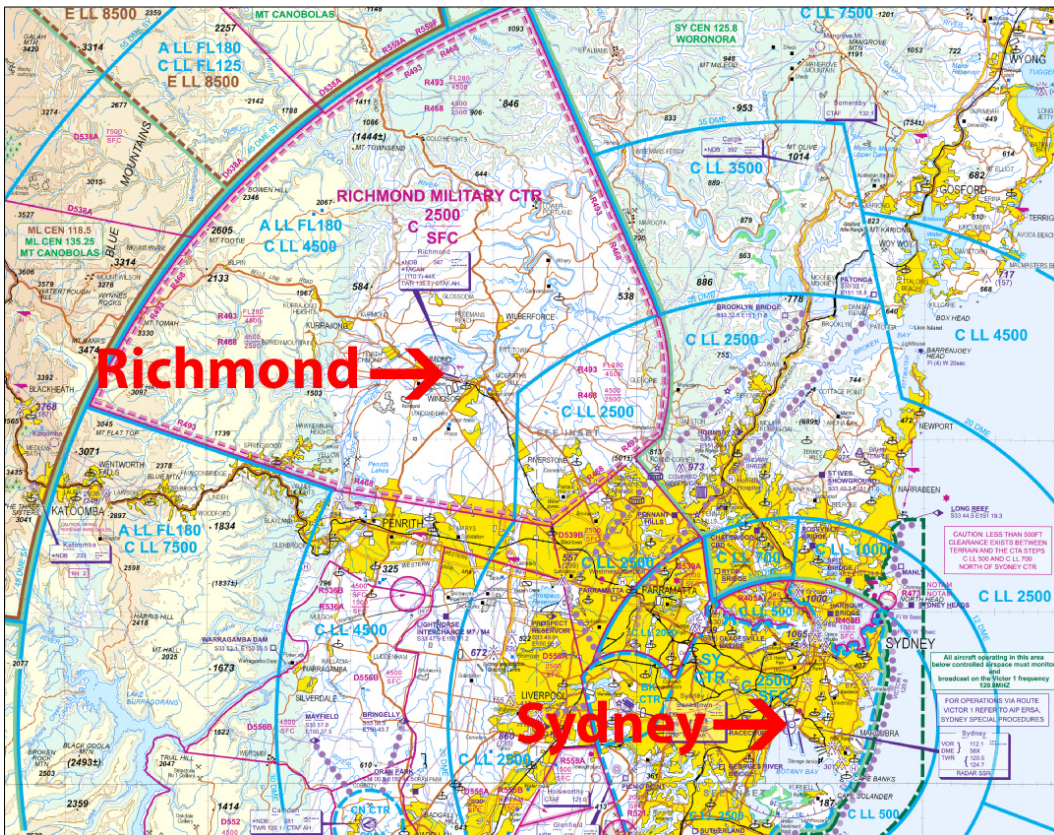
Figure 7: Airspace map

Richmond was a military aerodrome located 50 km north-west of Sydney with Australian Defence Force (ADF) controllers who were responsible for the provision of ATC Tower services within the Richmond Control Zone (CTR). This zone extended from the surface to 2,500 ft (Figure 7). Military operations had priority for the use of Richmond’s airspace.

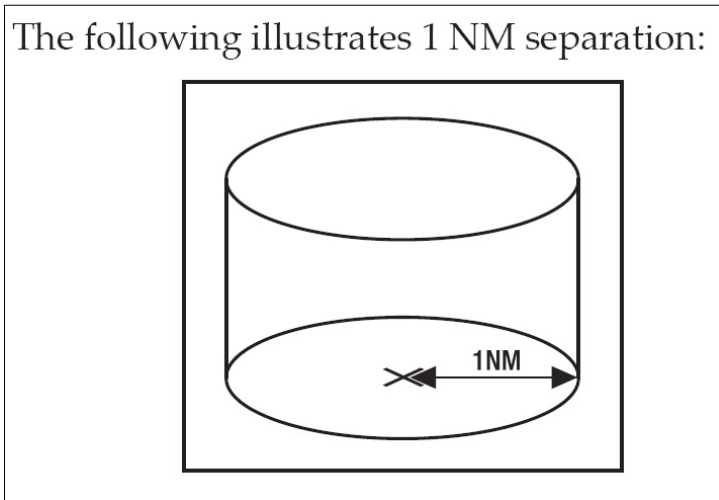
**Figure 8: MATS separation requirement for parachute operations**

MATS contained a graphical illustration of the separation area to be applied to parachuting operations (Figure 8).

According to the Civil Aviation Safety Authority, the 1 NM (1.85 km) radius around a declared parachute operations area had to be supplemented by an additional 1 NM buffer, as specified in MATS 10-60-420 for operations without a specifically defined separation standard (see also Figure 9 in the *Safety analysis – Loss of separation* section of this report). However, Airservices reported that it did not consider the buffer was a requirement.
