Australian Government
Australian Transport Safety Bureau

Aviation Short Investigations Bulletin

Issue 29

ATSB Transport Safety Report
Aviation Short Investigations
AB-2014-046
Final – 8 April 2014

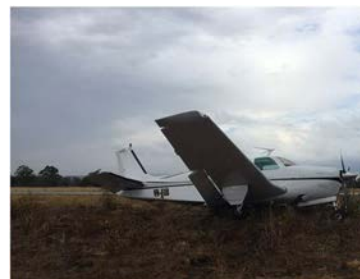
VH-EUB

On 19 February 2014, at about 1030 Eastern Daylight-savings Time (EDT), a Beech A36 (Bonanza) aircraft, registered VH-EUB, departed Lilydale aeroplane landing area (ALA), Victoria, for a training flight, with an instructor and pilot-under-instruction on board. The purpose of the flight was to complete a constant speed unit (CSU) and a retractable undercarriage (landing gear) endorsement and familiarise the pilot with the aircraft type.
