Australian Government  
Australian Transport Safety Bureau

# Aviation Short Investigations Bulletin

Issue 33

**ATSB Transport Safety Report**  
Aviation Short Investigations  
AB-2014-115  
Final – 6 August 2014

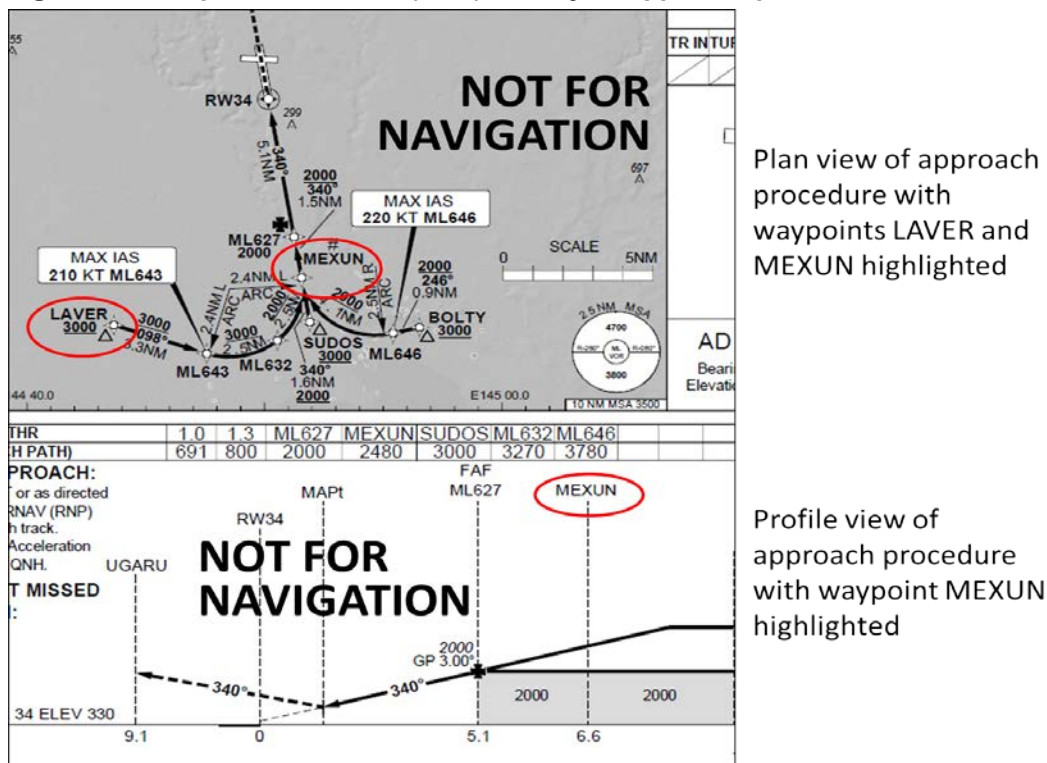
Figure 1: Excerpt from RNAV-P (RNP) runway 34 approach procedure<sup>2</sup>

<sup>4</sup> The approach procedure includes a table (Figure 1) that provides recommended altitudes at specific distances from the runway threshold and approach waypoints, to provide guidance with respect to a constant descent path. An aircraft flying a constant 'on profile' descent would normally pass over MEXUN at 2,480 ft as the table indicates, but that altitude does not represent a minimum safe altitude or altitude constraint.

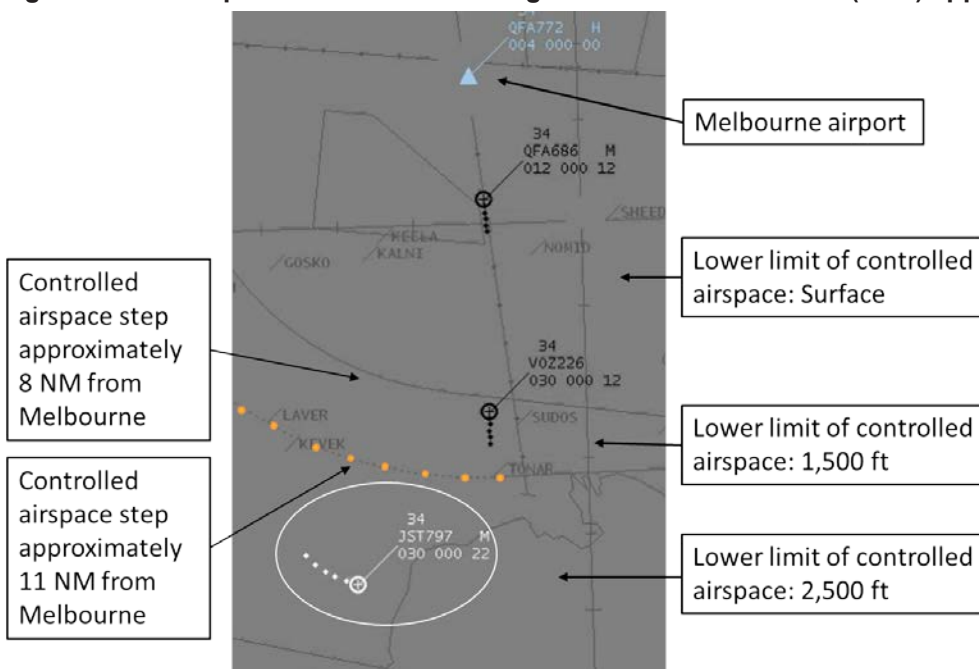
**Figure 2: Aircraft position soon after being cleared for the RNAV-P (RNP) approach**

The crew read back the clearance to track direct to MEXUN, which was followed almost immediately by an ATC clearance to conduct the RNAV-P (RNP) approach to runway 34. ATC did not issue further descent instructions with that clearance. The position of the aircraft at 3,000 ft, soon after being cleared for the RNAV-P (RNP) approach, is depicted on an ATC radar image at Figure 2. When cleared to track direct to MEXUN, the crew entered MEXUN as the next waypoint on the flight management guidance system (FMGS) flight plan. When cleared for the approach, the crew armed final approach mode<sup>3</sup> which engaged almost immediately.

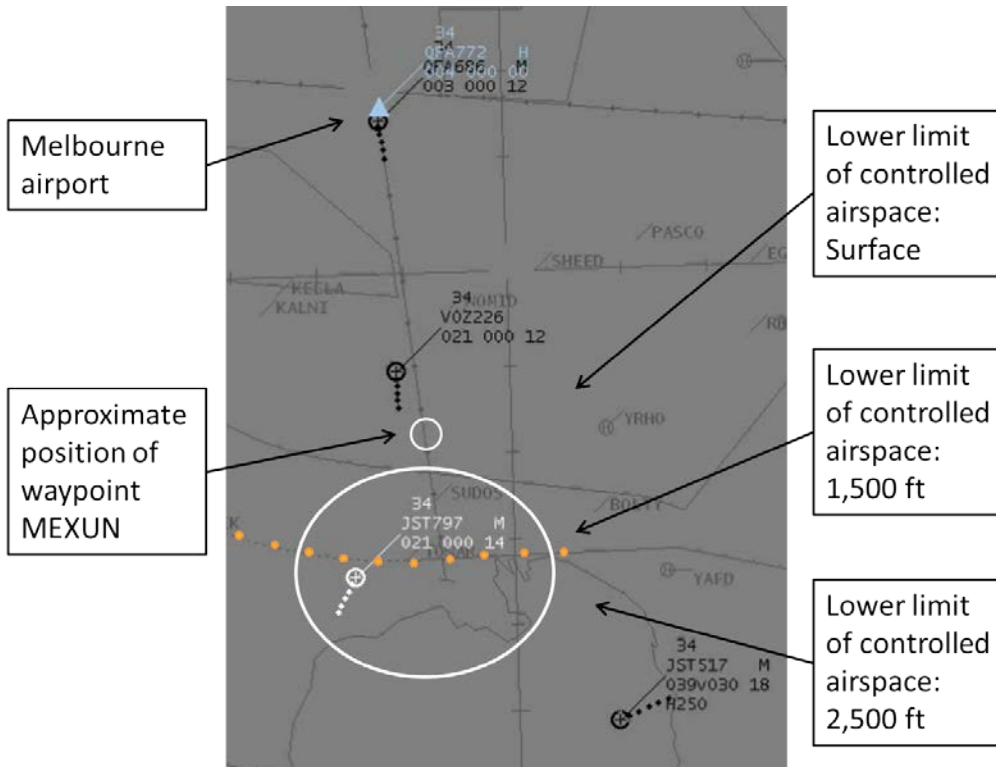
**Figure 3: Aircraft position at 2,100 ft tracking toward waypoint MEXUN**

Soon after, as the aircraft passed about 2,400 ft, ATC cautioned the crew to the effect that they were nearing the lowest safe altitude in their immediate area, and then updated that information as the aircraft continued toward MEXUN. Responding to the advice from ATC, the crew stopped the descent at 2,100 ft and continued towards MEXUN at that altitude. The point at which descent was stopped at 2,100 ft is depicted on an ATC radar image at Figure 3.

When the aircraft left 3,000 ft on descent, it entered the 500 ft buffer between the aircraft and the lower limit of controlled airspace,<sup>5</sup> then when it passed 2,500 ft, the aircraft left controlled airspace. Controlled airspace was re-entered as the aircraft reached the airspace with a lower limit 1,500 ft, 11 NM south of Melbourne. The elapsed time from the point the aircraft left 3,000 ft to the point it re-entered controlled airspace was about 1 minute and 15 seconds. The aircraft was outside controlled airspace for about 45 seconds. There was no conflict with other known air traffic and the approach continued normally from 2,100 ft following intercept of the intended descent profile.

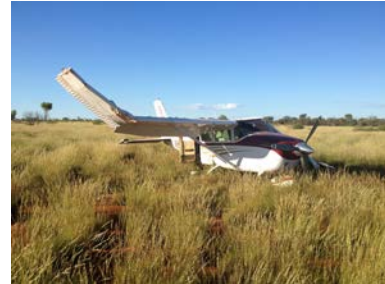
**Figure 1: Accident site**

On landing, the left wing impacted a tree and the aircraft spun around 180 degrees. The left wing was bent obstructing the only cockpit exit door. The fuel system had been disrupted and fuel was quickly entering the cockpit area. The pilot shut down all remaining systems and climbed into the rear section of the aircraft. The forward section of the cargo door was obstructed by the flaps in the full down position. The pilot exited the aircraft through the rear section of the cargo door and was not injured. The aircraft was substantially damaged (Figure 1).

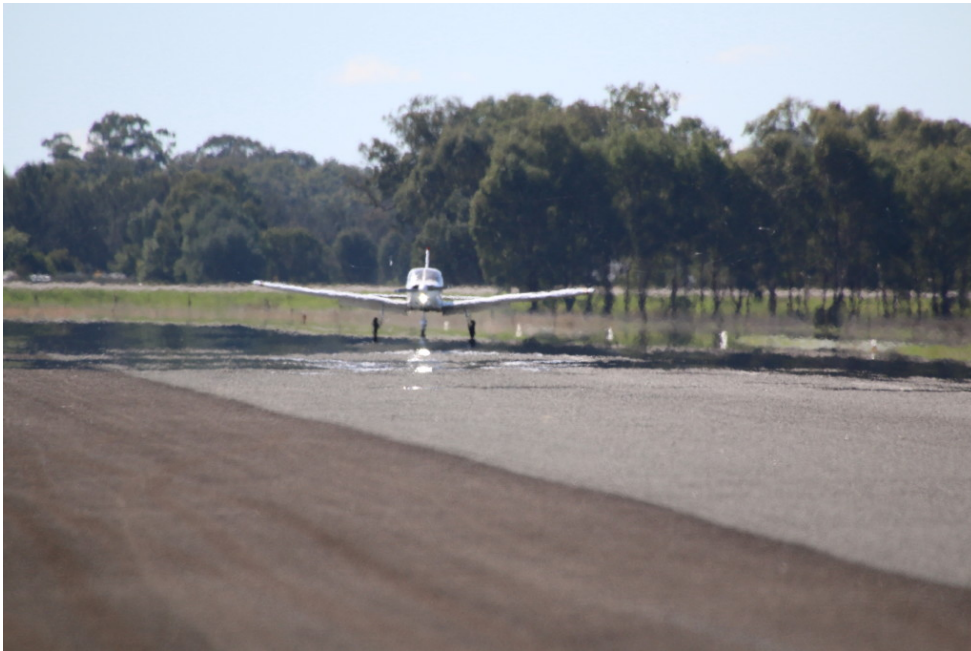
**Figure 2: The aircraft touchdown**

FEZ touched down near the threshold on runway 18 (Figure 2). As FEZ became airborne following the touch and go, the instructor then noticed some barricades off the right side of the

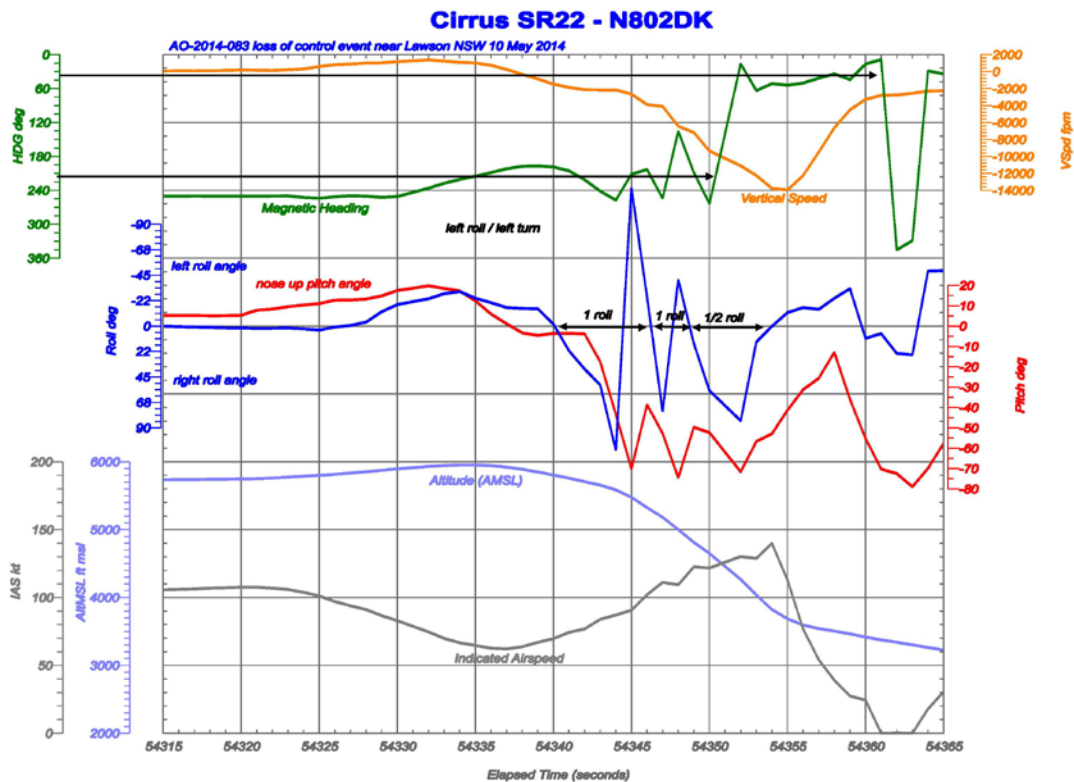
Figure 2: Roll and pitch data

At the commencement of the manoeuvre, when at about 5,800 ft AMSL, the aircraft nose pitched up to about 20°, and simultaneously entered a left turn with about 25° angle of bank (roll) (Figure 2). The maximum roll value in the turn was about 30° with a corresponding pitch angle of about 17°. The indicated airspeed reduced to about 62 kt. The right wing then dropped rapidly and the aircraft rolled to the right, the nose pitched down to about 70° and the aircraft commenced a nose low spin to the right. The first complete roll to the right took about 6 seconds and the second roll had a noticeably higher roll rate and took about 2.5 seconds. The roll rate then reduced, with the next 180° of roll taking about 5 seconds. The CAPS was deployed and the parachute inflated when the aircraft was about 1,000 ft above ground level. The aircraft continued to roll when the parachute inflated, and the aircraft nose pitched down about 80°. The maximum vertical speed reached about 14,000 feet per minute prior to the CAPS deployment.

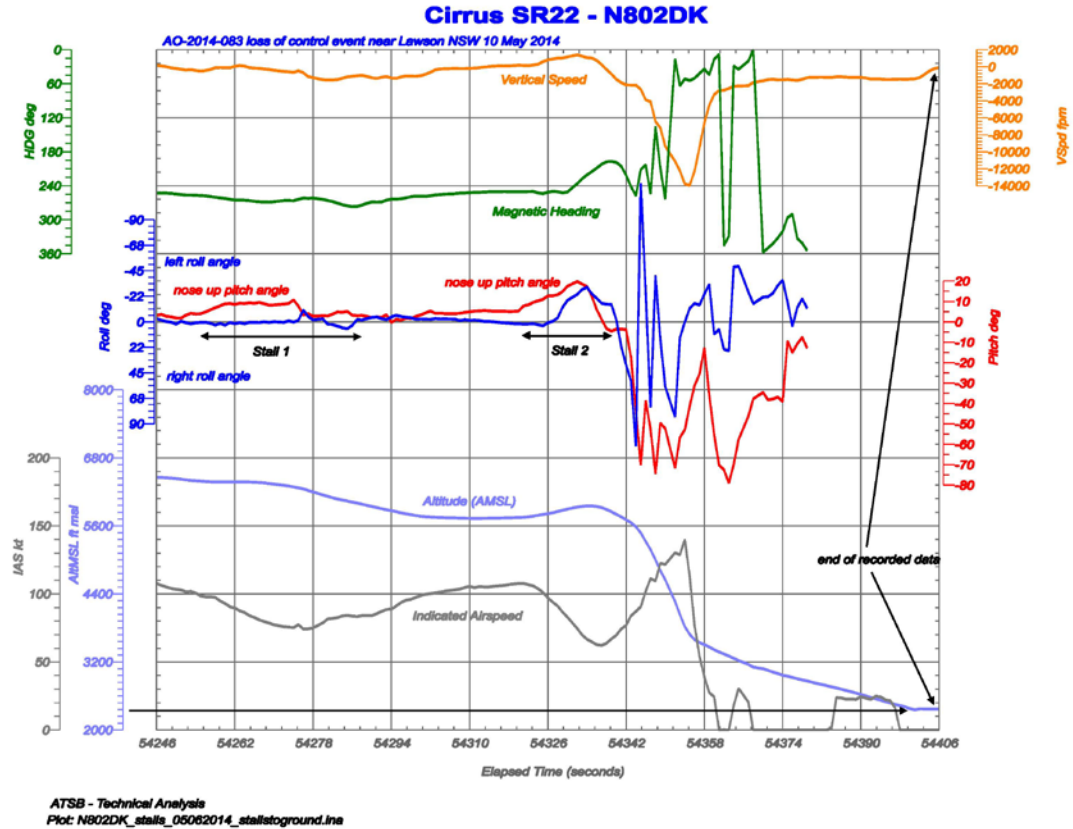
Figure 3: Flight data from N802DK

Figure 3 shows the flight data from the commencement of the first stall until the aircraft collided with the ground. The nose up pitch angle in the first stall reached a maximum of about 9°, and in the second stall about 20° was reached. The first stall developed over a period of about 25 seconds before recovery and the second was about 16 seconds prior to the aircraft nose dropping below the horizon. In the first stall, the airspeed reduced from 100 kt to 75 kt in about 25 seconds, and in the second stall the airspeed reduced from about 100 kt to 62 kt in about 12 seconds.

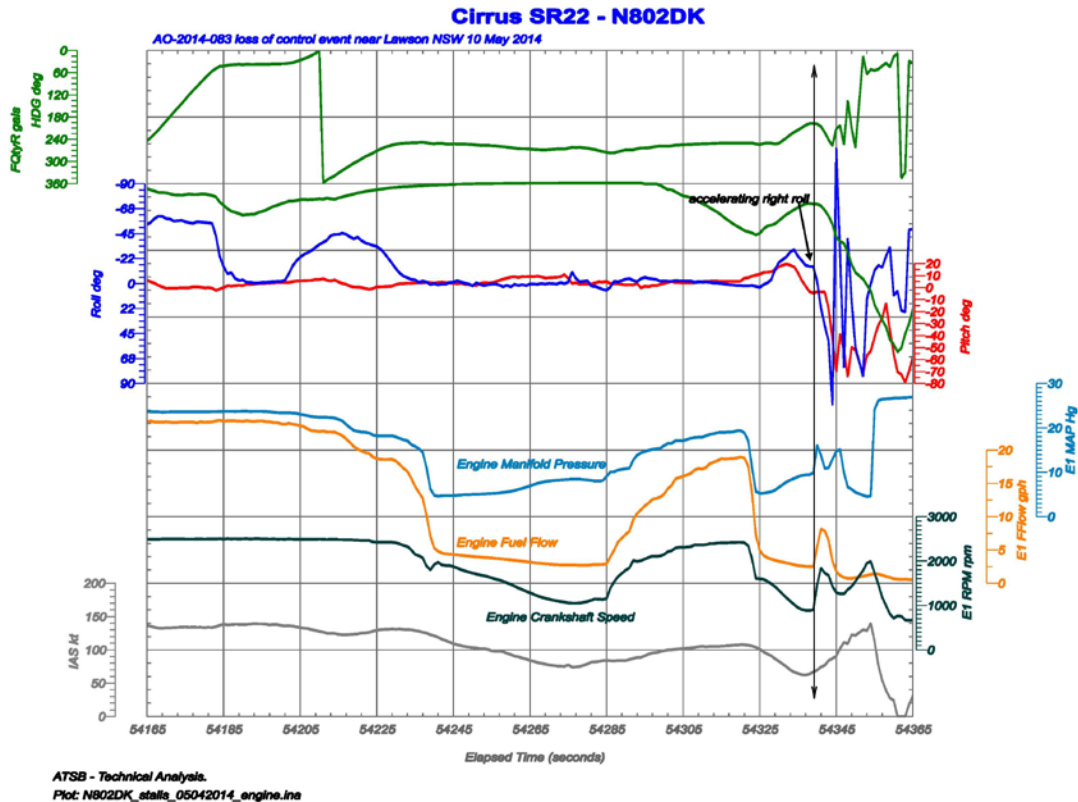
Figure 4: Flight data depicting engine settings

Figure 4 depicts the engine parameters during the steep turn, the wings-level stall and the subsequent stall, spin and CAPS deployment. The manifold pressure, fuel flow and crankshaft speed (rpm) were reduced prior to commencement of the manoeuvre. These then increased in a consistent manner at the incipient spin stage. The rpm increased momentarily prior to the engine shutdown while the manifold pressure was low. This may have been due to increasing airspeed, low nose attitude and high rate of descent.

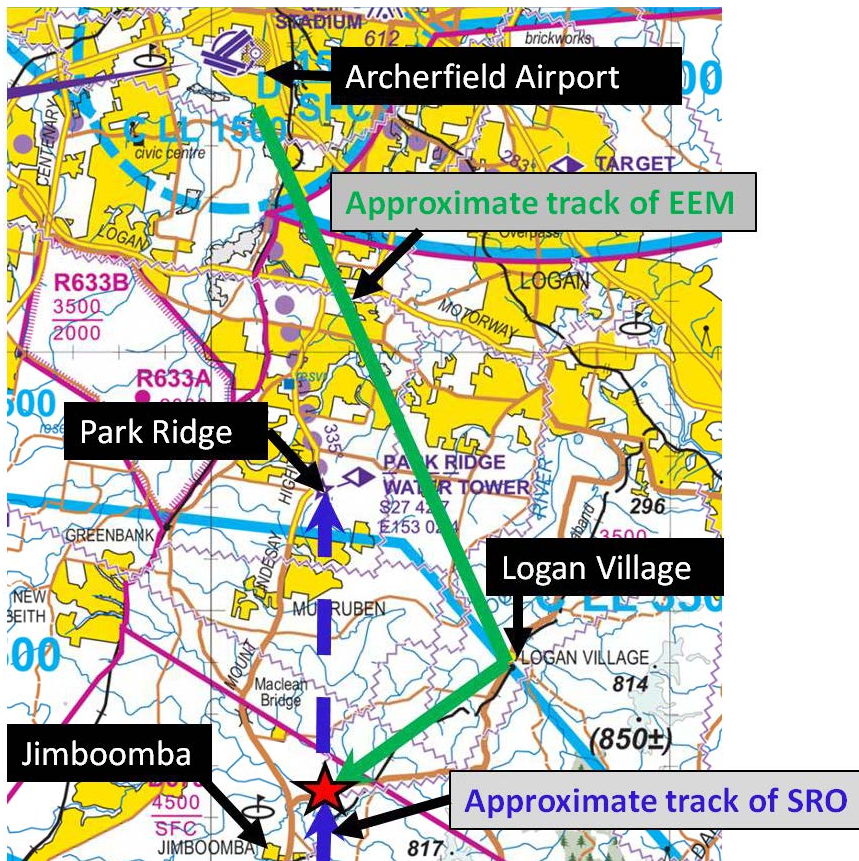
Figure 1: Aircraft tracks overlaid on Brisbane visual terminal chart

On 30 May 2014 at about 0900 Eastern Standard Time (EST), a Beech BE76 aircraft, registered VH-SRO (SRO), departed Archerfield Airport, Queensland, for a local flight to the training area south of the airport, with an instructor and a pilot in command under supervision (ICUS) on board. At about 0920, the student pilot of a Cessna 172 aircraft, registered VH-EEM (EEM), departed Archerfield for a solo local area flight. The student’s planned route was to track 135° (south-east) outbound from Archerfield at 1,000 ft above mean sea level (AMSL), and when overhead the Logan Motorway, climb to 2,500 ft AMSL and track towards Logan Village. At Logan Village, the student pilot climbed the aircraft to 3,000 ft AMSL and practiced turns before tracking towards Jimboomba (Figure 1). The pilot of another aircraft in the vicinity broadcast on the area frequency and the student pilot of EEM sighted that aircraft and responded.

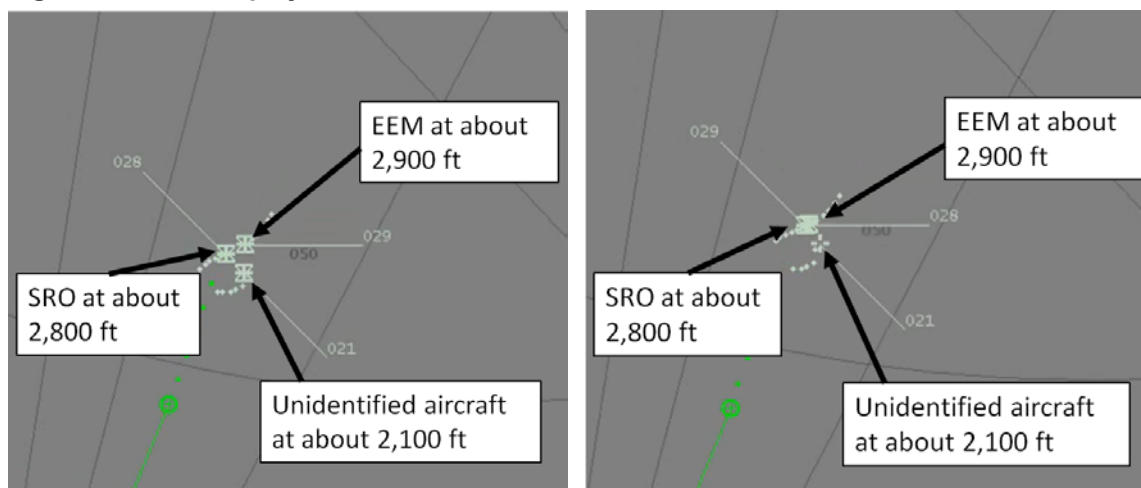
**Figure 2: Radar display of the incident**

Radar data provided to the ATSB by Airservices Australia indicated that EEM passed about 100 ft over SRO (Figure 2), with aircraft altitudes unverified.

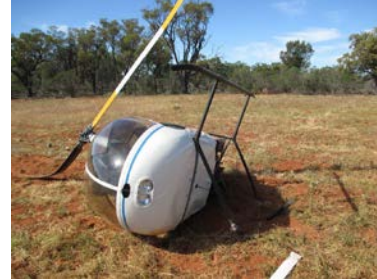
Accident site

As the helicopter turned left, the pilot felt a violent shudder through the cyclic<sup>2</sup> control. The pilot reported that the helicopter continued to yaw<sup>3</sup> and he applied opposite pedal in an attempt to counteract the yaw, however the pedal was ineffective and the yaw accelerated. The pilot rolled the throttle off, moved the cyclic forward and lowered the collective<sup>4</sup>. As the helicopter descended rapidly, the pilot then raised the collective to cushion the landing. The right skid touched down first and the helicopter rolled to the right, coming to rest on the right side (Figure 1).
